## **CLADDING MOISTURE REPORT**

INSPECTED FOR  
**TEST STUCCO**

**June 4, 2020**

Subject Property : , TX

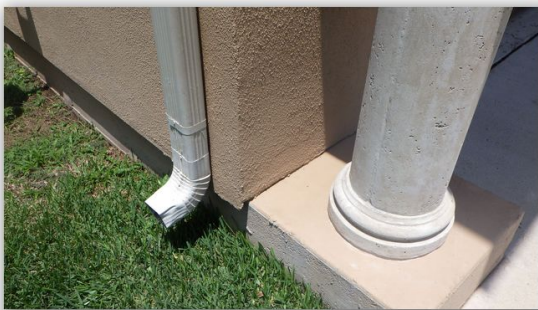
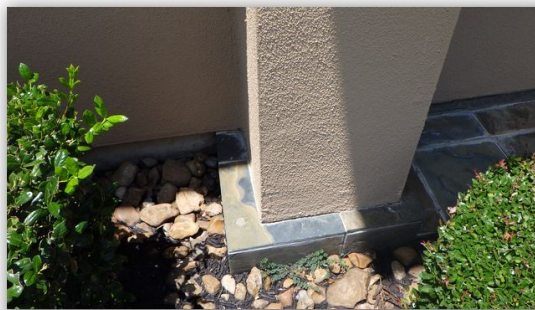
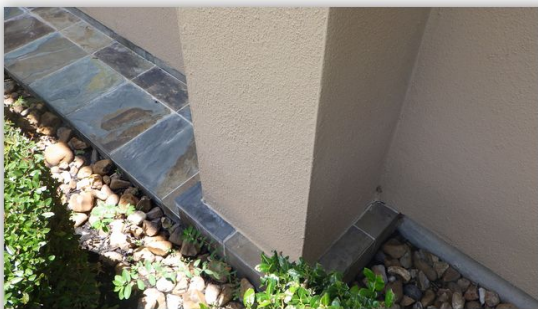
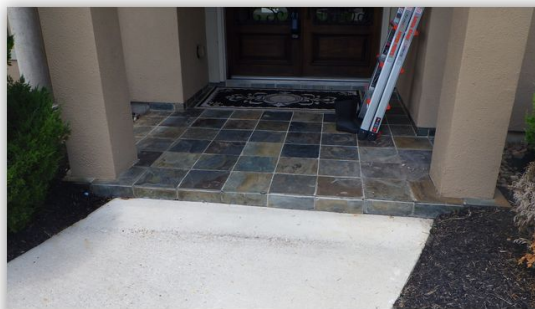
**Item Number 1**

- The stucco has poor clearance from the concrete flatwork. Under current installation standards, there should be at least 1.5 to 2-inches of clearance between the concrete flatwork and the stucco material. There are no visible defects related to this application at this time and no remedial repairs are recommended.

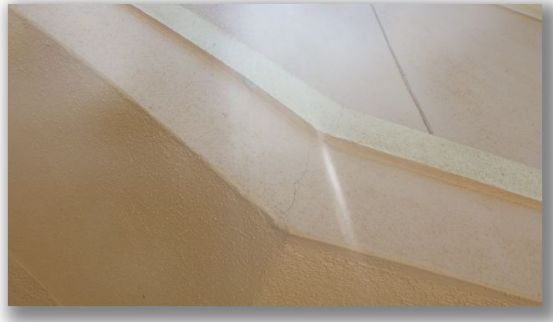
### Item Number 2

- Some minor cracking of the stucco finish was observed in one or more locations at the time of this inspection. The cracks observed were less than 1/16-inch and are consistent to be within accepted industry standards and no remedial repairs are recommended.

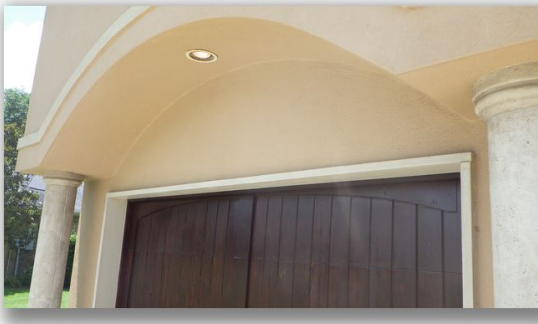
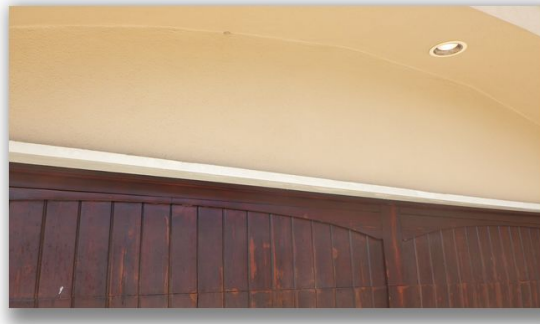
### Item Number 3

- There is no visible through wall flashing (head flashing) above the doors. Under current stucco installation standards, there should be through wall flashing continuously above all doors to help prevent water intrusion at these locations.

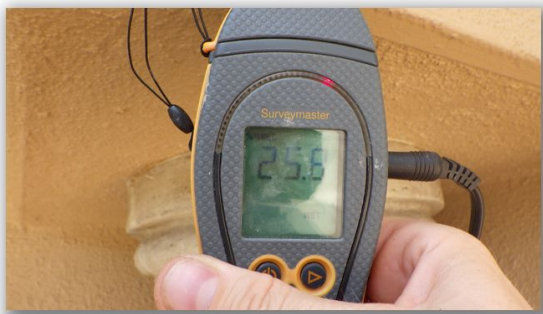
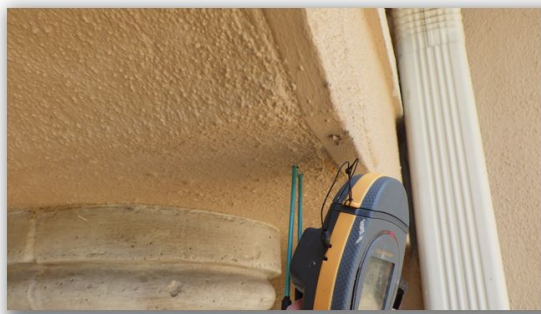
### Item Number 4

- There is missing kickout flashing details at the lower bottom edge of the roof line interface and the sidewall that continues past the edge of the roof. The lack of this kickout flashing will allow water to penetrate at these points. It is recommended to have kickout flashing details installed to help prevent future water intrusion at this locations.

- The substrate (sheathing) behind the stucco finishes appear to be compromised. The stucco is bulging and very spongy to the touch. This condition needs to be further evaluated and repaired as necessary. It is my professional opinion that the stucco in the affected areas will need to be removed, the substrate replaced and the stucco finishes replaced.

- There is visible evidence of water intrusion through the stucco cladding system. This condition has caused some visible damage to the stucco cladding. This condition should be further evaluated and [repairs are recommended](#).

- Rust was observed on the stucco finish. This is an indication that water intrusion behind the stucco finish has occurred. [Repairs are recommended](#).

- Elevated moisture levels were detected in the wall finished surfaces.

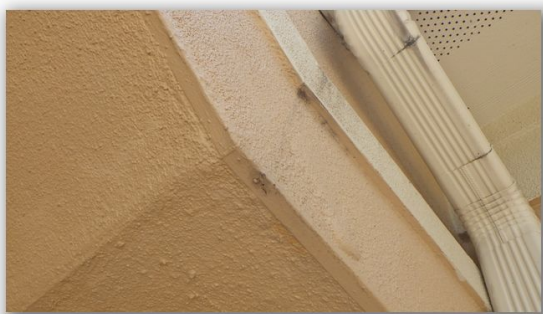
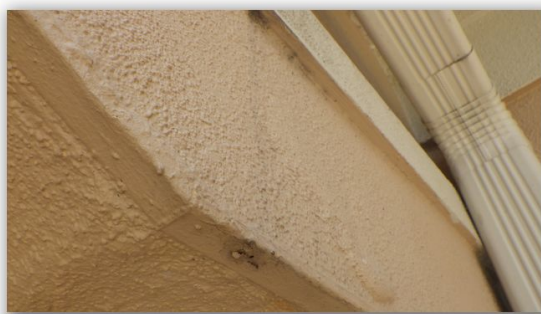
**Item Number 5**

- There is visible bulging and/or releasing of the stucco finish observed. This condition needs to be further evaluated and repairs are recommended.

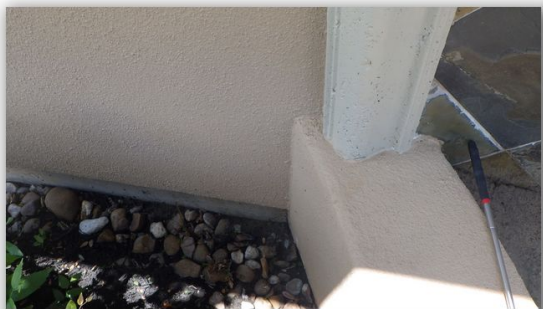
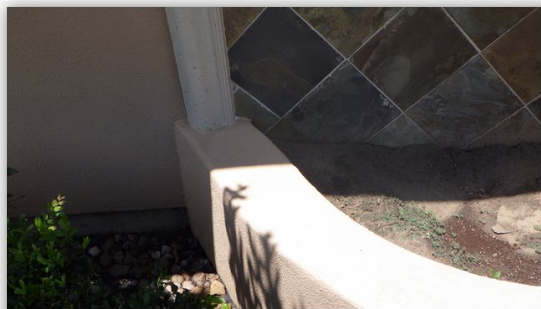
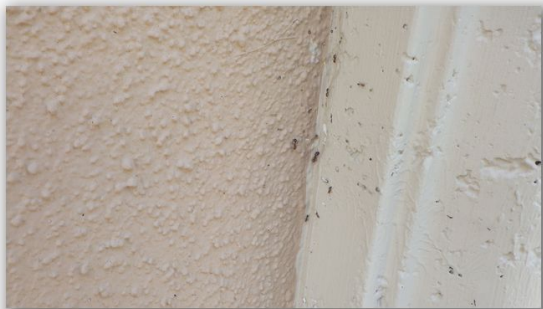
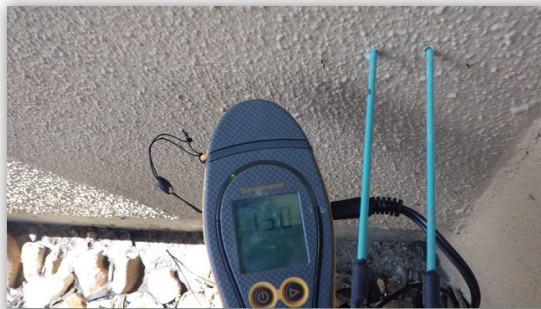
**Item Number 6**

- The ants have built a nest behind the stucco veneer. It is recommended to remove the nest to prevent moisture damage behind the stucco.

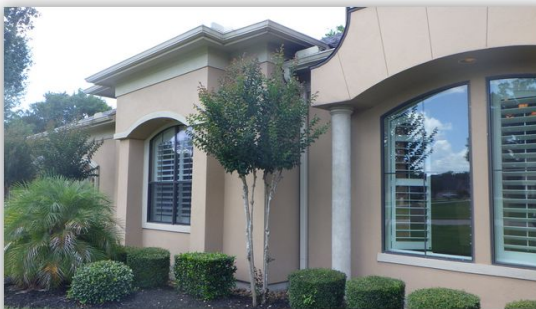
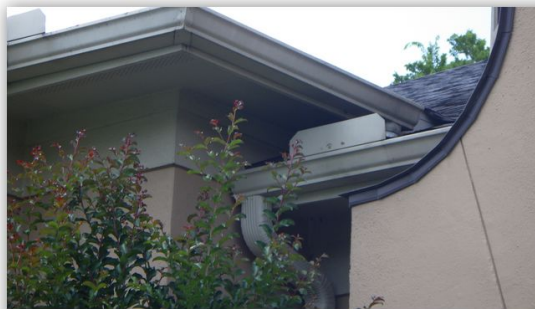
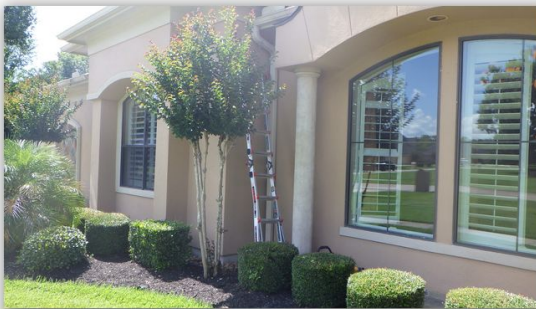
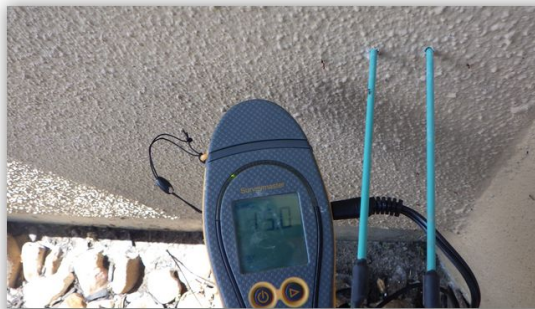
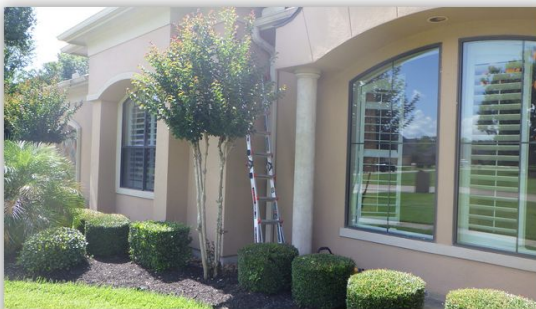
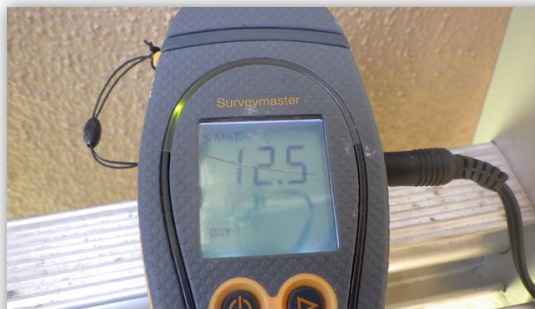
**Item Number 7**

- There is missing kickout flashing details at the lower bottom edge of the roof line interface and the sidewall that continues past the edge of the roof. The lack of this kickout flashing will allow water to penetrate at these points. It is recommended to have kickout flashing details installed to help prevent future water intrusion at this locations.
- The substrate (sheathing) behind the stucco finishes appear to be compromised. The stucco is bulging and very spongy to the touch. This condition needs to be further evaluated and repaired as necessary. It is my professional opinion that the stucco in the affected areas will need to be removed, the substrate replaced and the stucco finishes replaced.

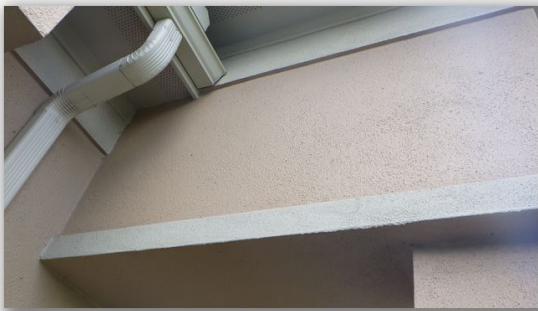
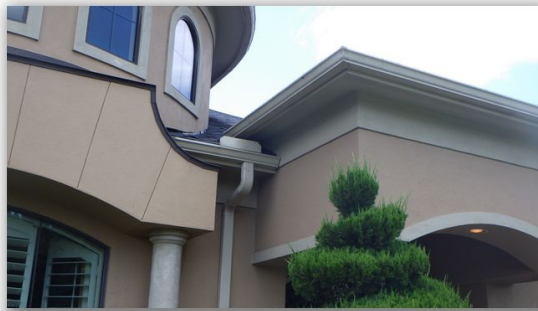
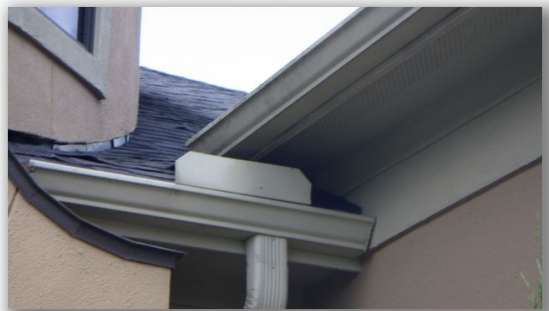
**Item Number 8**

- There is missing kickout flashing details at the lower bottom edge of the roof line interface and the sidewall that continues past the edge of the roof. The lack of this kickout flashing will allow water to penetrate at these points. It is recommended to have kickout flashing details installed to help prevent future water intrusion at this locations.
- The stucco weep screed was observed to be missing.

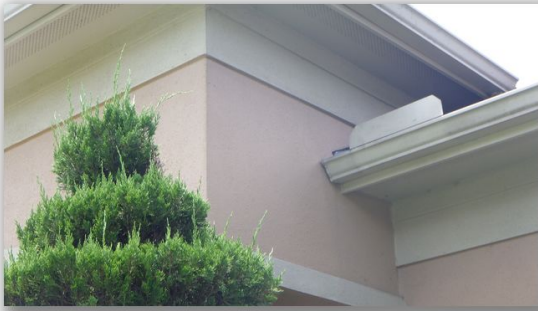
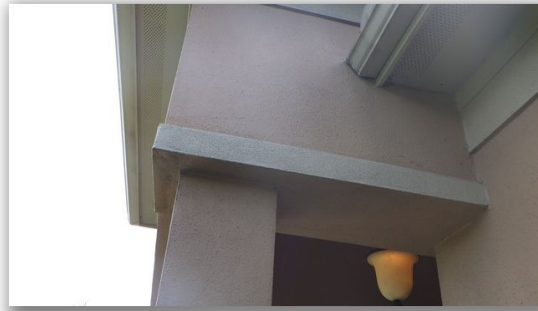
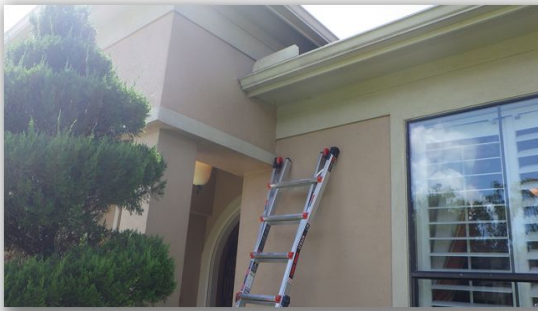
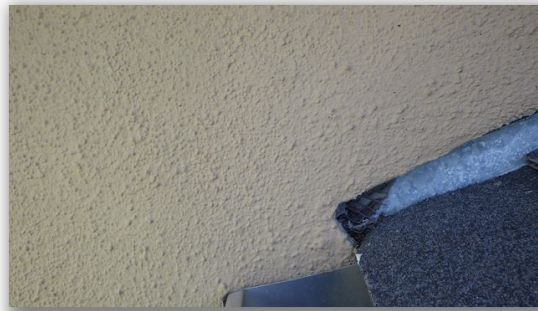
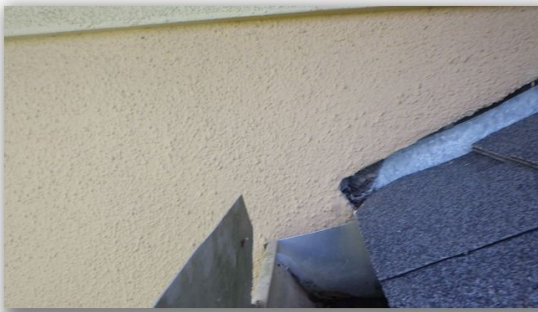
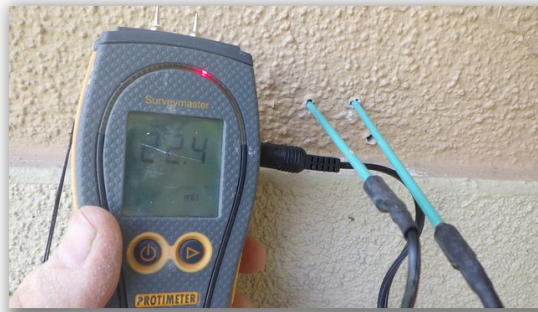
**Item Number 9**

- There is missing kickout flashing details at the lower bottom edge of the roof line interface and the sidewall that continues past the edge of the roof. The lack of this kickout flashing will allow water to penetrate at these points. It is recommended to have kickout flashing details installed to help prevent future water intrusion at this locations.
- The substrate (sheathing) behind the stucco finishes appear to be compromised. The stucco is bulging and very spongy to the touch. This condition needs to be further evaluated and repaired as necessary. It is my professional opinion that the stucco in the affected areas will need to be removed, the substrate replaced and the stucco finishes replaced.

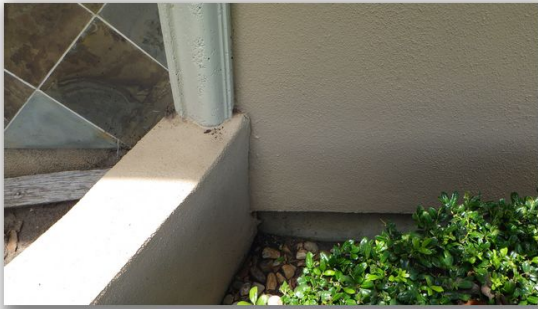
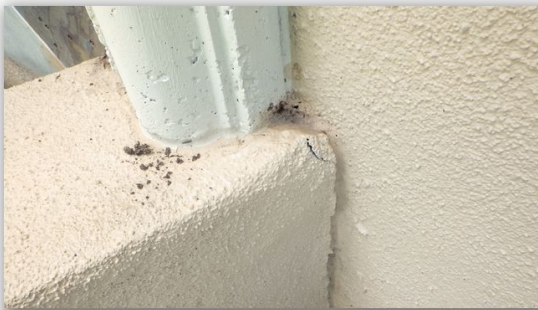
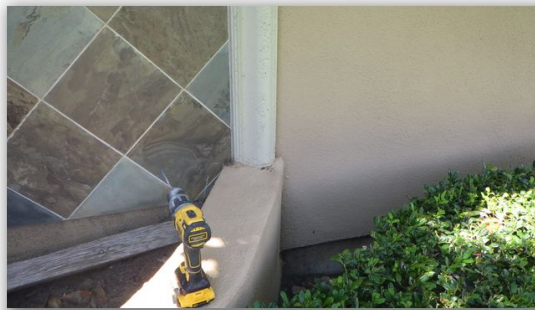
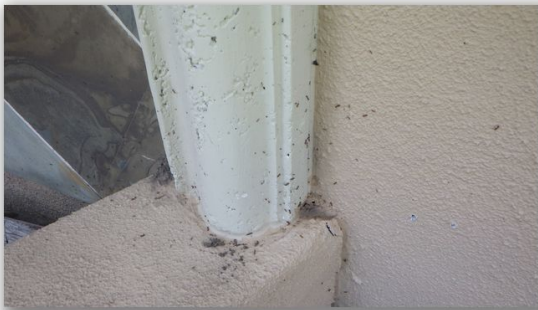
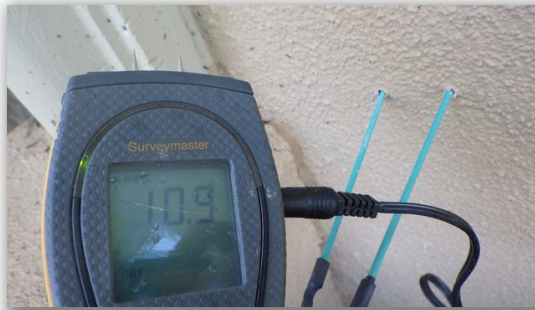
**Item Number 10**

- The ants have built a nest behind the stucco veneer. It is recommended to remove the nest to prevent moisture damage behind the stucco.

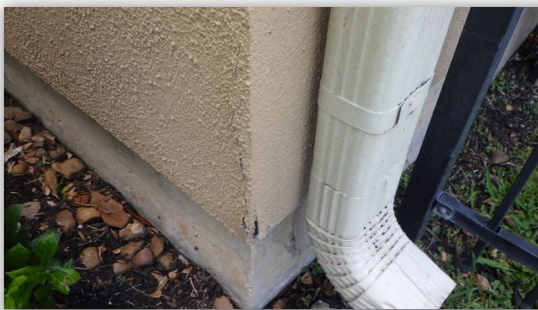
**Item Number 11**

- Impact damage was observed in one or more locations. Repairs are recommended.

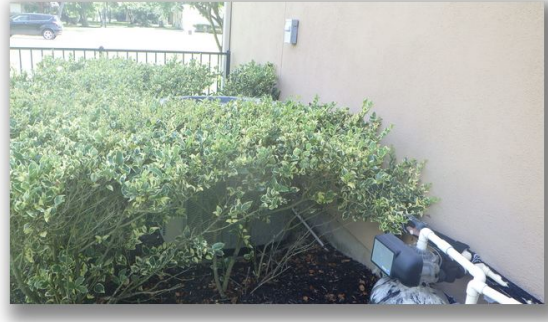
### Item Number 1

- There is foliage in contact with the exterior stucco finishes. It is recommended to trim the foliage at least 18-inches off the exterior walls.

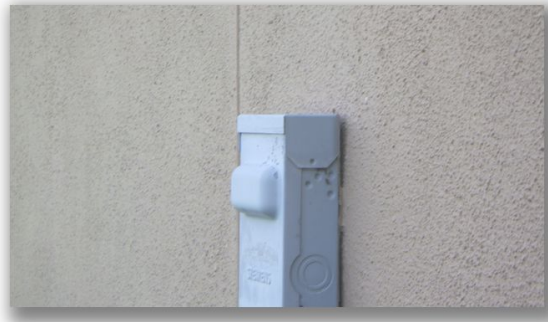
### Item Number 2

- The area between the exterior cladding / veneer and all of the wall penetrations / openings need to be properly sealed. Areas such as utility connections, downspouts, hose bibbs, lighting fixtures, receptacles etc. It is recommended to use an elastomeric caulking / sealant.

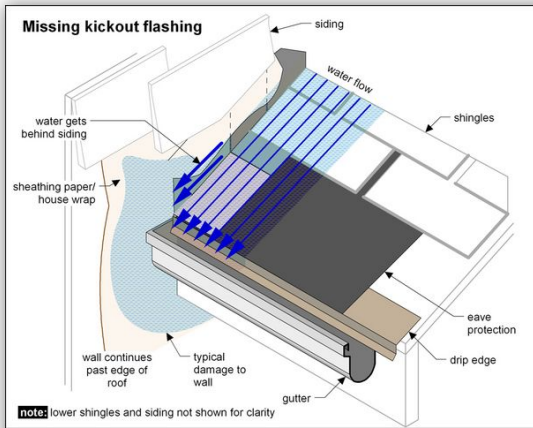
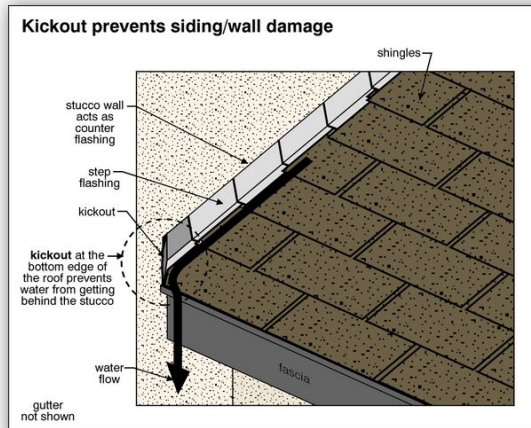
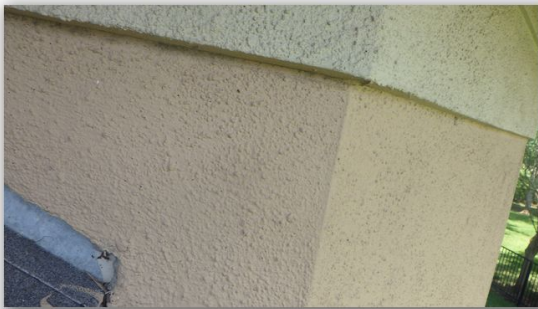
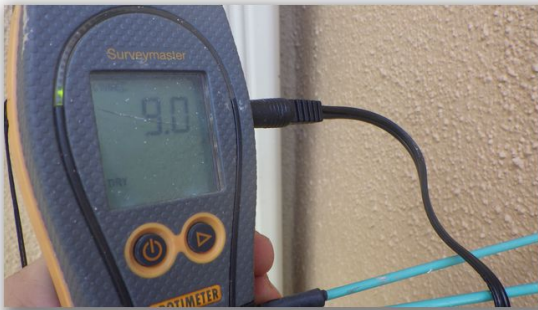
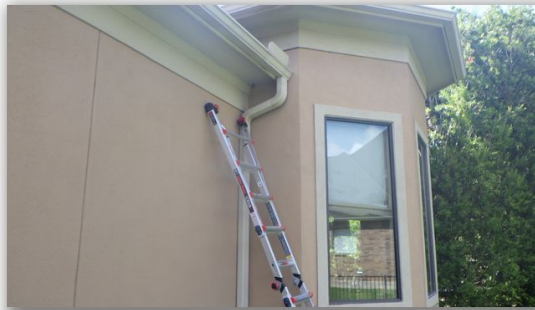
### Item Number 3

- There is missing kickout flashing details at the lower bottom edge of the roof line interface and the sidewall that continues past the edge of the roof. The lack of this kickout flashing will allow water to penetrate at these points. It is recommended to have kickout flashing details installed to help prevent future water intrusion at this locations.

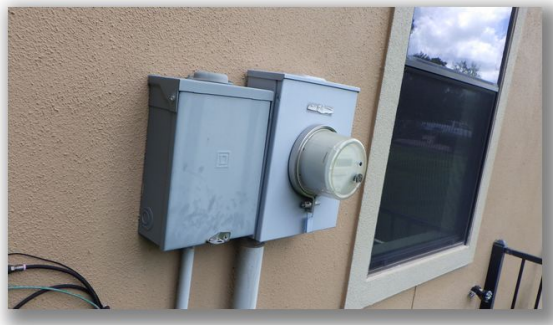
#### Item Number 1

- The area between the exterior cladding / veneer and all of the wall penetrations / openings need to be properly sealed. Areas such as utility connections, downspouts, hose bibbs, lighting fixtures, receptacles etc. It is recommended to use an elastomeric caulking / sealant.

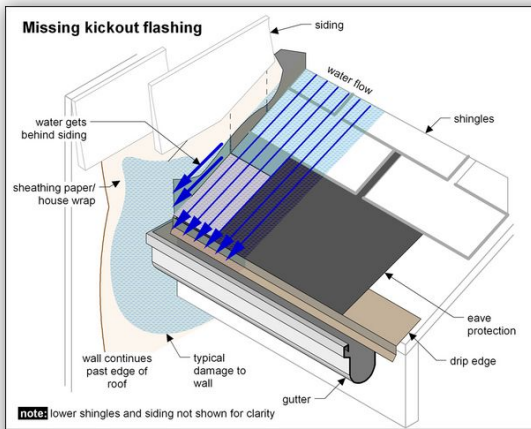
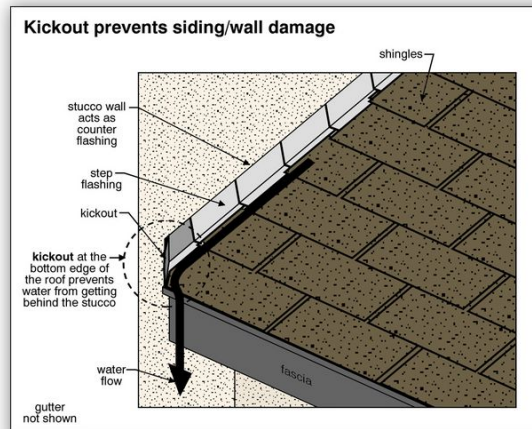
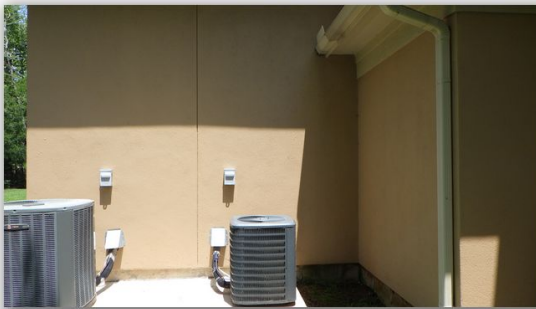
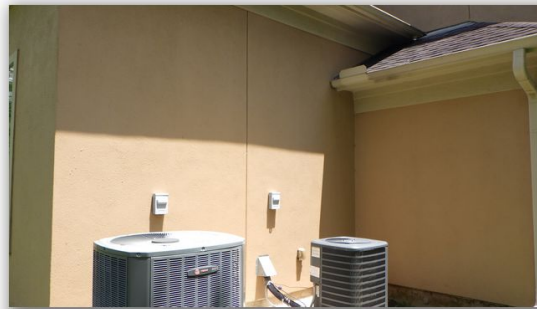
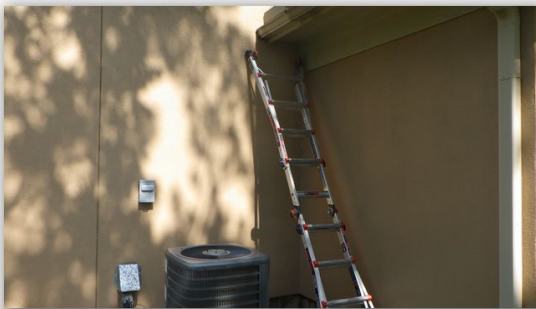
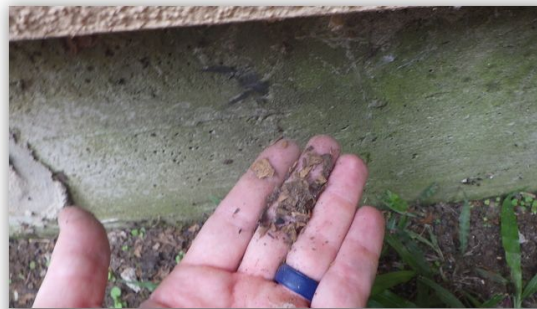
### Item Number 1

- There is missing kickout flashing details at the lower bottom edge of the roof line interface and the sidewall that continues past the edge of the roof. The lack of this kickout flashing will allow water to penetrate at these points. It is recommended to have kickout flashing details installed to help prevent future water intrusion at this locations.

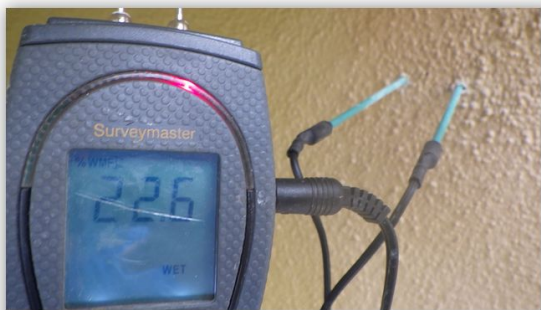
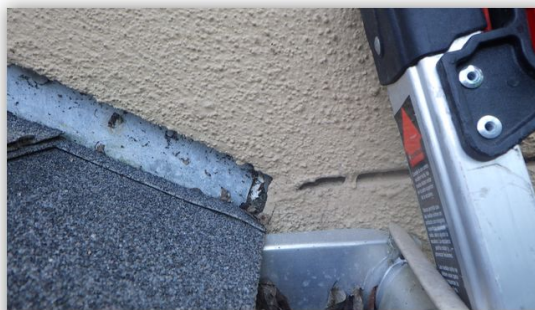
### Item Number 2

- There is missing kickout flashing details at the lower bottom edge of the roof line interface and the sidewall that continues past the edge of the roof. The lack of this kickout flashing will allow water to penetrate at these points. It is recommended to have kickout flashing details installed to help prevent future water intrusion at this locations.

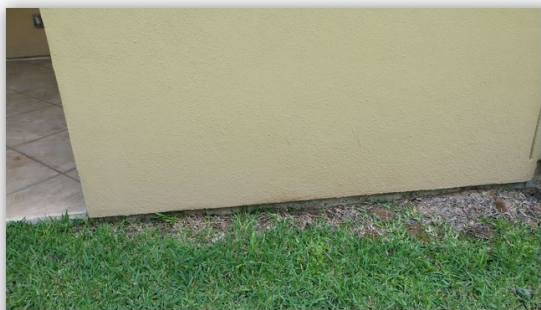
### Item Number 3

- The stucco weep screed was observed to be missing.

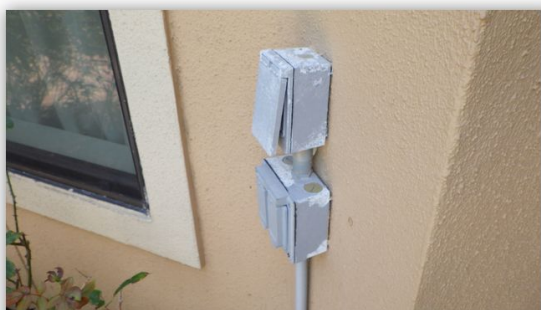
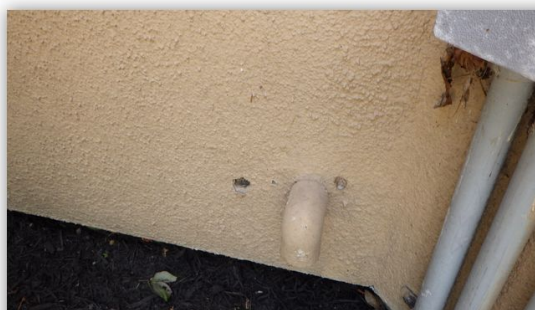
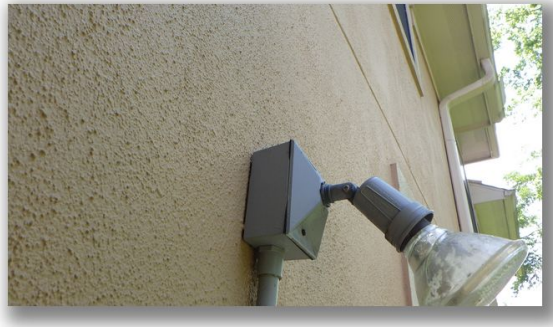
### Item Number 4

- The area between the exterior cladding / veneer and all of the wall penetrations / openings need to be properly sealed. Areas such as utility connections, downspouts, hose bibbs, lighting fixtures, receptacles etc. It is recommended to use an elastomeric caulking / sealant.

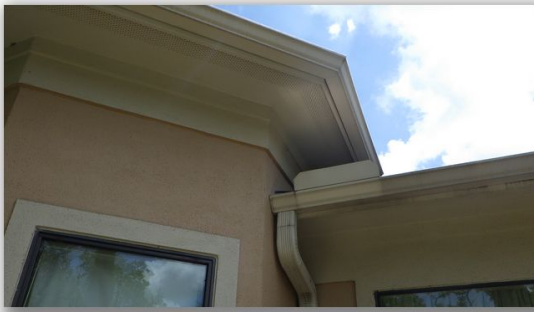
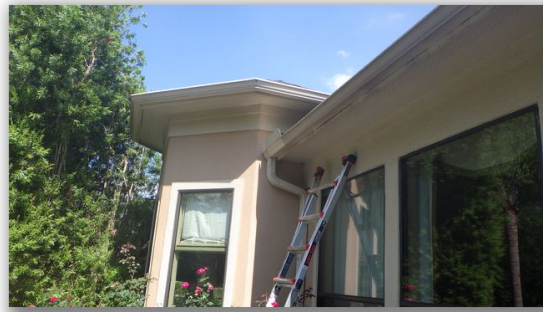
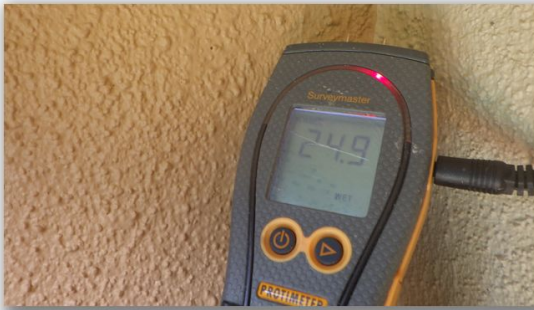
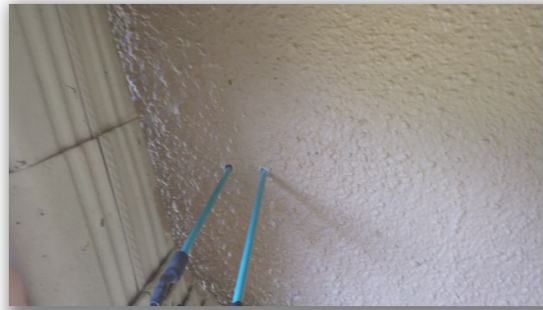
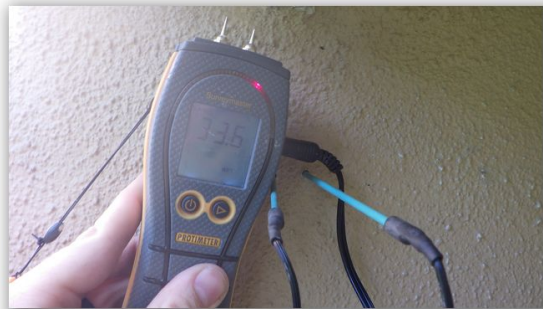
### Item Number 5

- There is missing kickout flashing details at the lower bottom edge of the roof line interface and the sidewall that continues past the edge of the roof. The lack of this kickout flashing will allow water to penetrate at these points. It is recommended to have kickout flashing details installed to help prevent future water intrusion at this locations.
