## **CLADDING MOISTURE REPORT**

**Stucco Inspection  
1234 No Name Street  
TX**

April 30, 2020

## Cladding Inspection Report

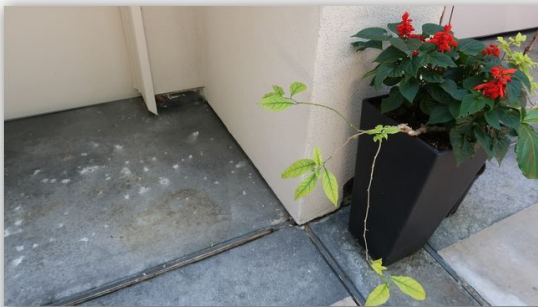
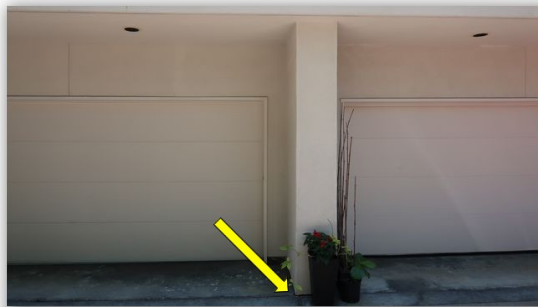
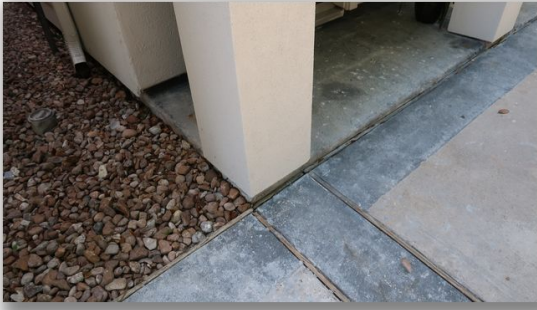
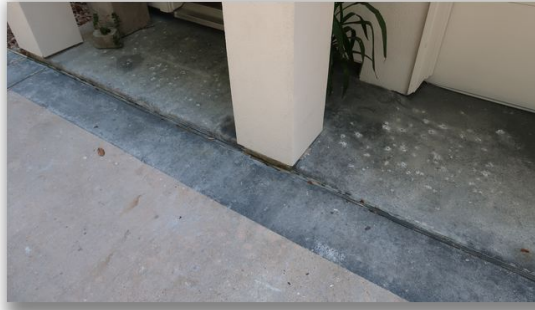
#### Item Number 1

- The stucco has poor clearance from the concrete flatwork. Under current installation standards, there should be at least 1.5 to 2-inches of clearance between the concrete flatwork and the stucco material. There are no visible defects related to this application at this time and **no remedial repairs are recommended.**

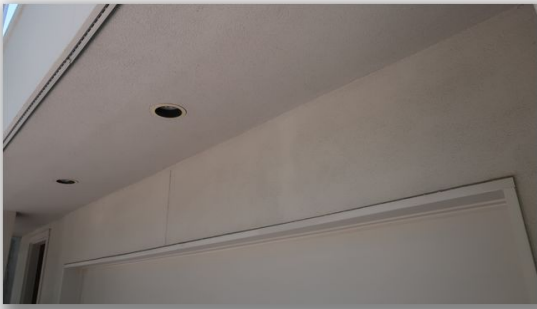
### Item Number 2

- There is no visible through wall flashing (head flashing) above the doors. Under current stucco installation standards, there should be through wall flashing continuously above all doors to help prevent water intrusion at these locations. **No Repairs Recommended.**

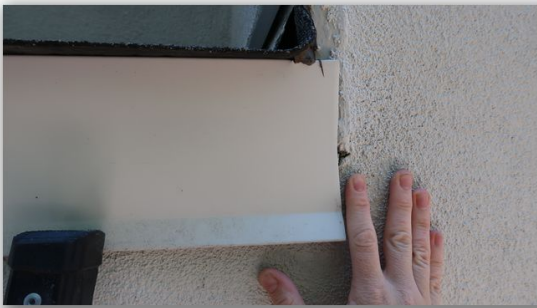
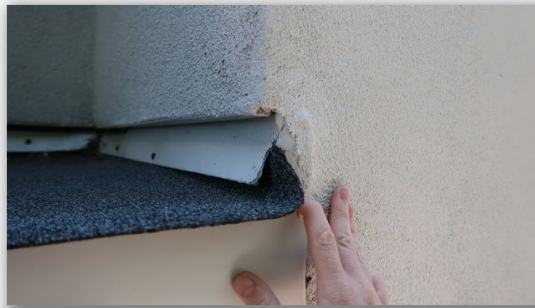
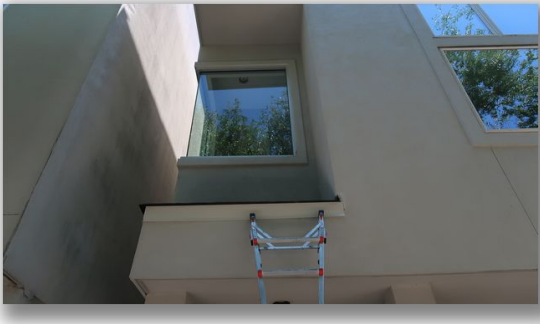
### Item Number 3

- The overhang floor pan is not water tight or otherwise compromised. [Repairs are recommended](#) to be made to prevent further moisture intrusion and damage to the stucco system.
- The sidewall flashing is missing on the front door overhang. [Repairs recommended](#) to prevent water intrusion to the stucco.

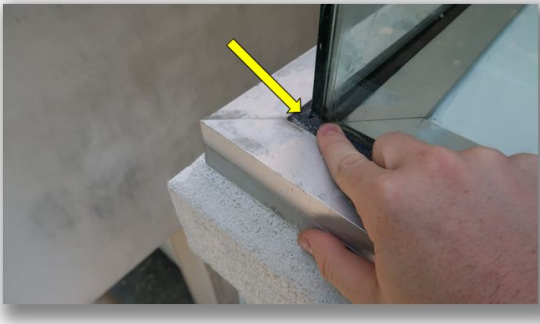
**Item Number 4**

- There is failing and/or missing sealant at and around the window openings. [Repairs recommended](#) to prevent water intrusion to the stucco.

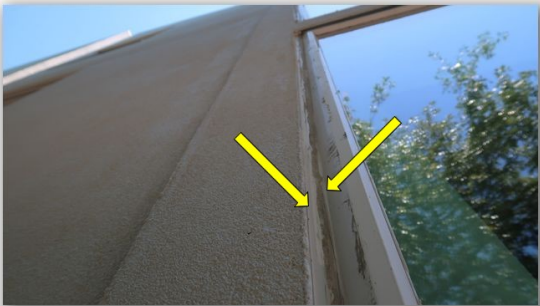
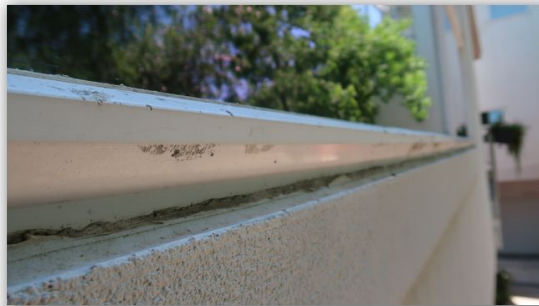
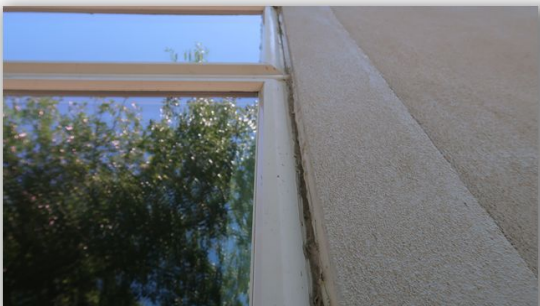
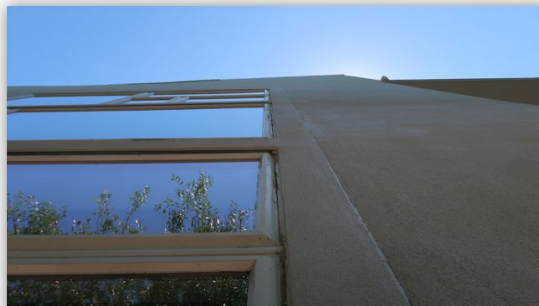
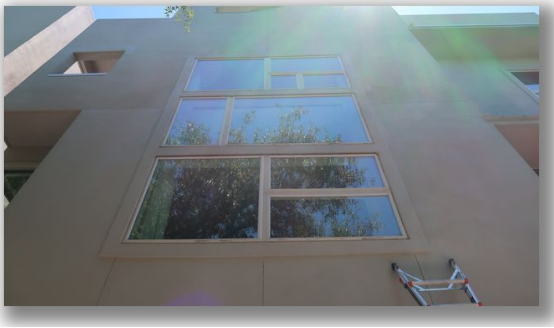
**Item Number 5**

- A previous caulking repair was not properly installed. All old/previous caulking needs to be removed and install a new bead of elastomeric sealant. It is [recommended to complete this repair](#) to prevent water intrusion to the structure.

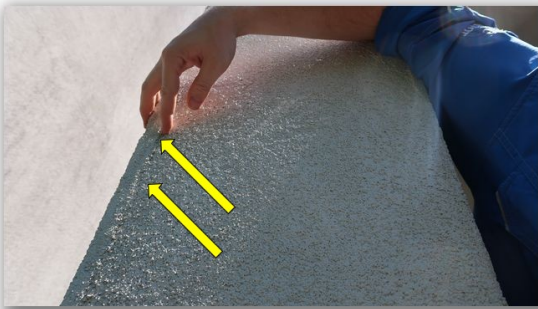
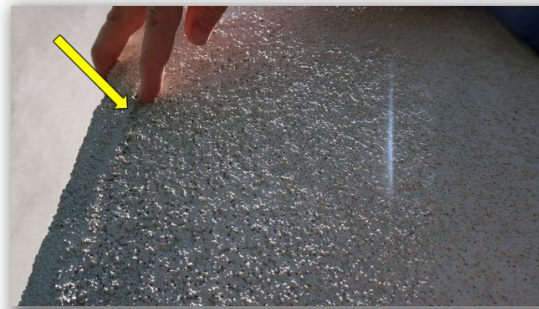
### Item Number 6

- There is visible mesh exposed on the stucco finish observed. This condition **needs to be corrected** to prevent moisture intrusion in to the structure.
