## **CLADDING MOISTURE REPORT**

**Stucco Inspection  
1234 Any Address  
TX**

**May 8, 2020**

**Subject Property :** 1234 Any Address, TX

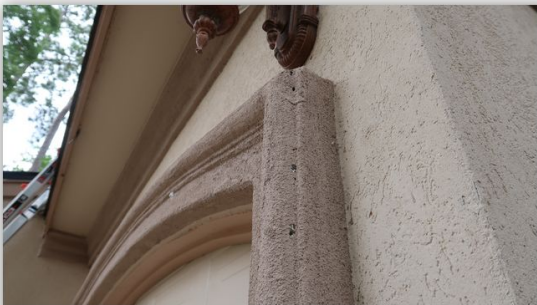
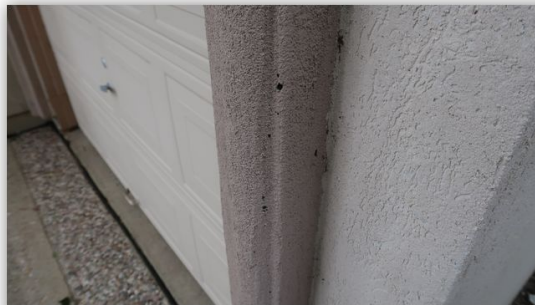
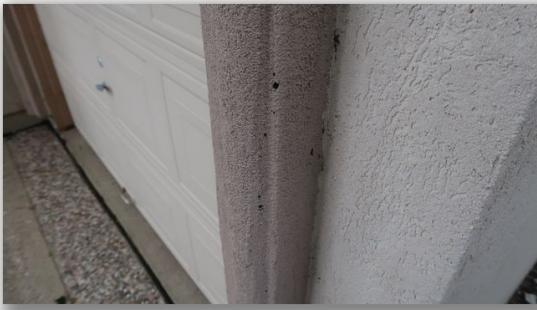
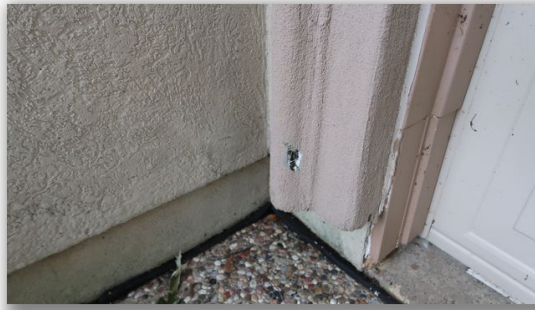
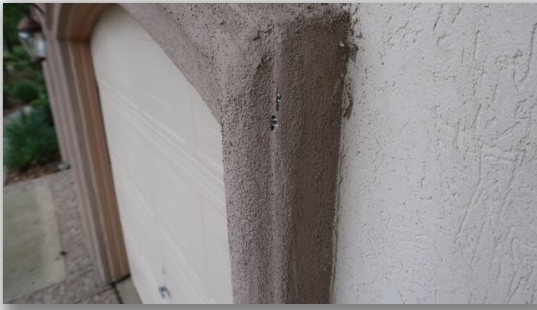
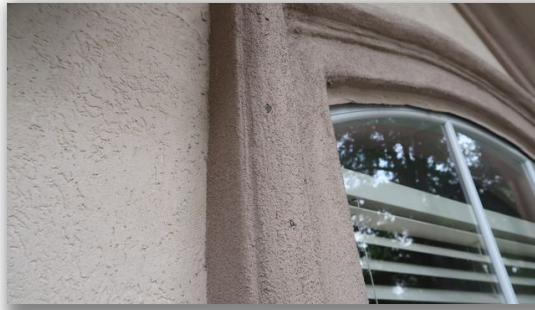
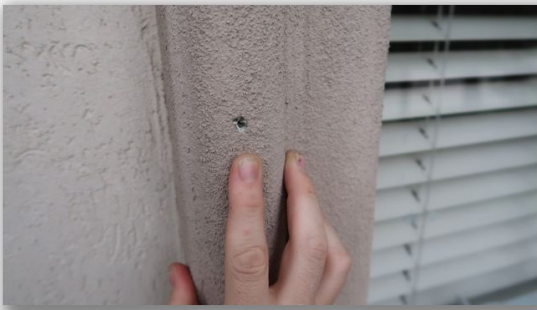
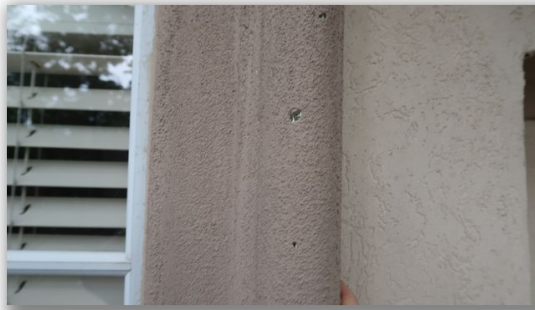
#### Item Number 1

- The EPS band(s) were observed to be damaged and [repairs are recommended](#).

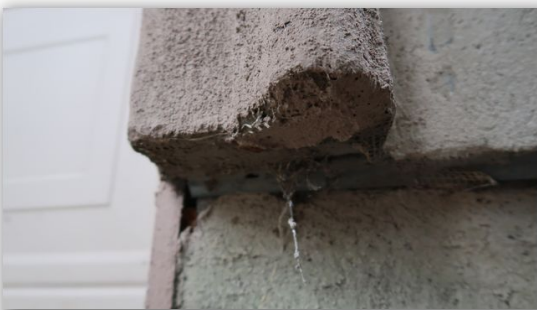
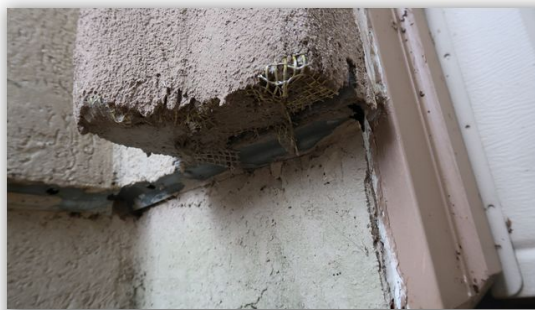
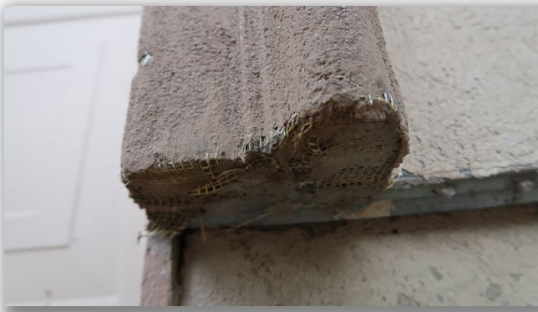
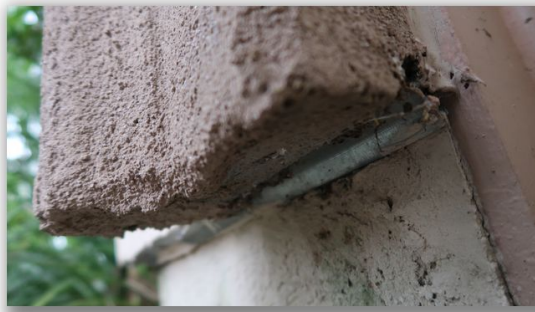
## Item Number 2

- The EPS is not properly wrapped (back wrap) at the lower edge / bottom termination. It is recommended to wrap the lower termination so to totally encapsulate the EPS to seal and strengthen the system. These is performed by bringing the reinforcing mesh around the system terminations and embedded it in base coat.

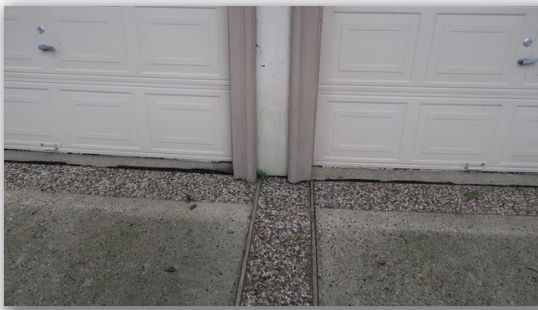
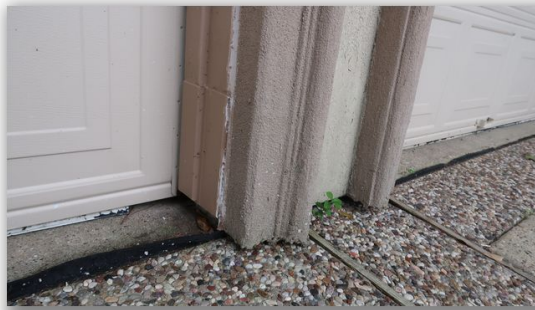
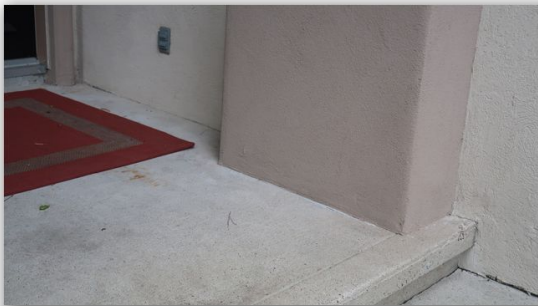
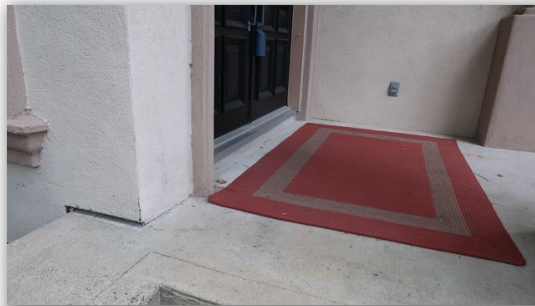
### Item Number 3

- The stucco has poor clearance from the concrete flatwork. Under current installation standards, there should be at least 1.5 to 2-inches of clearance between the concrete flatwork and the stucco material. There are no visible defects related to this application at this time and **no remedial repairs are recommended.**

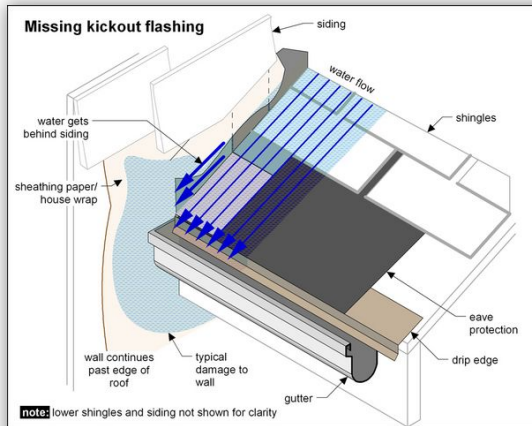
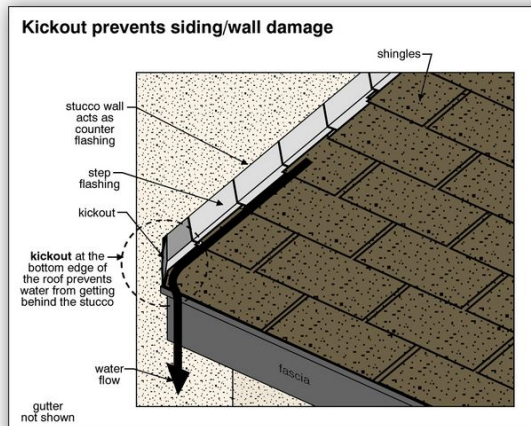
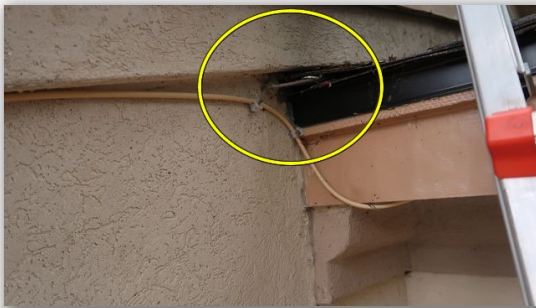
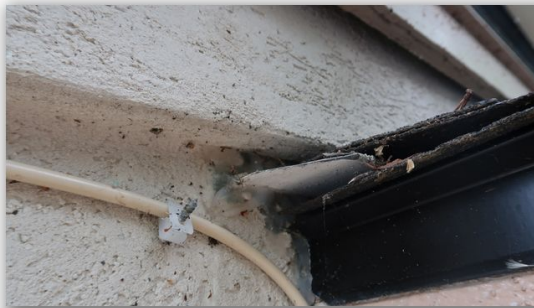
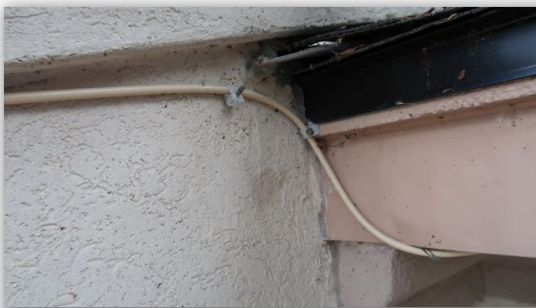
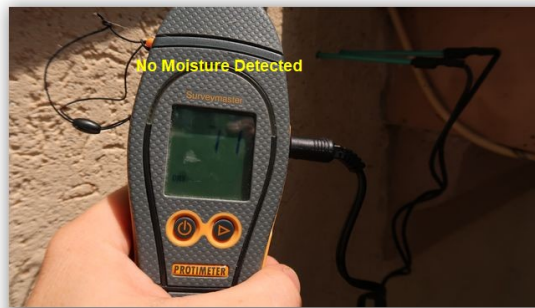
## Item Number 4

- There is missing kickout flashing details at the lower bottom edge of the roof line interface and the sidewall that continues past the edge of the roof. The lack of this kickout flashing will allow water to penetrate at these points. It is recommended to have kickout flashing details installed to help prevent future water intrusion at this locations. No remedial repairs are recommended.
- **No remedial repairs are recommend** The inspector performed an intrusive moisture tested and did not identify any moisture issues. It is recommended to continue the caulking maintenance in this area to prevent any future moisture issues.

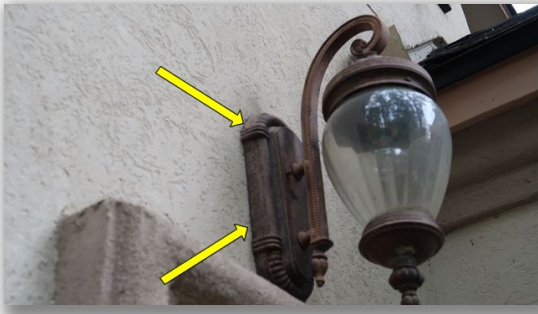
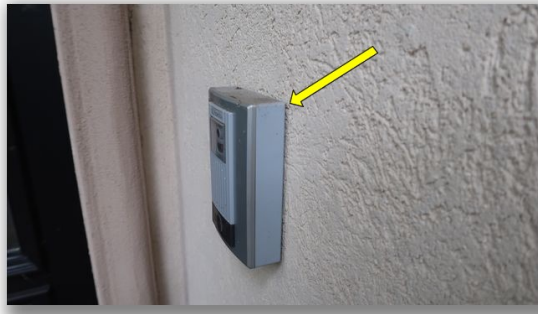
### Item Number 5

- The area between the exterior cladding / veneer and all of the wall penetrations / openings need to be properly sealed. Areas such as utility connections, downspouts, hose bibbs, lighting fixtures, receptacles etc. It is recommended to use an elastomeric caulking / sealant.

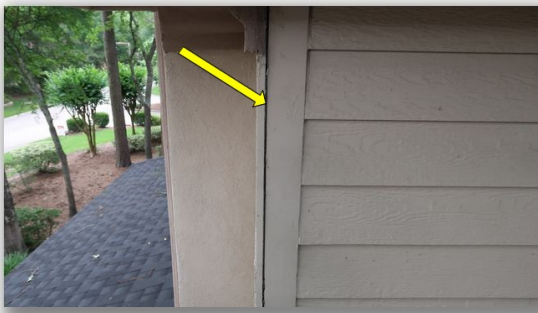
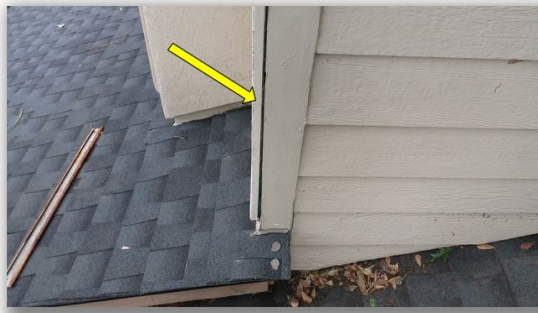
### Item Number 6

- The area between the exterior cladding / veneer and all of the wall penetrations / openings need to be properly sealed. It is recommended to use an elastomeric caulking / sealant.

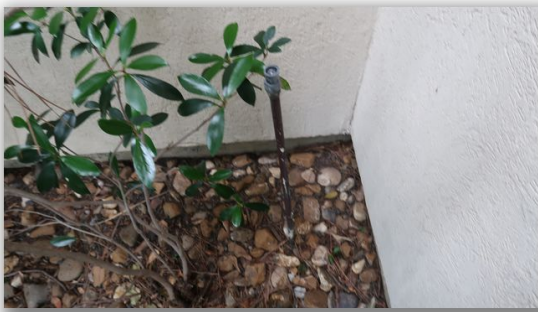
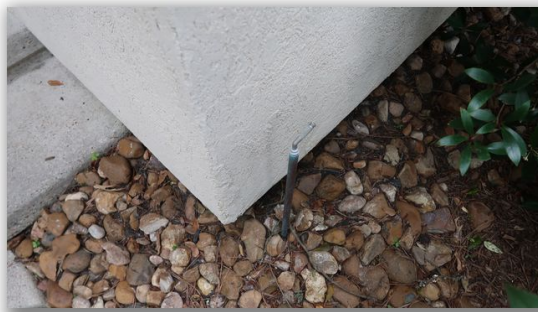
### Item Number 7

- All sprinkler heads within 12-inches of the exterior walls should be relocated a minimum of 12-inches away from the walls and directed so that water does not spray directly onto the walls.

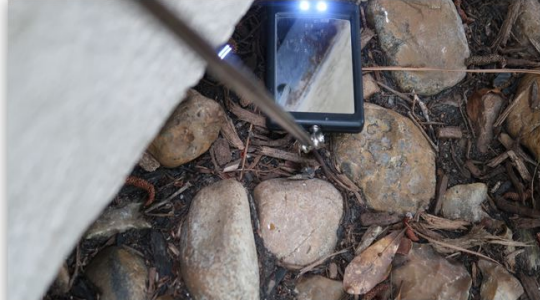
### Item Number 8

- The lower track / weep screed was observed to be rusted in one or more locations. There are no visible defects related to this condition at this time and no remedial repairs are recommended. The cause of the rust is due to the sprinklers spraying on to the stucco wall.

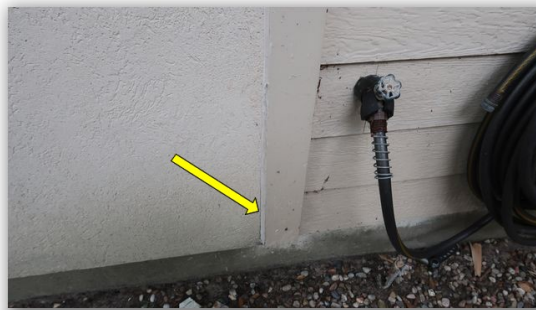
#### Item Number 1

- The area between the exterior cladding / veneer and all of the wall penetrations / openings need to be properly sealed. It is recommended to use an elastomeric caulking / sealant.

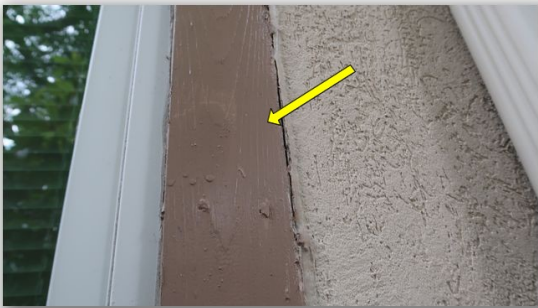
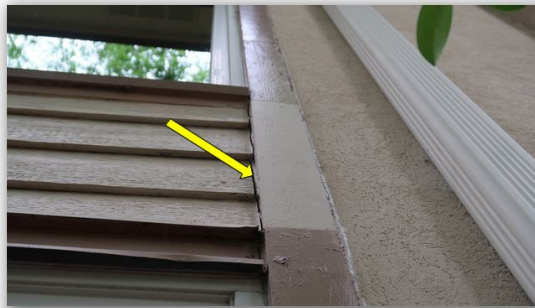
#### Item Number 1

- The area between the exterior cladding / veneer and all of the wall penetrations / openings need to be properly sealed. It is recommended to use an elastomeric caulking / sealant.
