PHASE 1 PRE-POUR INSPECTION REPORT

**Sample Report
1234 Any Street
Anytown, TX 12345**

PRE-POUR INSPECTION REPORT

Concerning: 1234 Any Street, Anytown, TX 12345
(Address of Inspected Property)

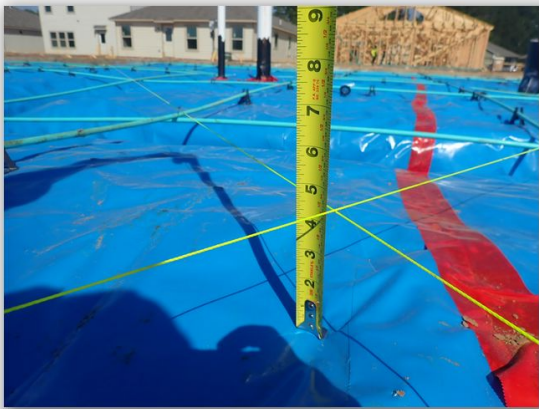
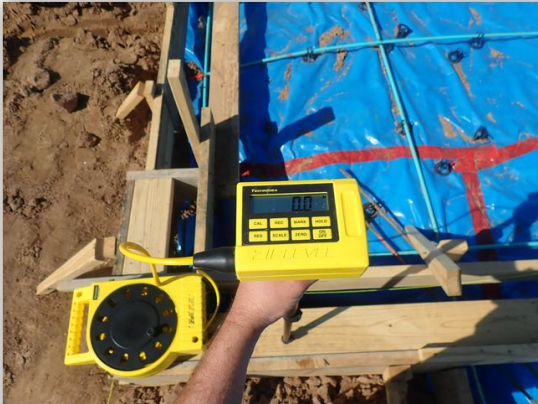
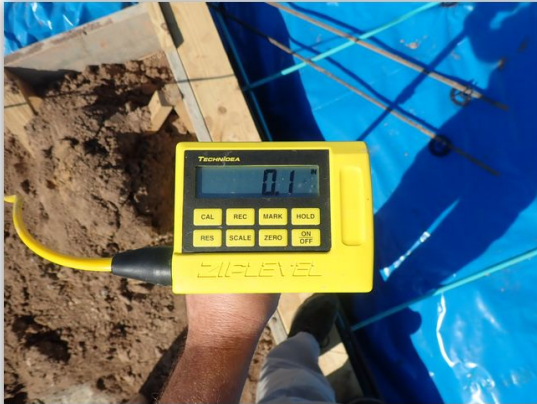
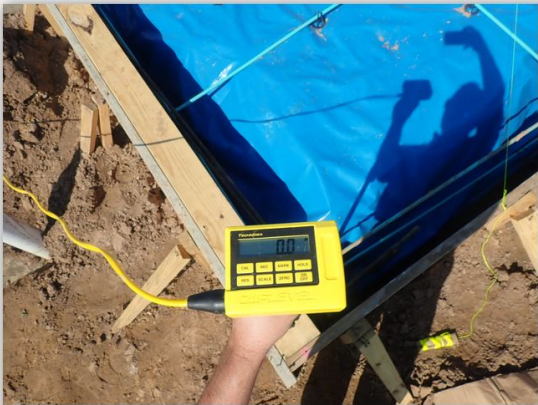
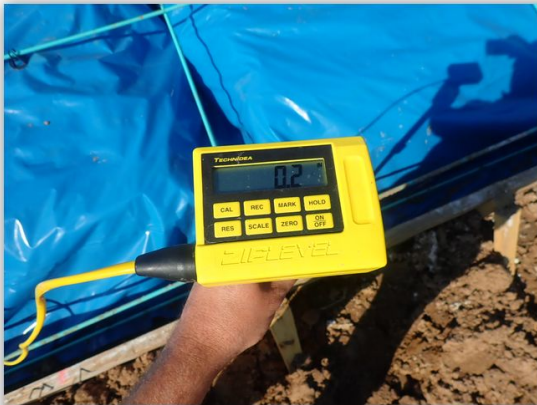
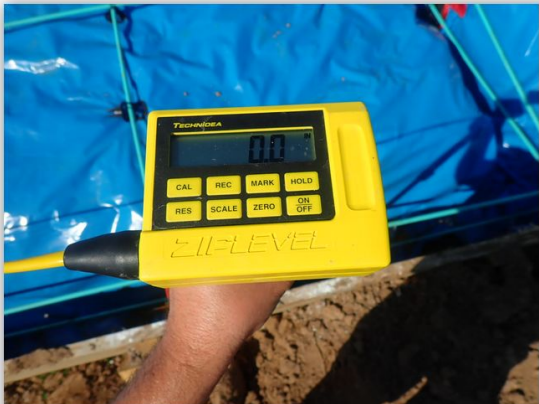
A. Edge Forms

- The form boards are not properly backfilled to help prevent blowouts on the north side, east side, west side of the foundation.

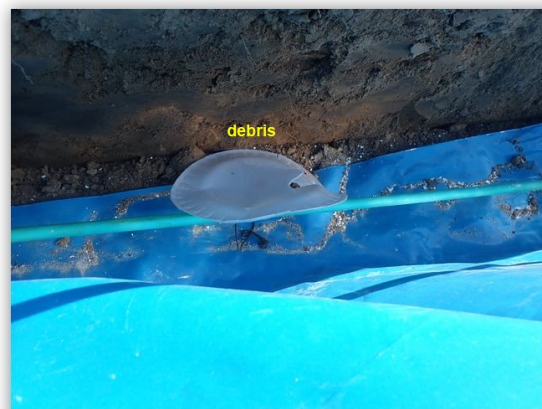
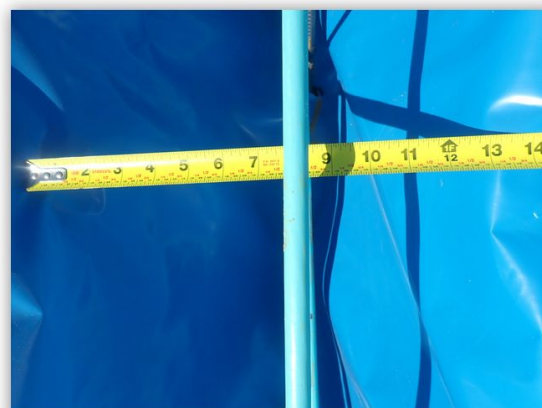
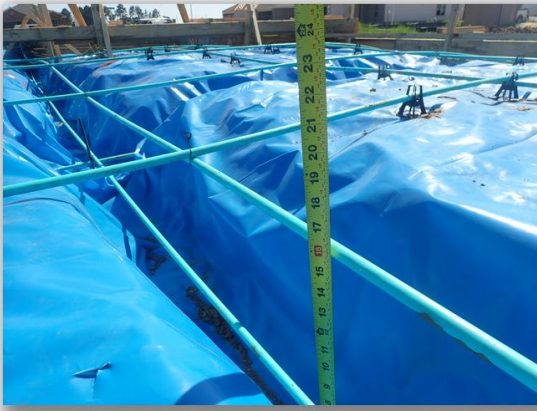
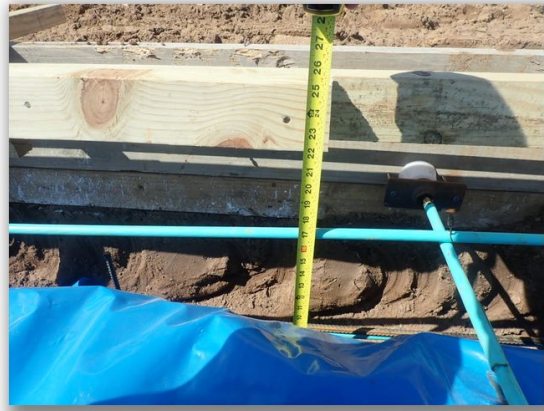
B. Beams and Footings

- There is a cave-in in the beam in the area of the kitchen. The cave-in needs to be cleaned out to maintain the proper beam depth and width.
- All debris in the foundation beam trenches need to be cleaned out before the concrete is poured.

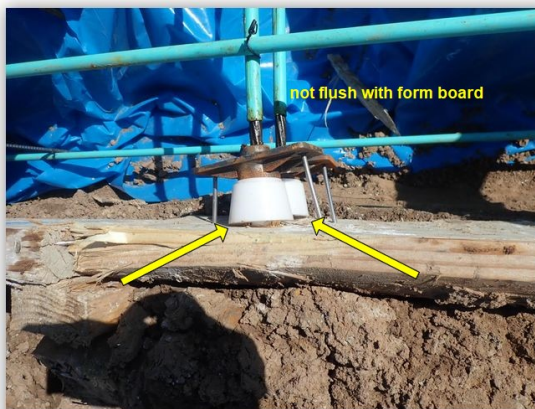
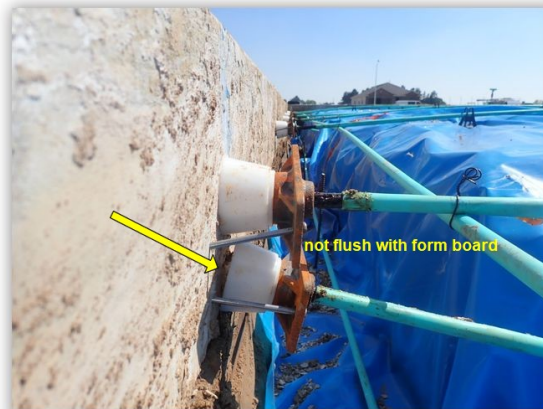
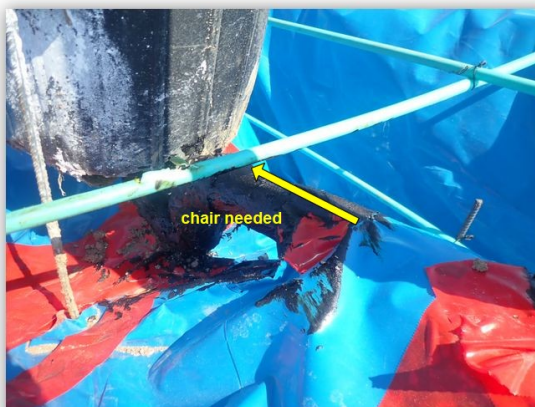
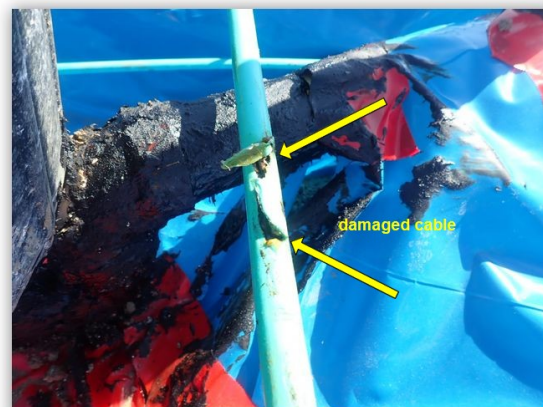
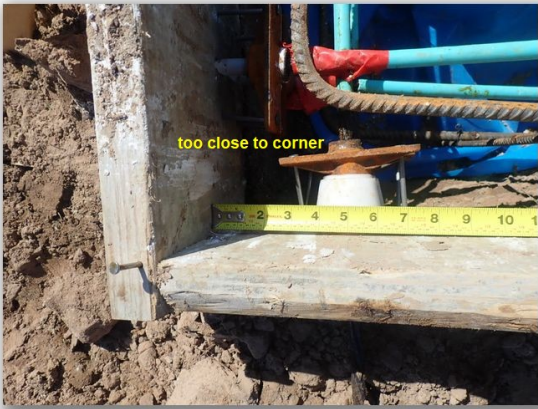
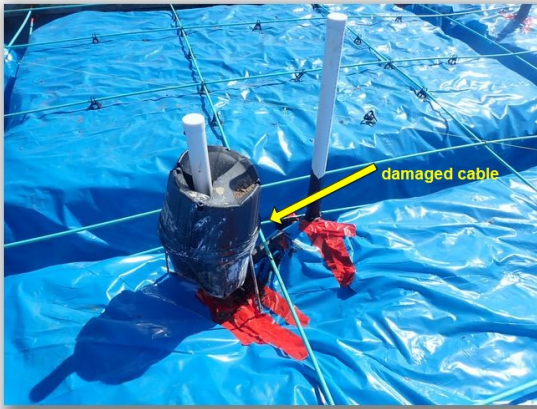
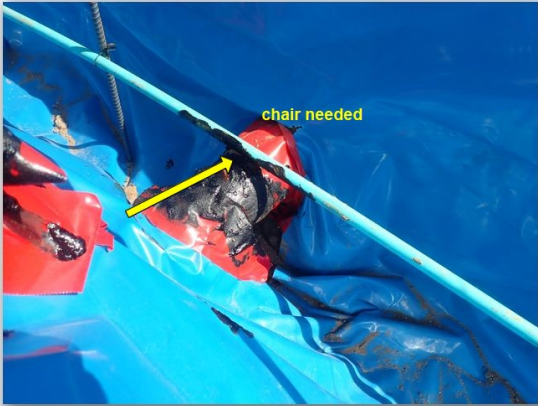
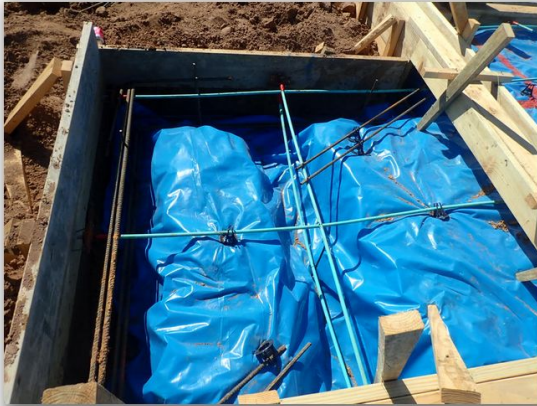
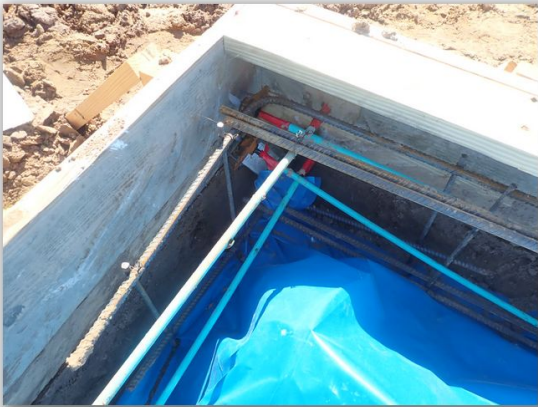
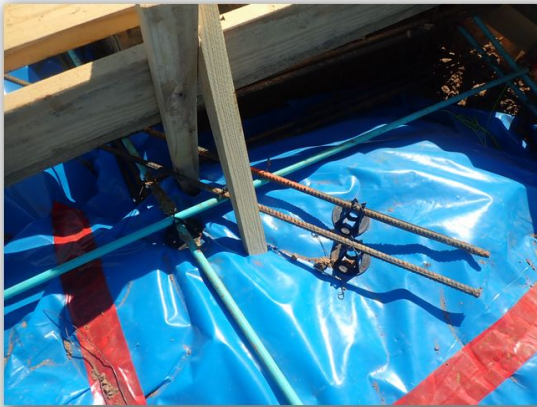
C. Reinforcement

- The post tension tendon should have a minimum of 3-inches of clearance from waste pipes through the beams footings. A support chair can be placed between the pipe and the tendon tied in place to correct this condition.
- The post tension anchors are installed within 6-inches of the form corners on the east side of the foundation. The anchors should be moved a minimum of 6-inches away from the corners to help prevent blowouts from occurring when tension is applied to the tendons.
- The pocket former at the end of cable is not installed flush with the form on the north side, east side of the foundation.
- There is damaged sheathing on the post tension cables in the area of the master bathroom. This should be corrected to help prevent concrete from adhering to the metal post tension cable.

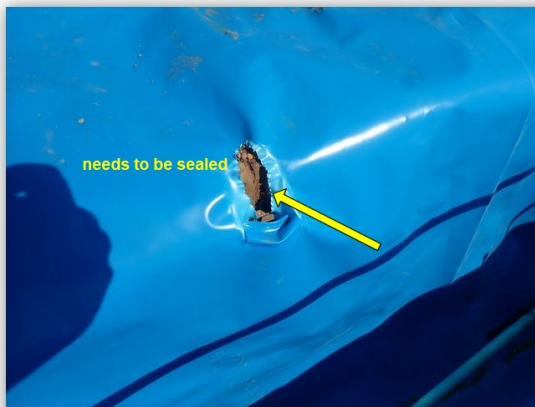
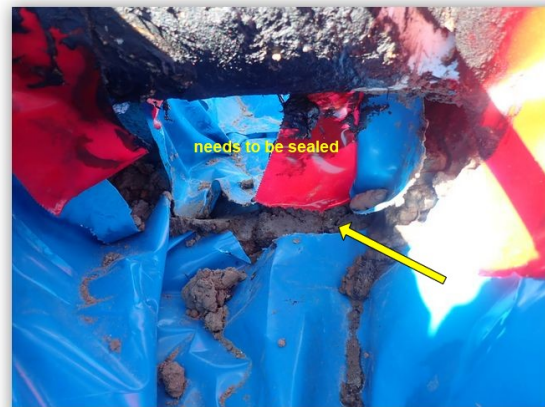
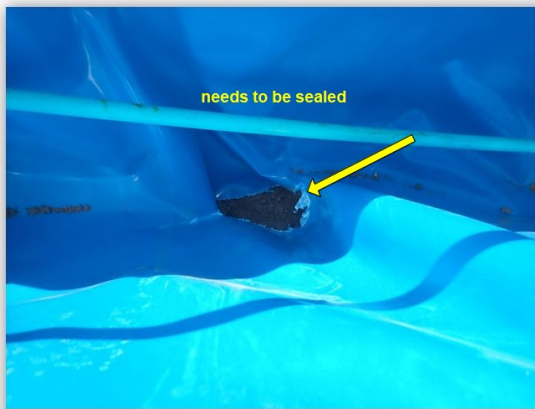
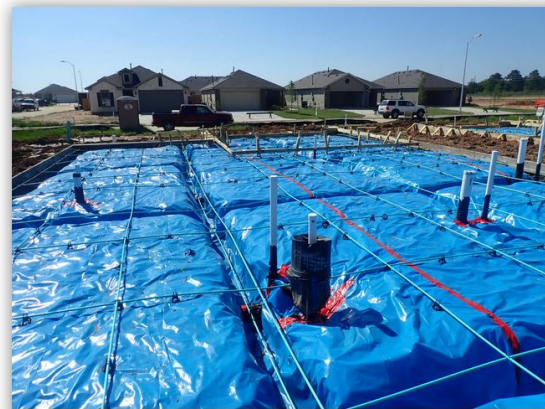
D. Moisture / Vapor Barrier

- All openings in the moisture/vapor barrier should be closed and/or taped.
- The moisture/vapor barrier is not properly overlapped in the master bathroom, hall bathroom, kitchen area. The moisture/vapor barrier should be overlapped a minimum of 6-inches to provide a continuous sheet under the entire foundation and any joints taped to ensure that there is no separation when concrete is placed.

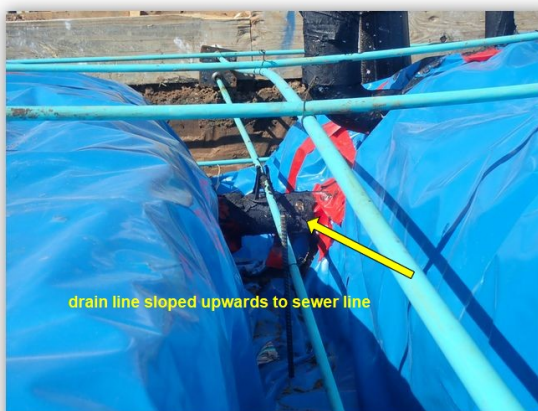
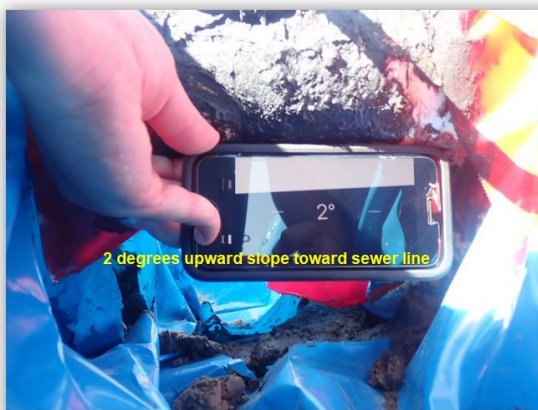
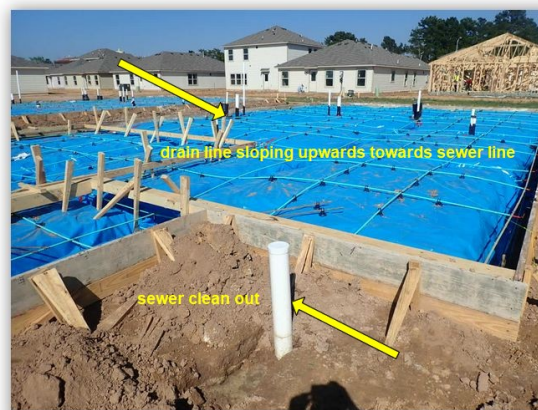
E. Plumbing

- The drain lines need to be properly protected in the beam / footing areas. The drain line is not properly insulated across the beam / footing. This condition should be corrected prior to the concrete being poured to help prevent future slab leaks from occurring.
- One or more drain lines are not properly sloped towards the sewer line. This condition should be corrected prior to concrete pour to prevent poor drainage/blockage.
