Sample Report 12345 Sample Report Humble, TX 77346

PROPERTY INSPECTION REPORT FORM

Sample Report Name of Client	12/08/2021 Date of Inspection			
12345 Sample Report, Humble, TX 77346 Address of Inspected Property				
James Lee Name of Inspector	23485 TREC License #			
Name of Sponsor (if applicable)	TREC License #

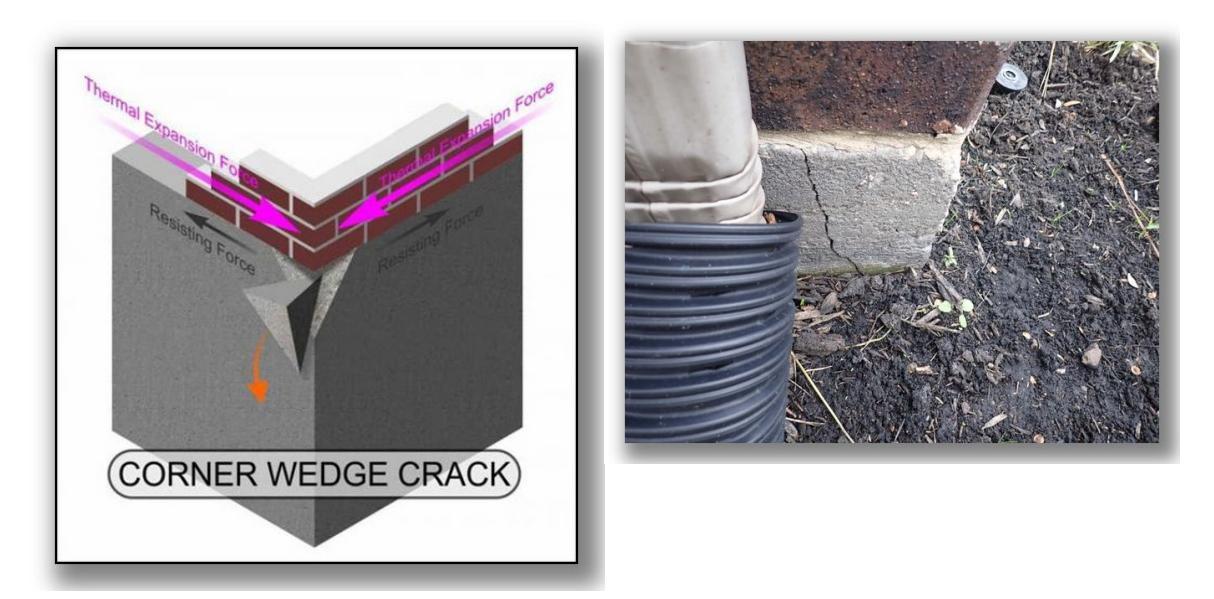
One or more of the foundation perimeter beam corners were observed to be sheared off (corner pop). This is a common condition to observe and is due to thermal expansion and contraction of the different building materials. This condition does not adversely affect the foundation performance. However, in some cases, some cosmetic improvements may be necessary.

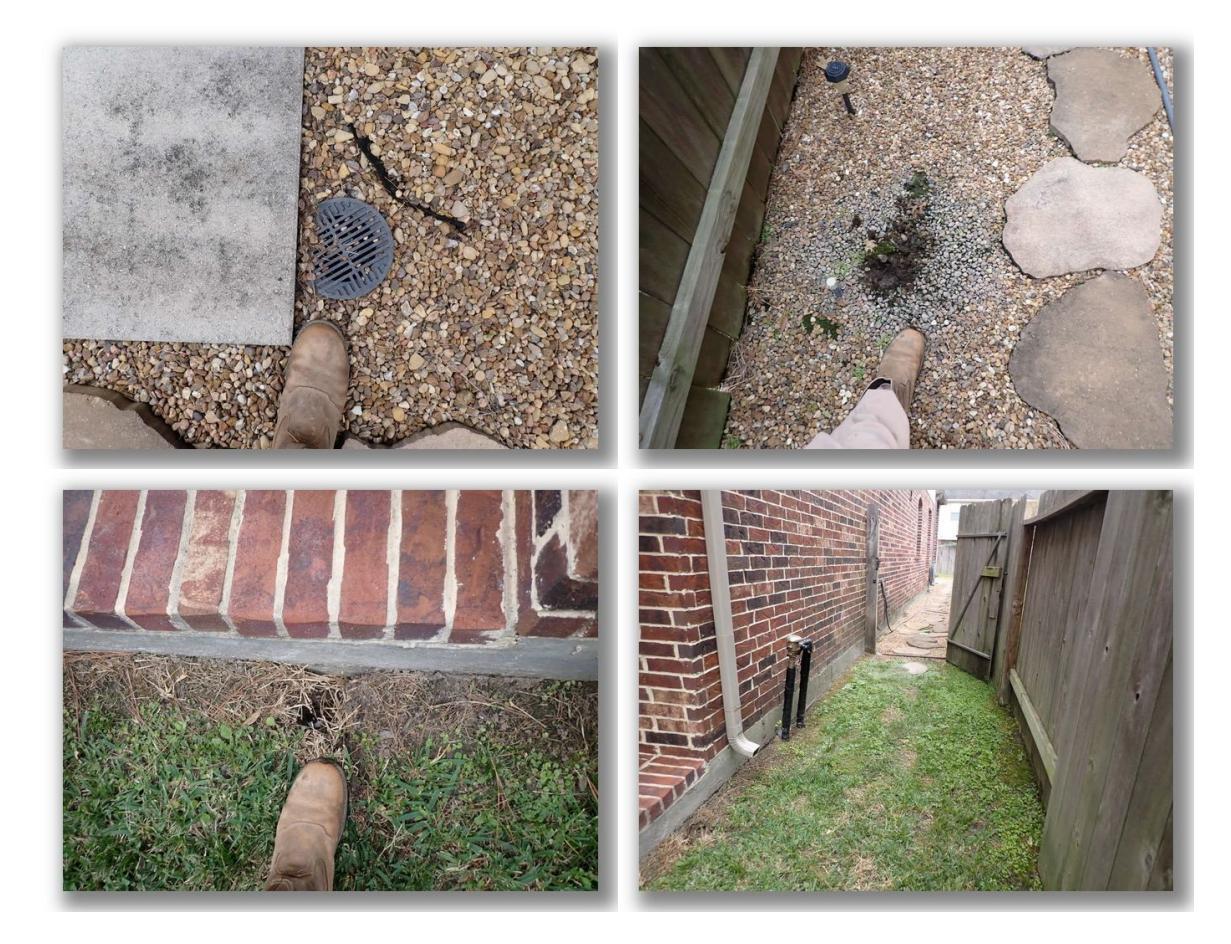
- Fill dirt is needed on the east side of the structure. The low spots in the finished grade (ground) adjacent to the foundation perimeter wall need to be filled in to help prevent water from standing and/or ponding next to the foundation area.
- Marginal site drainage was observed on the east side of the structure. Proper drainage is needed to help prevent water from standing and/or ponding next to the foundation beam. Corrective measures may be needed if the water stands within 10-feet of the foundation perimeter beam for more than 24-hours.

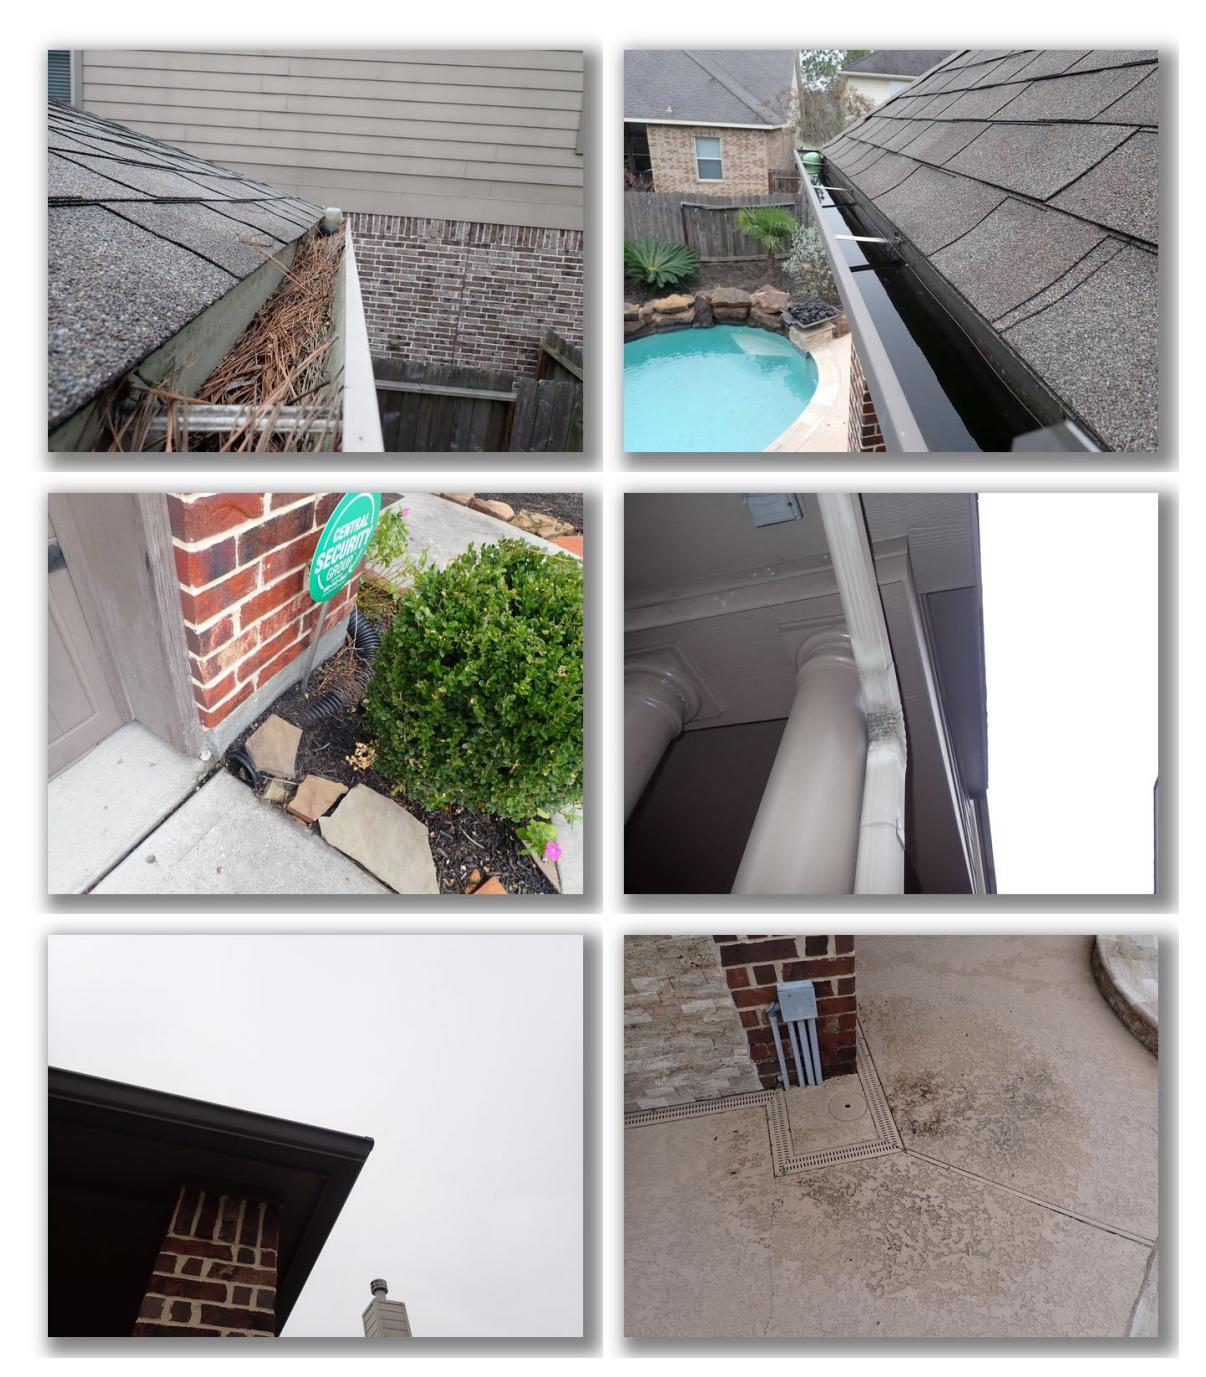
Gutter & Downspout System

- Minor leaks in the gutter joints and seams should be repaired.
- The gutters require cleaning.
- The gutters do not appear to have sufficient slope to drain properly on the north side of the roof structure. If they do not perform as intended, the slope should be adjusted.

Note: The gutter downspouts should discharge water at least thirty-six inches (36") away from the foundation perimeter beam. Storm water should be encouraged to flow away from the structure at the points of discharge.

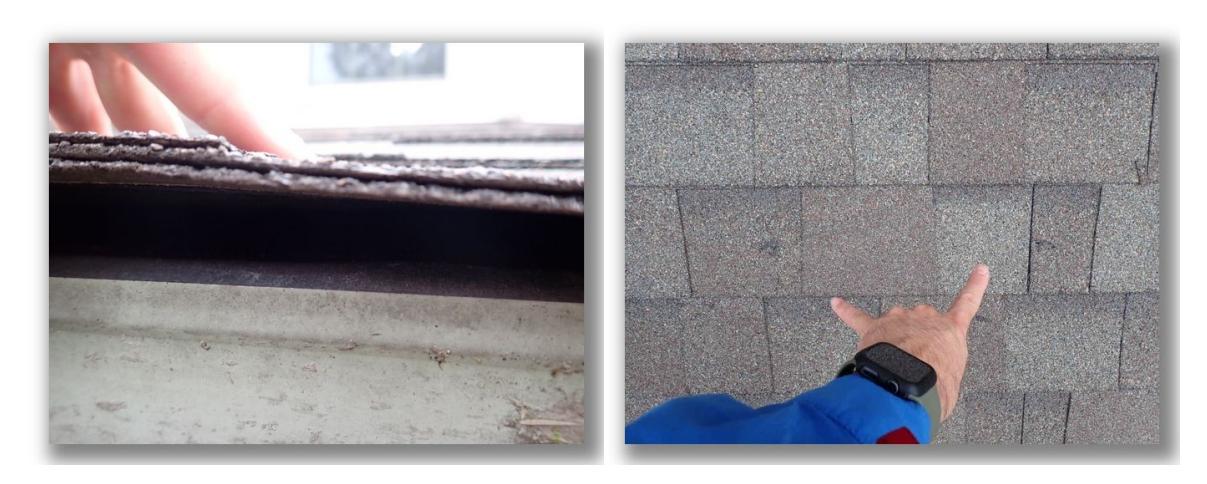
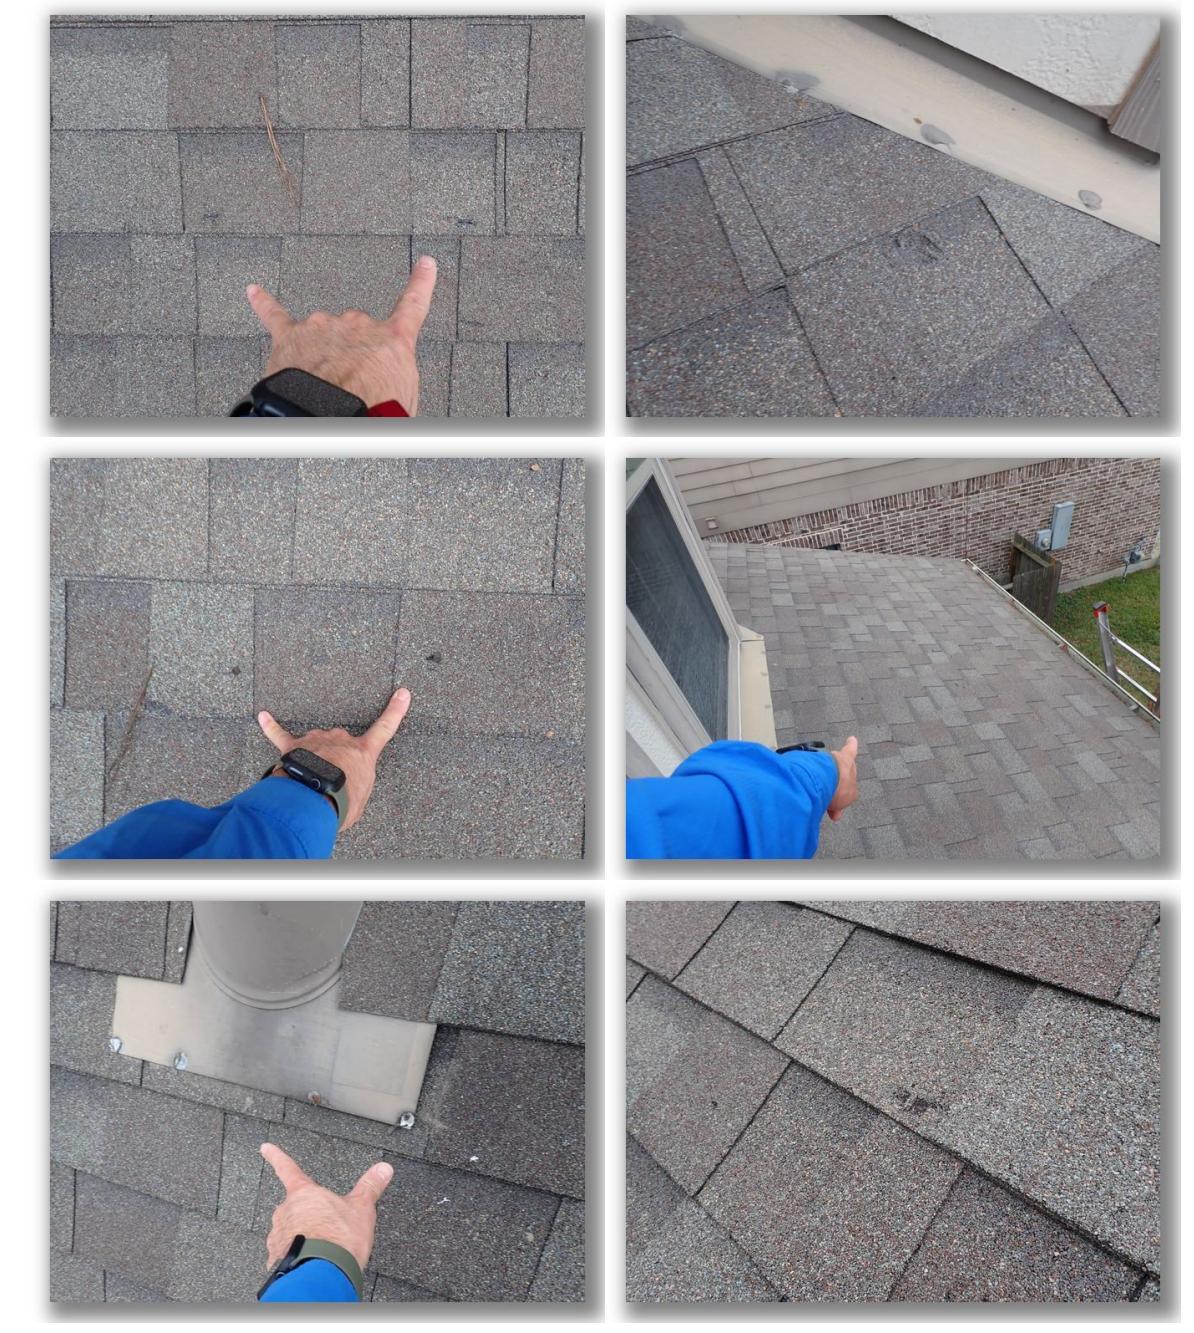
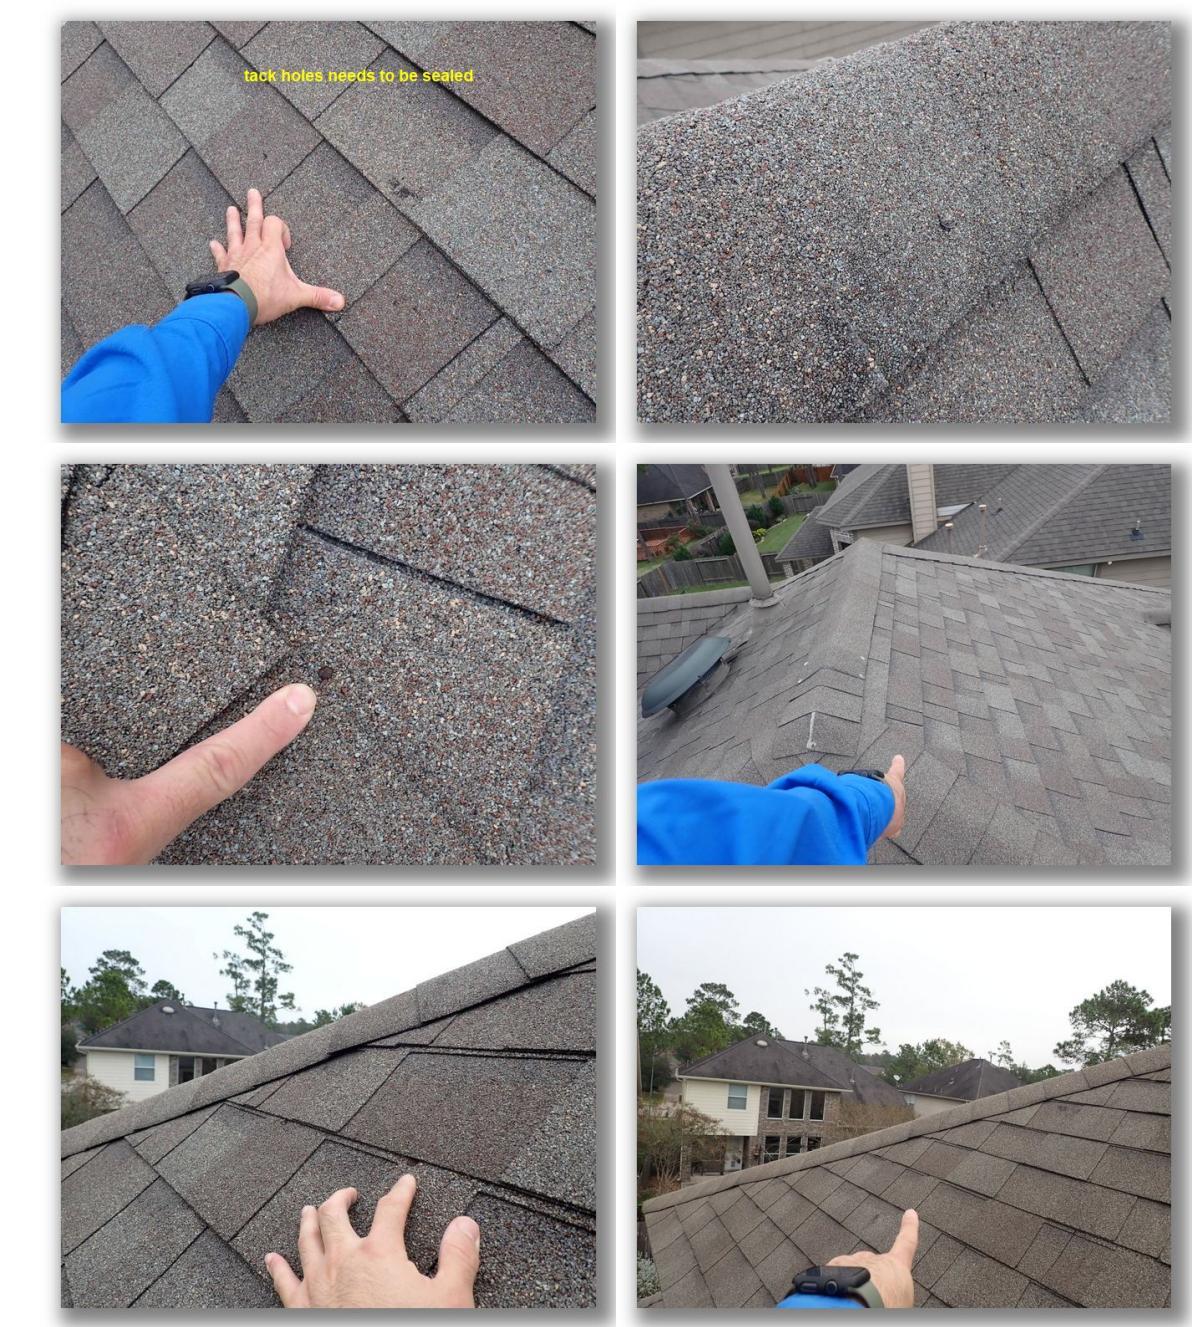
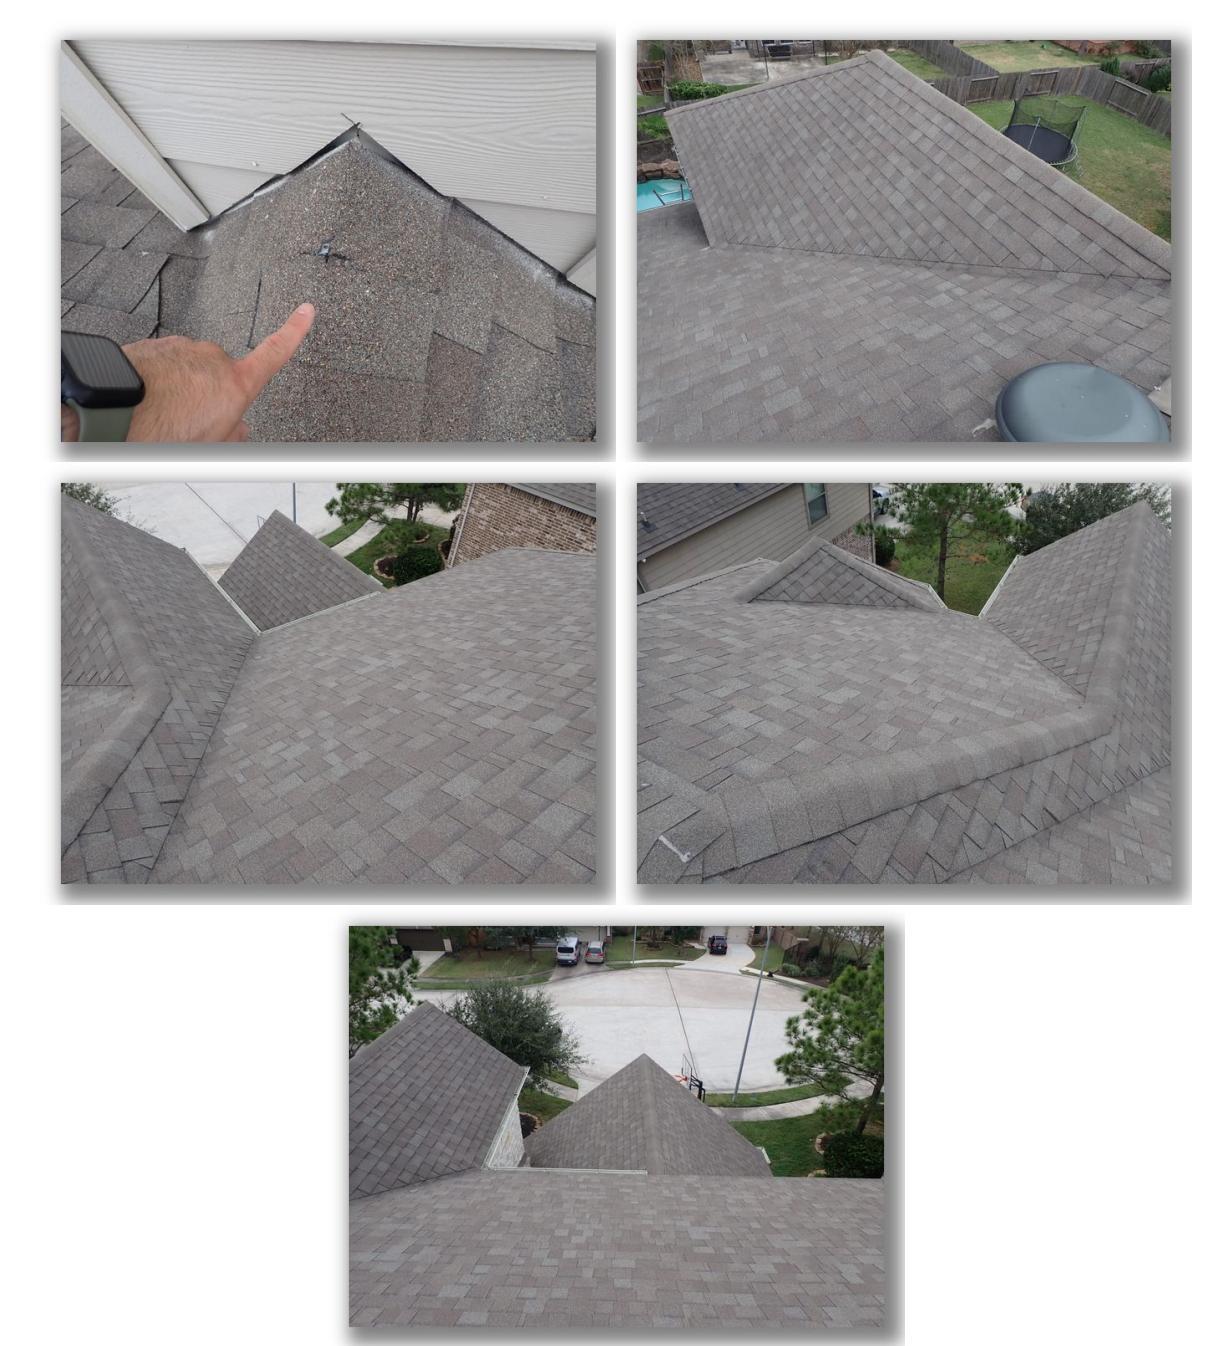
- Damaged shingles were observed on the south side of the roof structure.
- One or more of the ridge cap shingles were observed to be damaged.
- Exposed fasteners were observed at the shingles in one or more locations.
- Shingle fasteners (staples and/or nails) were observed to be pushing through the roofing material in various locations.
- Tack holes were observed on the south side of the structure at the time of inspection. This condition should be further evaluated.

Note: Roof fasteners (nails and/or staples) were observed to be exposed and should be properly sealed at the ridge caps and flashing areas.

You are strongly encouraged to have a properly certified roofing contractor to physically inspect the roof, prior to the expiration of any time limitations such as option or warranty periods, to fully evaluate the condition of the roofing material. The observation made to support the rendering of this opinion are listed but not limited to the following:

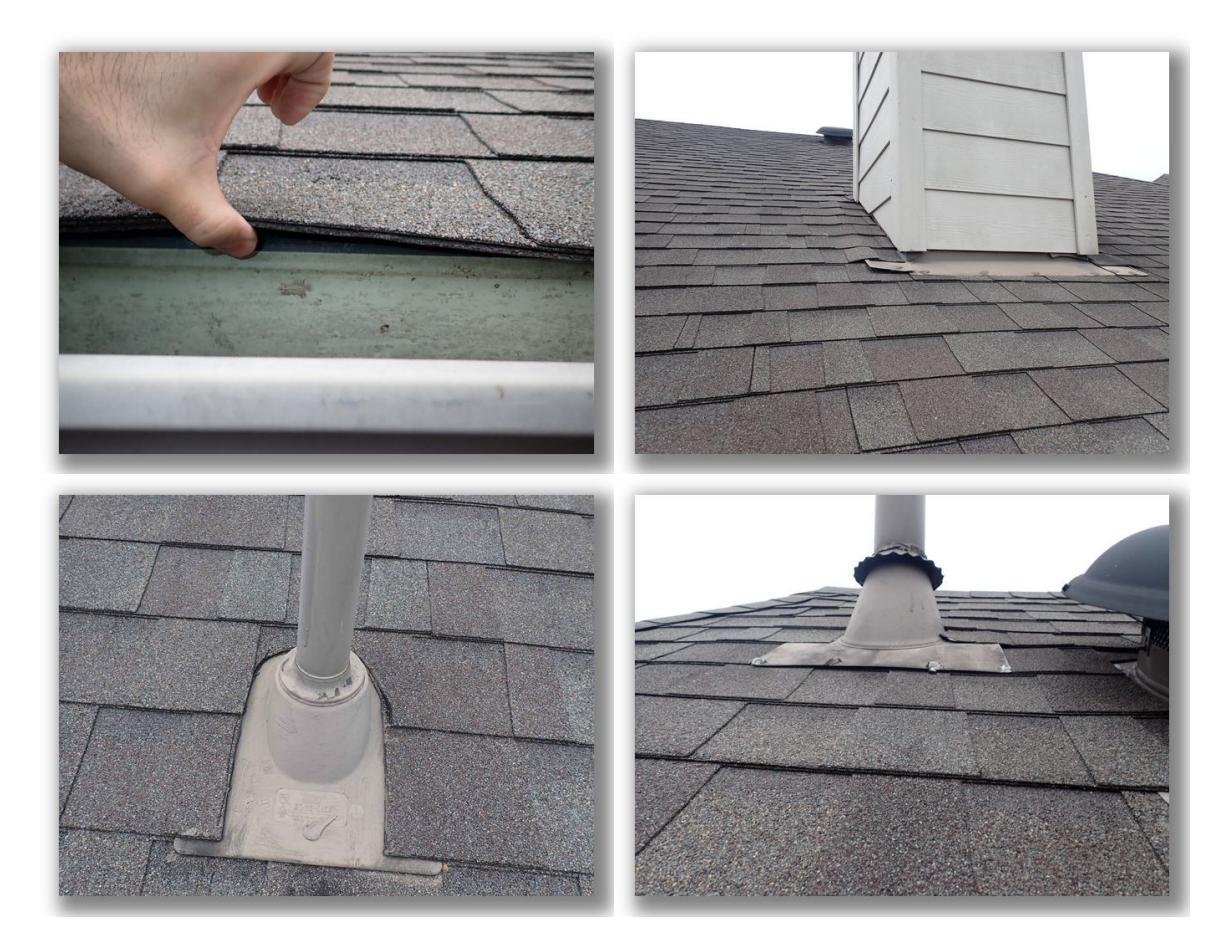
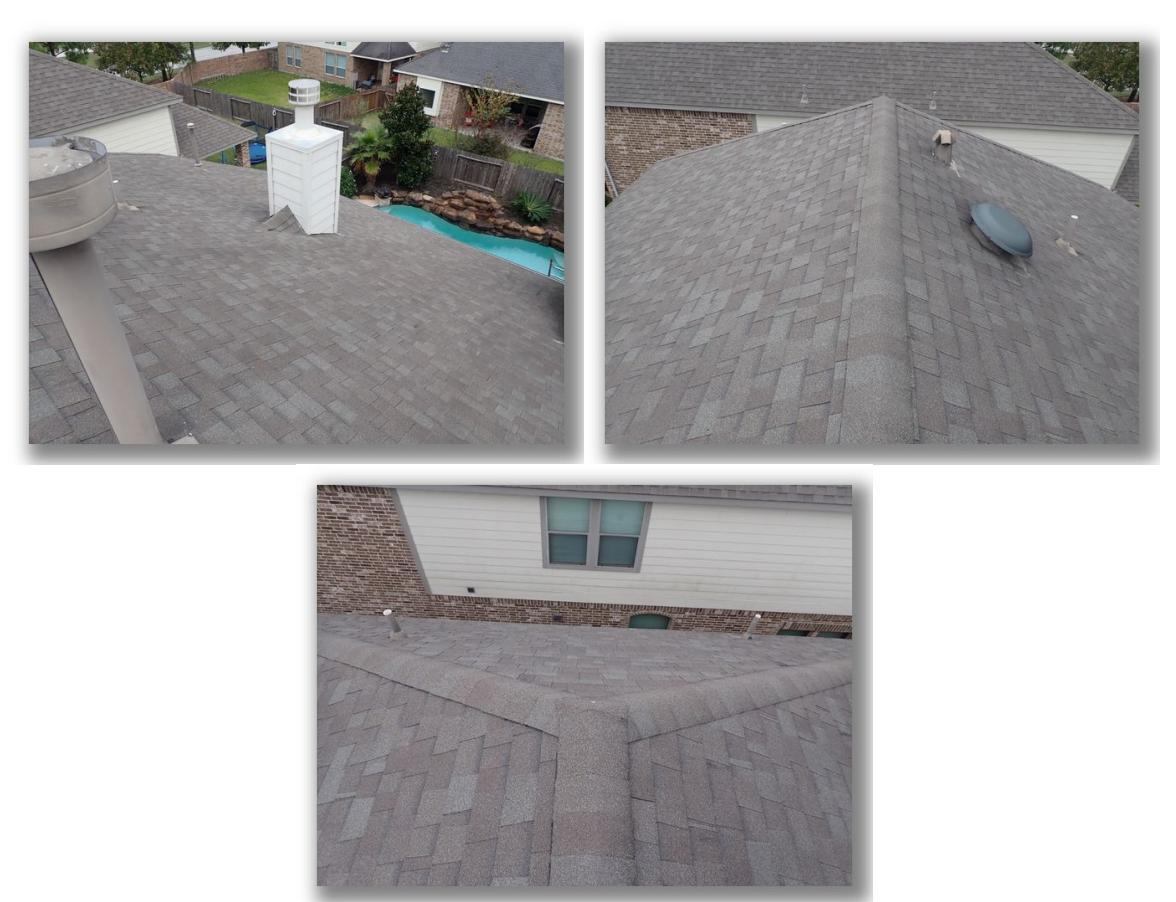
- It is recommended to seal all plumbing stack boots to prevent water intrusion.
- The flashing is lifting and/or pulling loose and should be re-secured on the north side of the roof structure.
- The flashing needs to be painted to prevent rust and/or UV damage.
- The drip edge flashing is not properly installed at the gutter. The drip edge flashing should be installed behind the gutter to prevent water intrusion/damage at this location.

The flashing details needs to be checked, reset or repaired as necessary. The observations made to support the rendering of this opinion are listed but may not be limited to:

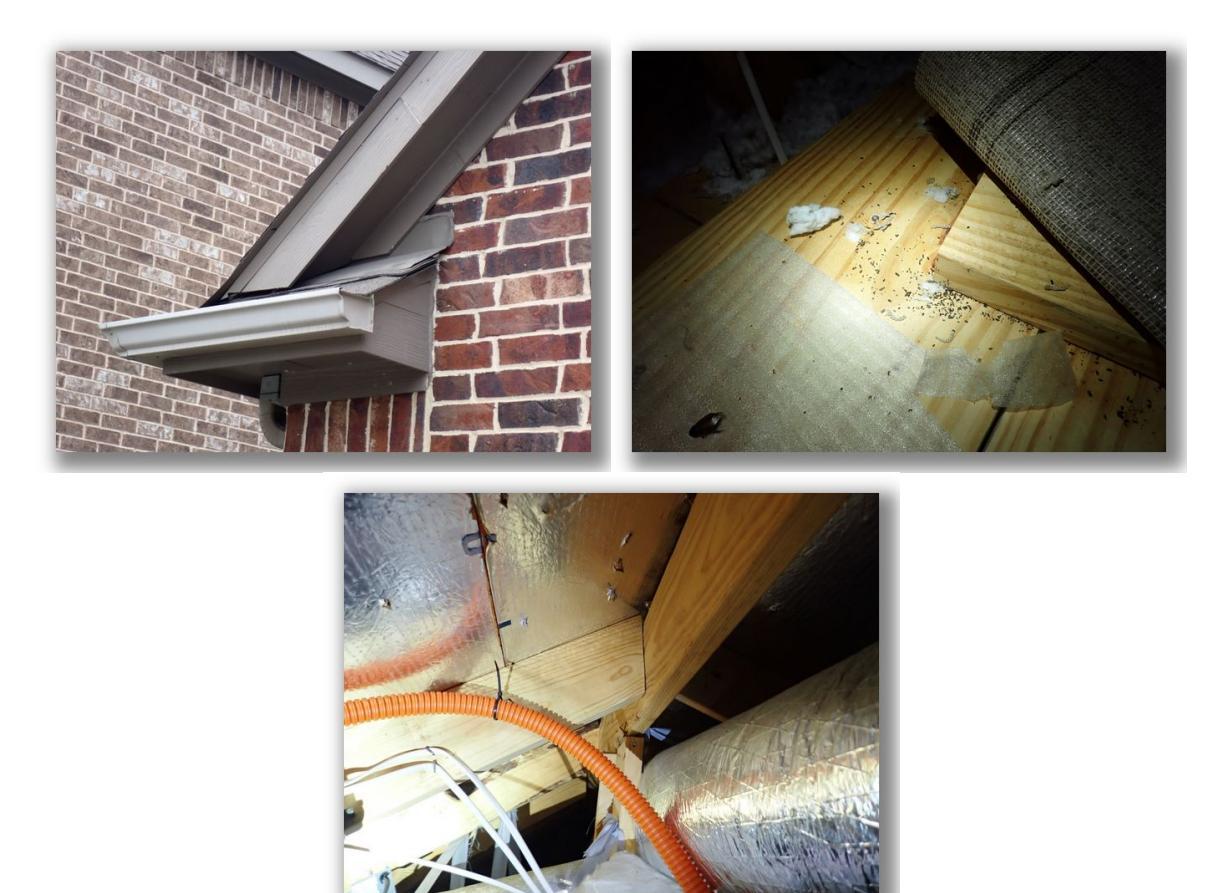
• It is recommended to seal all openings between the soffit and roof covering to prevent pest/rodent intrusion at this point.

Note: Visible evidence of rodent activity was observed in the attic area. It is recommended to have a Certified Pest Control Operator further evaluate this condition and make corrections as necessary.

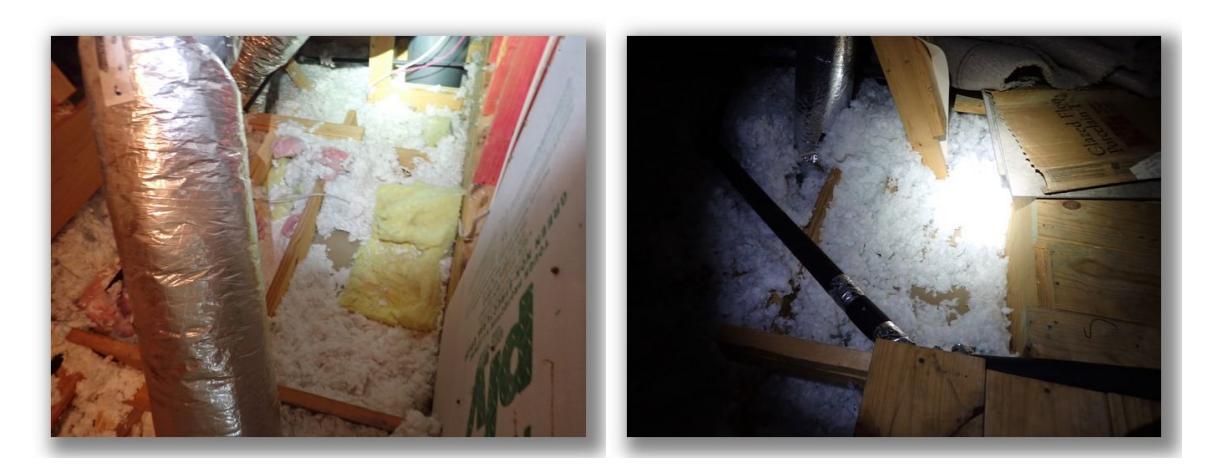
• The attic floor insulation needs to be redistributed in one or more locations.

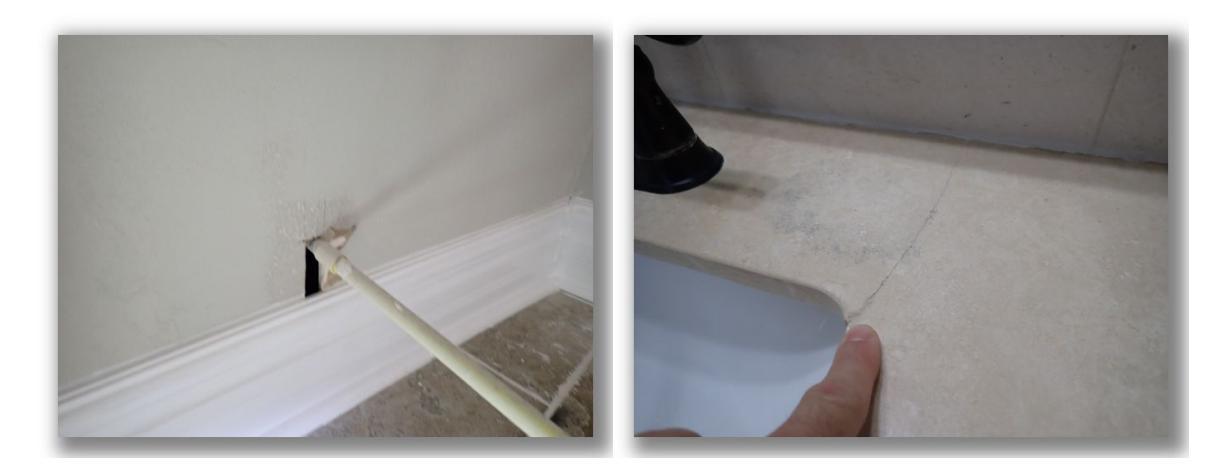
Note: There is evidence of painting and patching to the interior finish and prior interior finish repairs. This condition could limit the Inspectors visual observations and ability to render accurate opinions as to the performance of the structure.

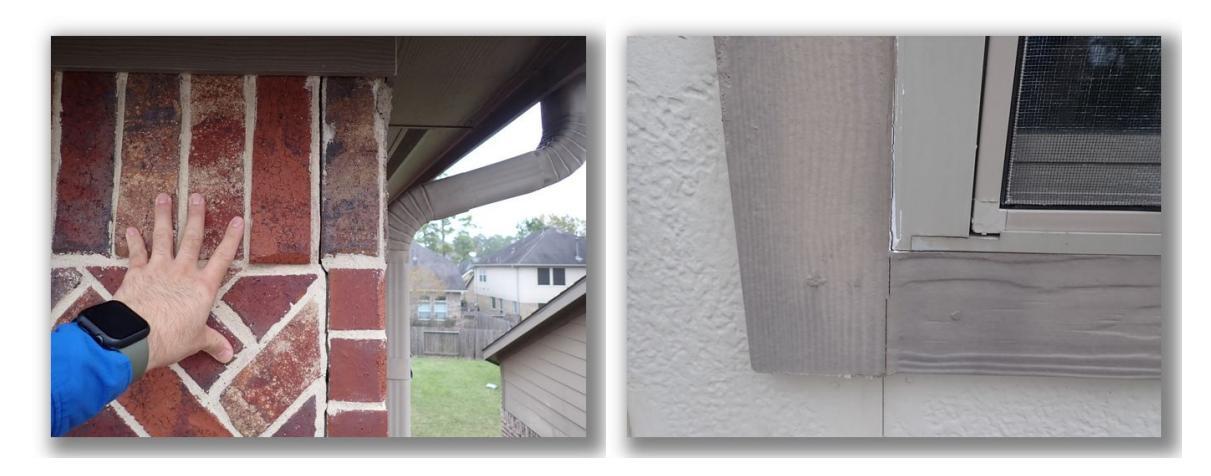
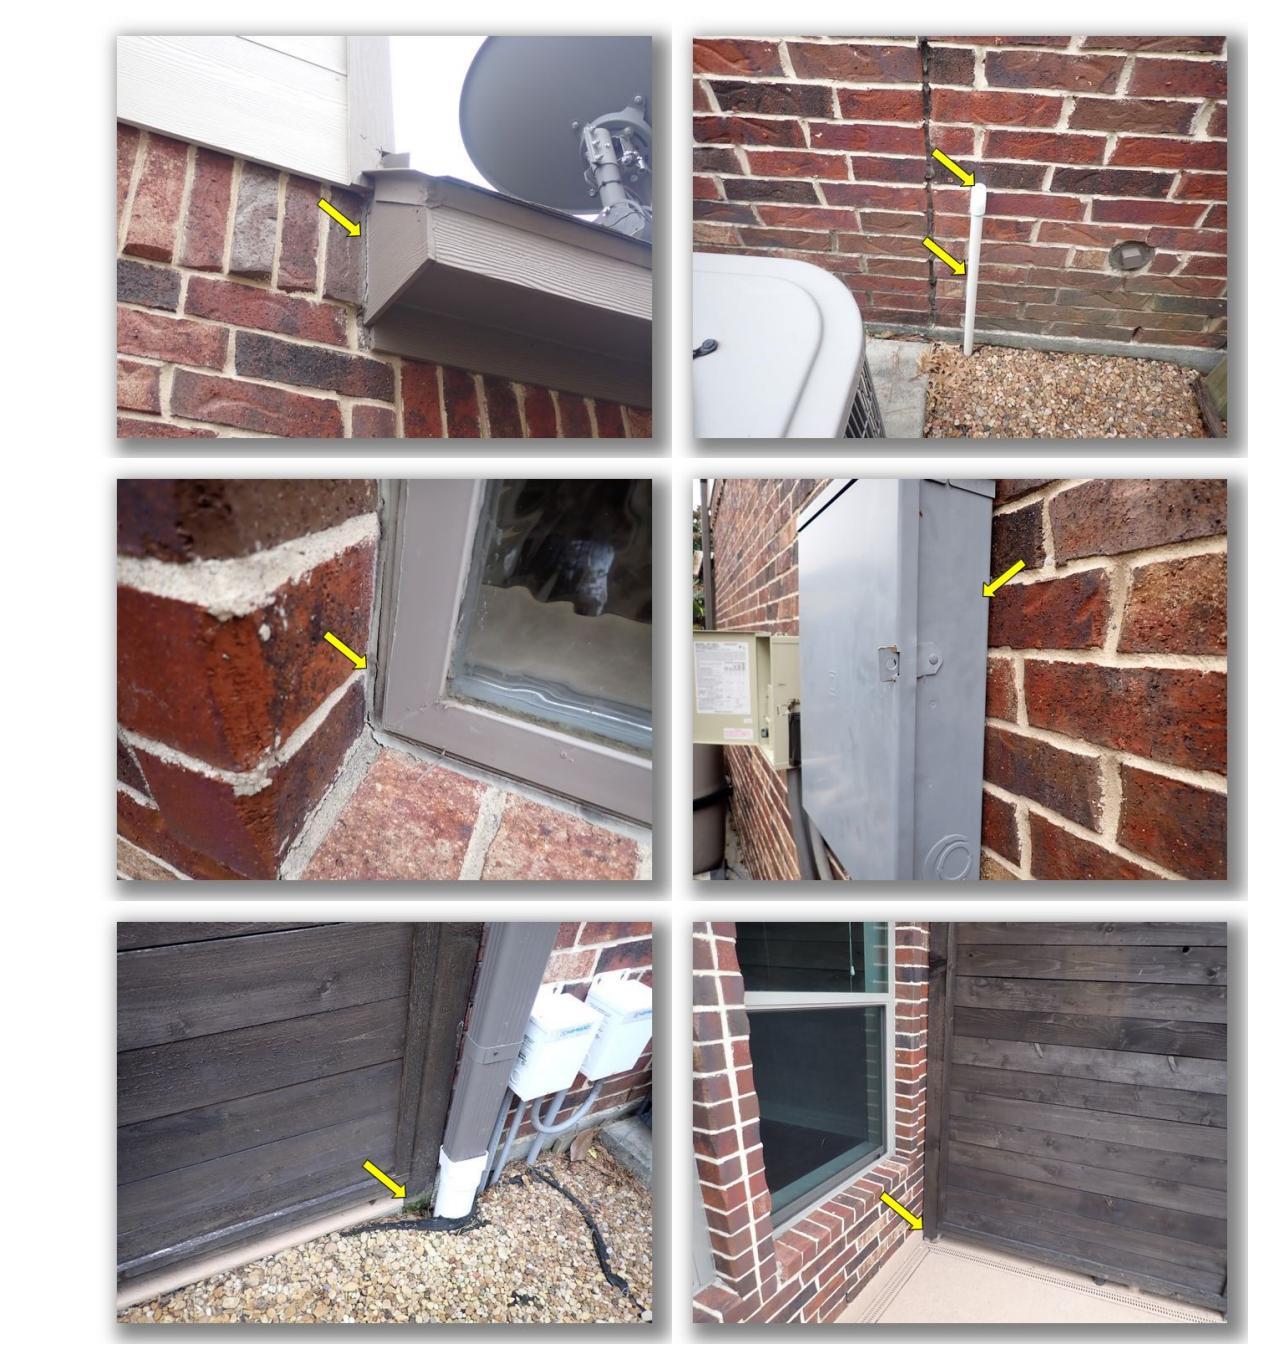
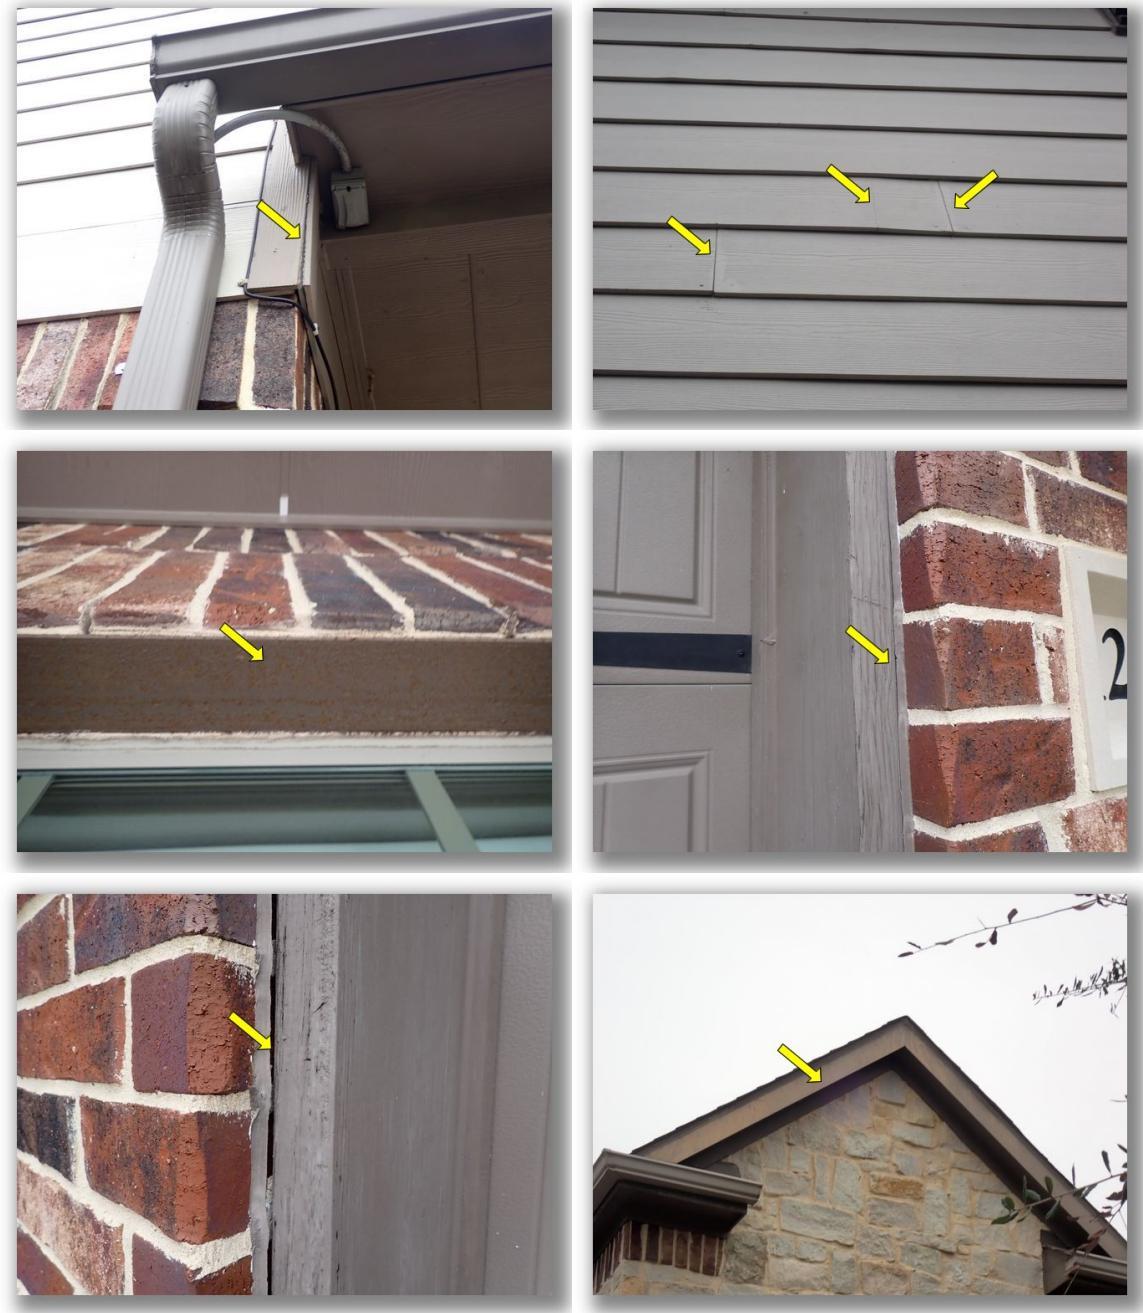
- All of the exterior wood type surfaces need a fresh coat of paint.
- The flashing needs to be painted to prevent rust and/or UV damage.

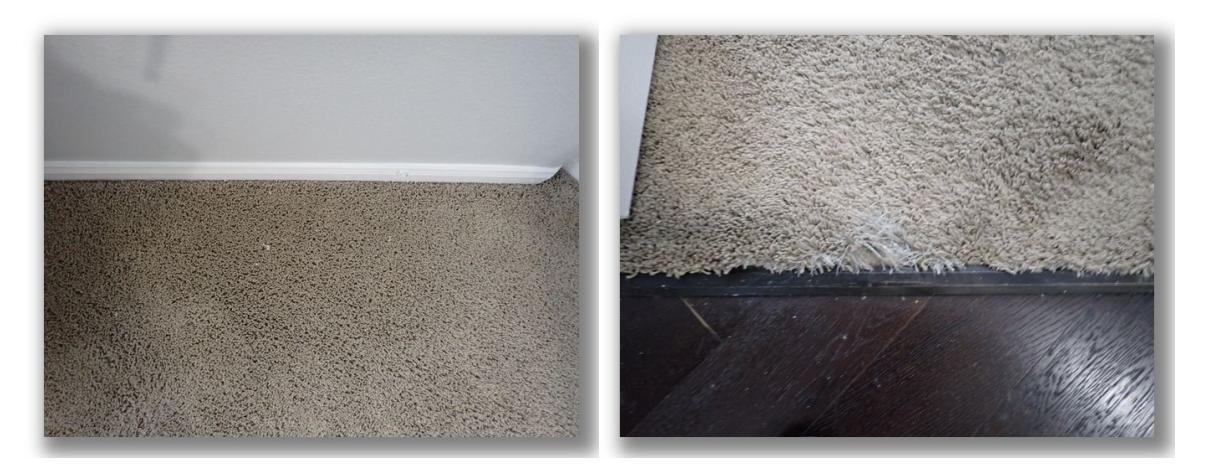
- The floor covering is stained in one or more locations of the home.
- The floor covering is worn and/or damaged in one or more locations of the home.
- The floor covering was observed to be damaged in the upstairs rear corner bedroom.

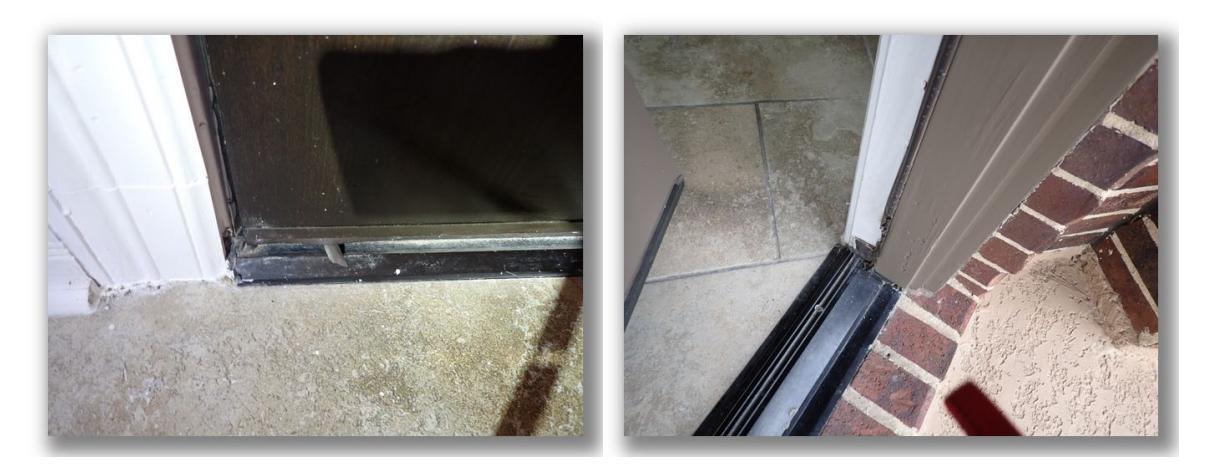
- Weather-stripping improvements are recommended for the front entry, backyard entry exterior door(s).
- The door is not latching properly to the front entry door.

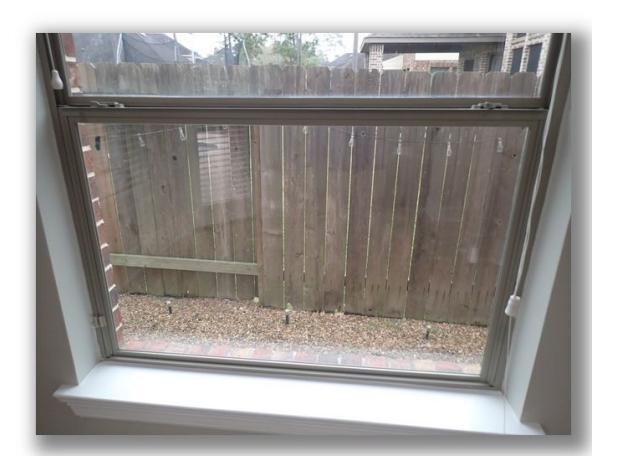
• One or more of the window screens were observed to be missing.

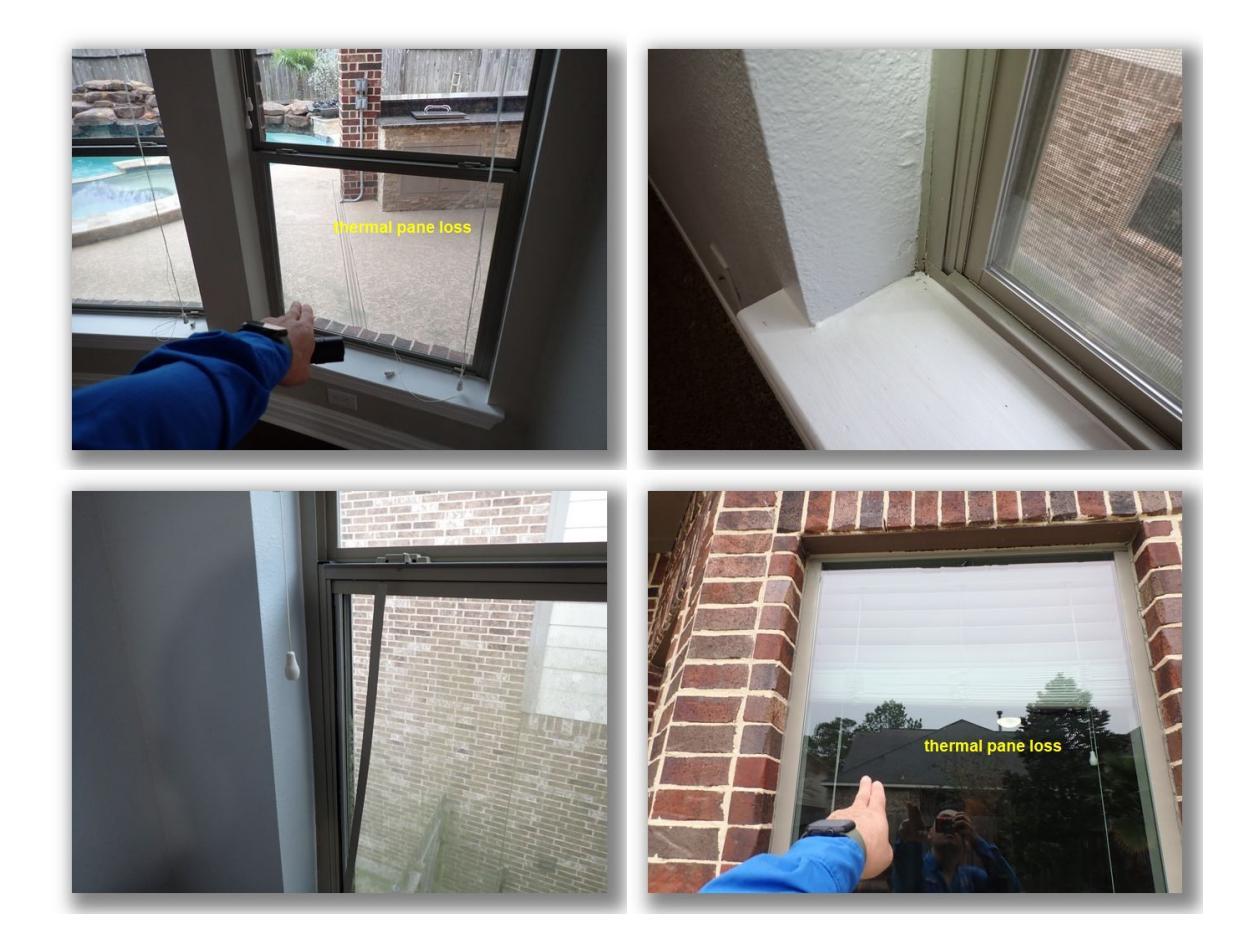
- Visible evidence of water intrusion was observed at and/or around the window(s) in the upstairs rear corner bedroom. The cause and remedy should be investigated and corrected as necessary.
- The window weather-stripping is damaged and/or missing at one or more of the windows and improvements are recommended.

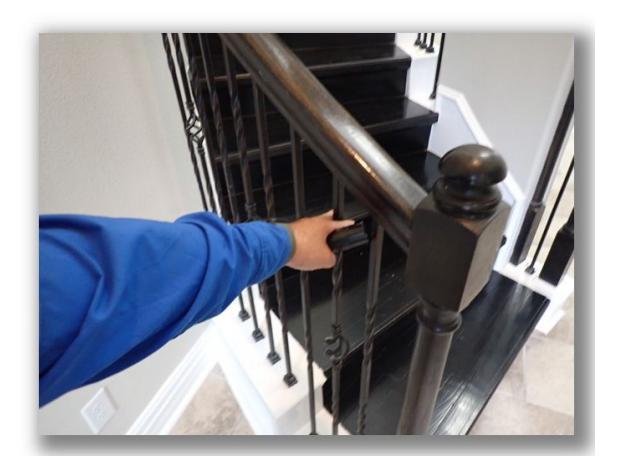
• One or more of the spindles and/or balusters was observed to be loose.

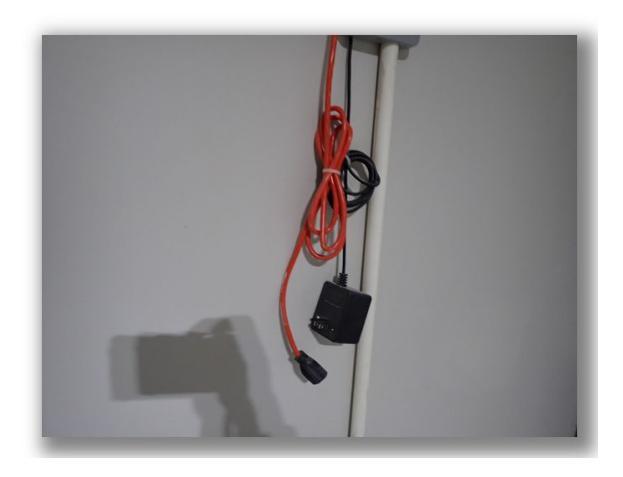
Distribution Wiring

Electrical flex extension cords should not be used for permanent wiring or pass through walls or . ceilings. The improper use of extension cord was observed in or around the garage area.

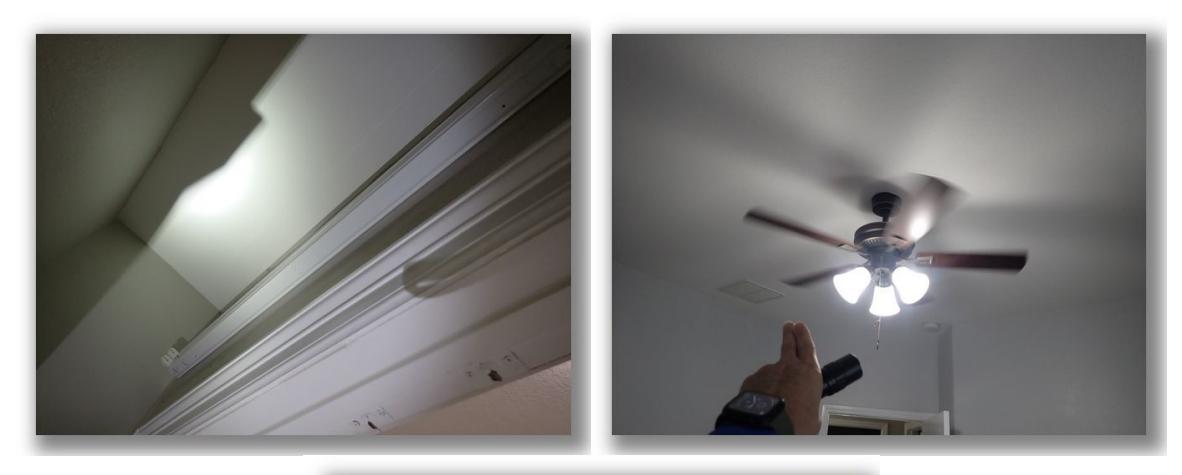
- One or more of the light fixtures appear to be inoperative in the pantry. This may be due to a bad bulb or some other unknown condition. This condition should be further evaluated and corrected as necessary.
- The ceiling fan was observed to be noisy when operated in the upstairs rear corner bedroom.
- The ceiling fan is not balanced properly and wobbles when operated in the upstairs side middle bedroom, upstairs rear corner bedroom.
- The upstairs hall bathroom fixture was observed to be flickering at the time of inspection. This condition should be further evaluated.
