Sample Report 12345 Sample Report Humble, TX 77346

PROPERTY INSPECTION REPORT FORM

Sample Report Name of Client	12/08/2021 Date of Inspection			
12345 Sample Report, Humble, TX 77346 Address of Inspected Property				
James Lee Name of Inspector	23485 TREC License #			
Name of Sponsor (if applicable)	TREC License #

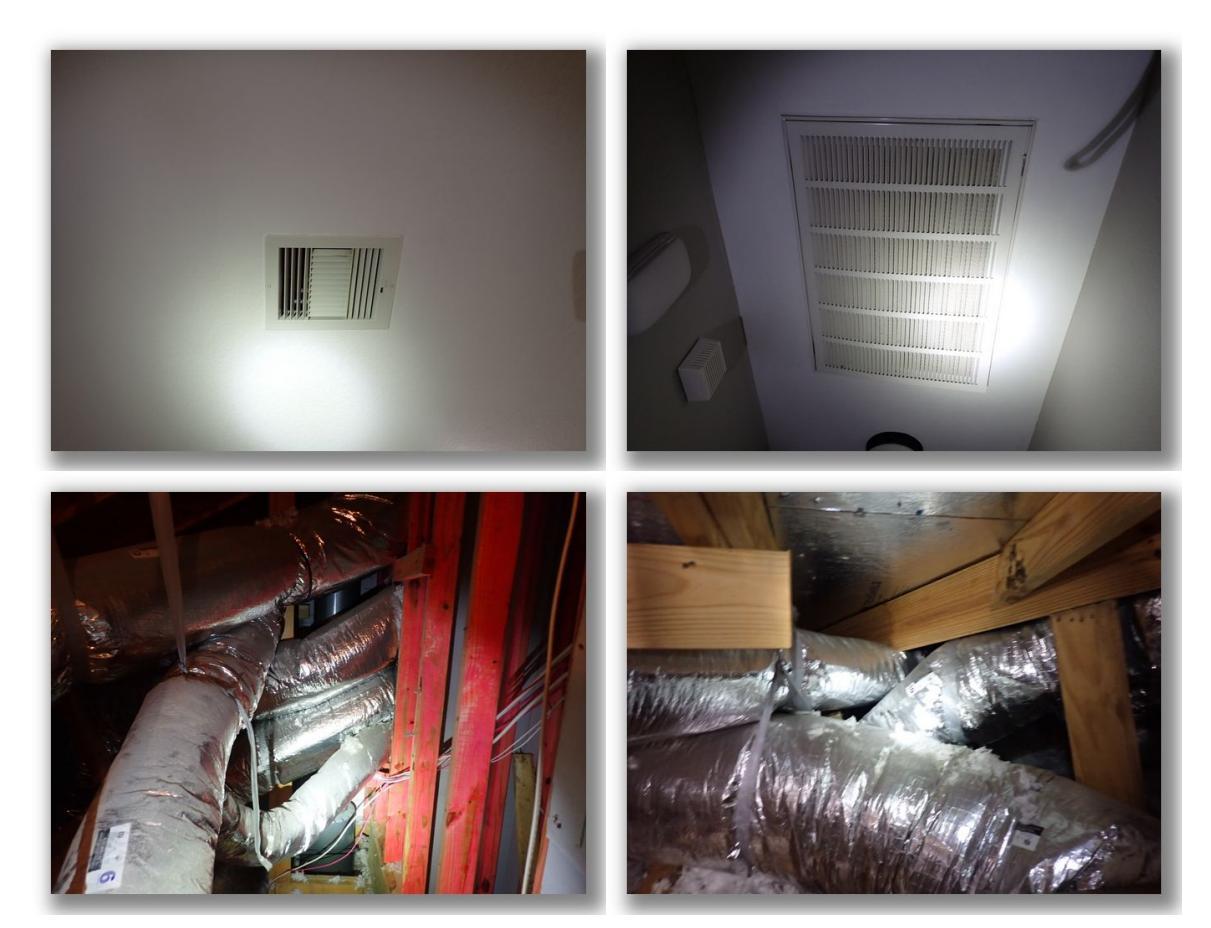
- The duct work in the attic area does not appear to be properly separated to help prevent condensation from developing. It is recommended to separate the duct work with a minimum intervals of 1.5-inches.
- The air-return chase for the HVAC system is dirty and should be cleaned to help maintain good air quality.
- There is visible dust and/or mildew on the air registers in the kitchen. The cause and remedy should be further evaluated. It is recommended to have the air registers and duct system cleaned for air quality purposes.

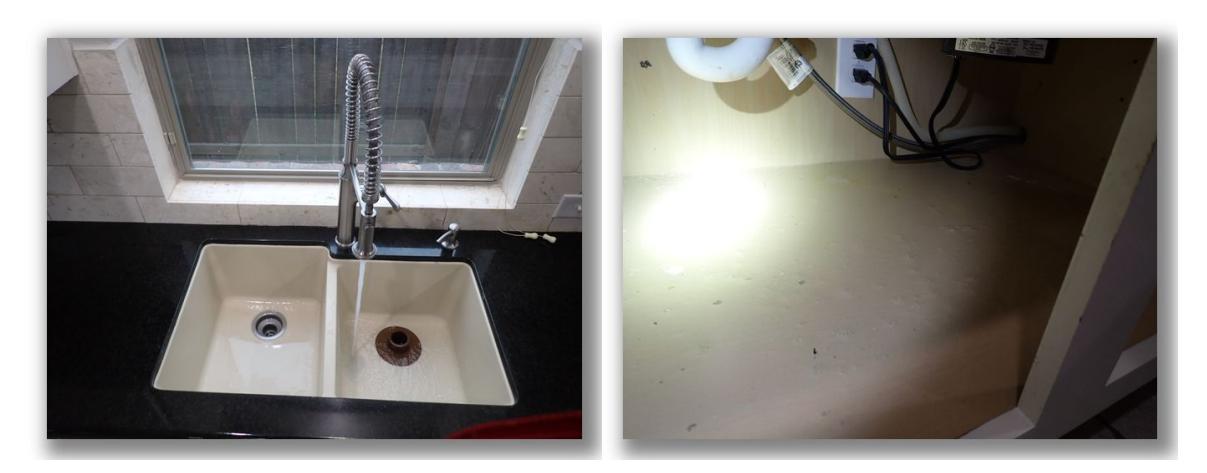
• The shelf in the cabinet under the sink is damaged.
