INSPECTED FOR
Sample Report
1234 Sample Road
Anywhere, TX 12345

PROPERTY INSPECTION REPORT FORM

1234 Sample Road, Anywhere, TX 12345

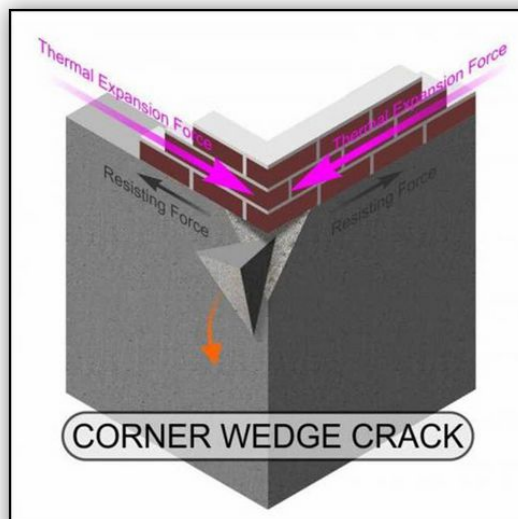
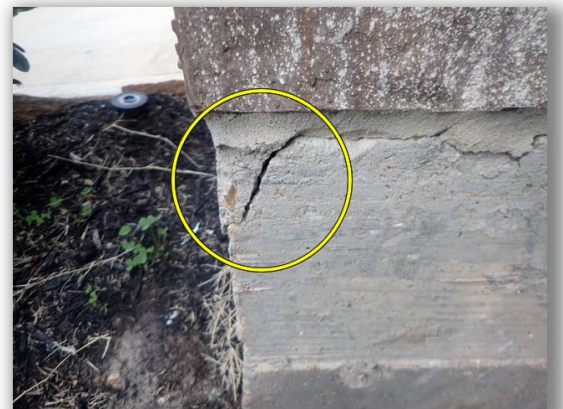
- One or more of the foundation perimeter beam corners were observed to be sheared off (corner pop). This is a common condition to observe and is due to thermal expansion and contraction of the different building materials. This condition does not adversely affect the foundation performance. However, in some cases, some cosmetic improvements may be necessary.

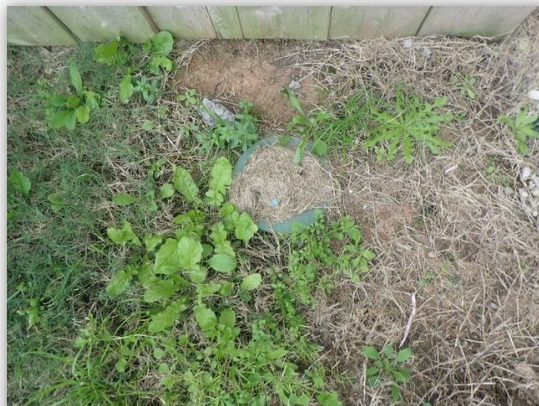
Grading & Drainage

- There is an underground and/or surface drainage system in place. It appears that the surface water collector(s) and/or drain(s) are clogged and/or filled with debris. This condition will adversely affect the performance of the drainage system and corrective measures are needed at this time.

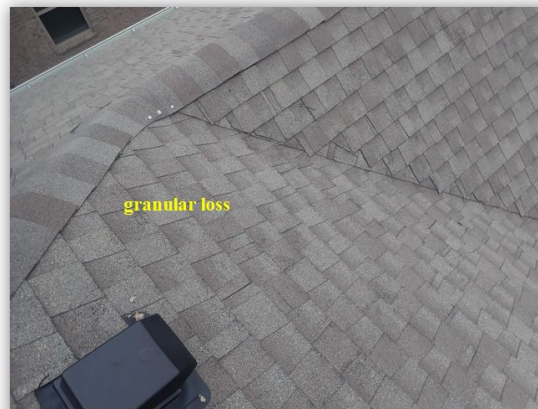
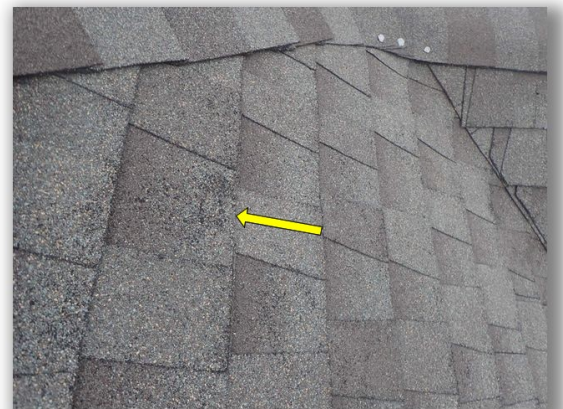
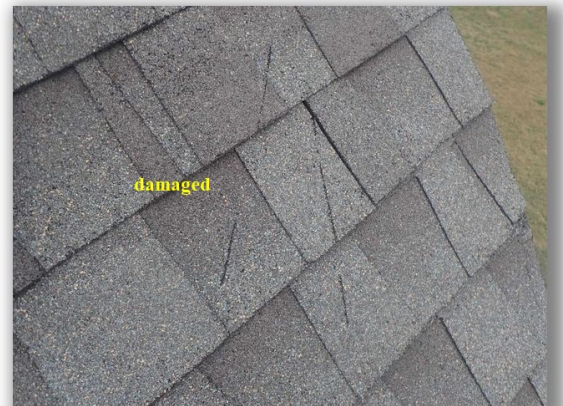
- One or more of the shingles were observed to be lifting on the west side of the roof structure.
- Damaged shingles were observed on the east side, west side of the roof structure.
- The composition roofing material has experienced granular loss in various locations throughout the roof.

You are strongly encouraged to have a properly certified roofing contractor to physically inspect the roof, prior to the expiration of any time limitations such as option or warranty periods, to fully evaluate the condition of the roofing material. The observation made to support the rendering of this opinion are listed but not limited to the following:

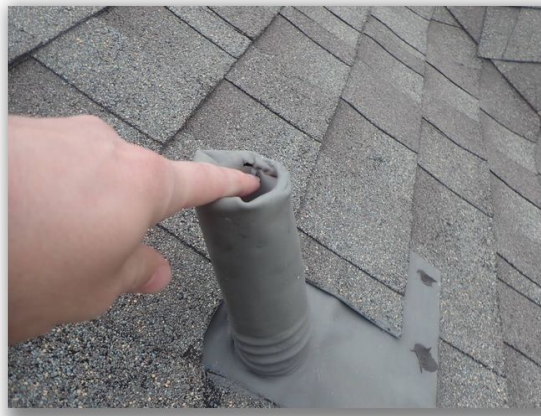
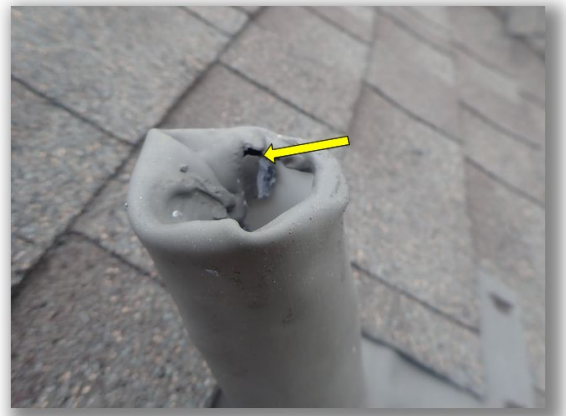
Flashing Details

- The lead jack flashing at the plumbing vent stack needs to be checked, reset or repaired as necessary. The lead jack flashing detail was observed to be improperly installed at one or more of the roof level plumbing vent pipes. The lead flashing should run the full length of the vent pipe and turn down into the top of the vent pipe to help prevent water intrusion at this point.
- The storm collar(s) at the roof level gas equipment vent pipe(s) need to be properly sealed to help prevent water intrusion into the structure.

The flashing details needs to be checked, reset or repaired as necessary. The observations made to support the rendering of this opinion are listed but may not be limited to:

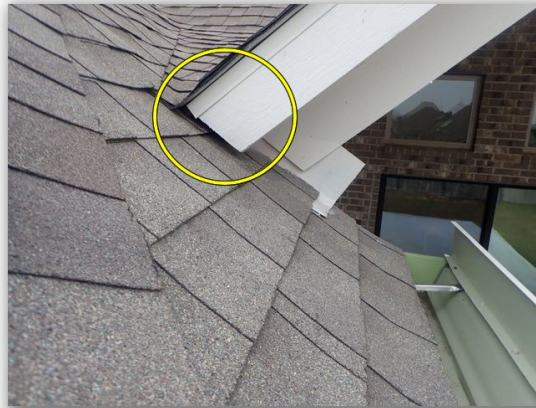
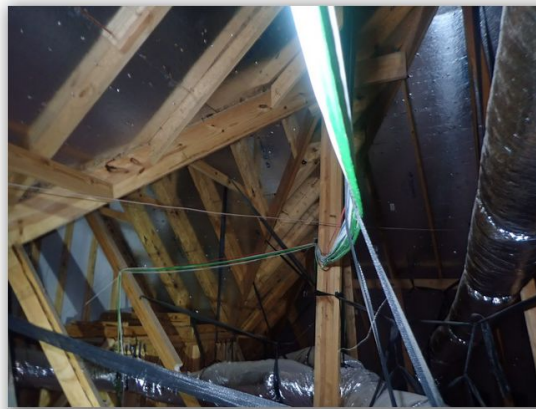
Roof Structure

- It is recommended to seal all openings between the soffit and roof covering to prevent pest/rodent intrusion at this point.

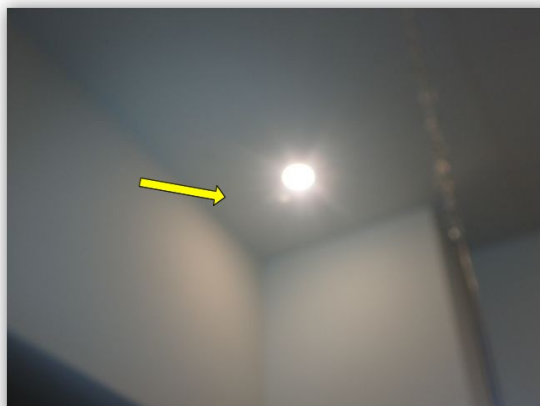
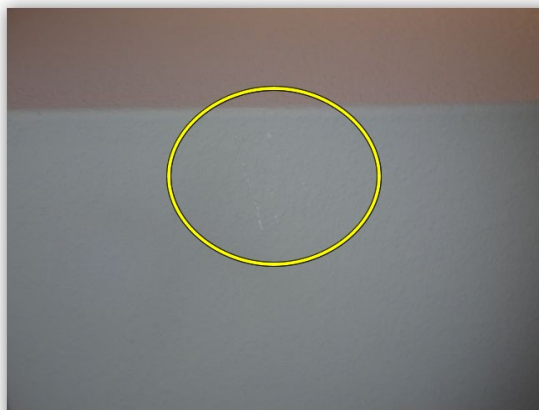
Ceilings

- Ceiling joint cracks were observed in the kitchen, garage, rear middle bedroom.
- Paint touch ups are recommended in several locations.

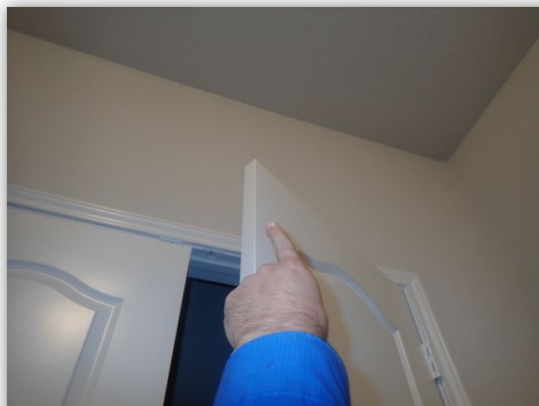
Interior Doors

- The door is not latching properly to the front corner bedroom closet.

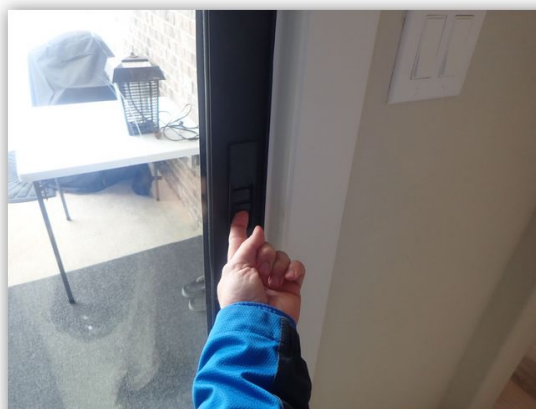
Exterior Doors

- The door hardware is not functioning properly to the backyard entry door.
- Weather-stripping improvements are recommended for the front entry exterior door(s).

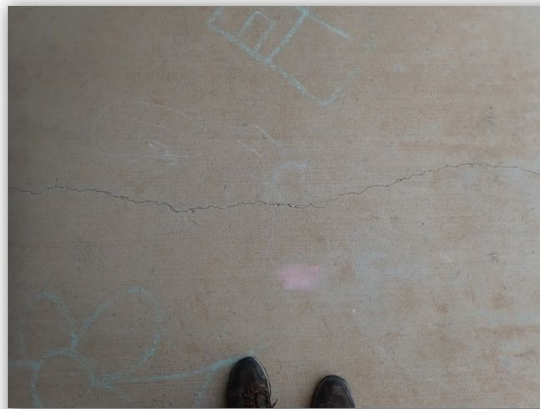
Porches / Patio

- Minor cracks and/or deficiencies were observed in the patio.

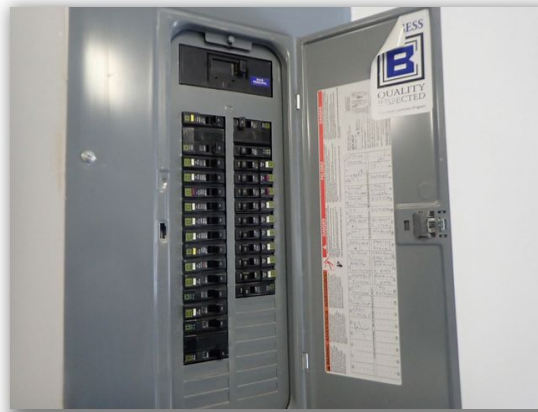
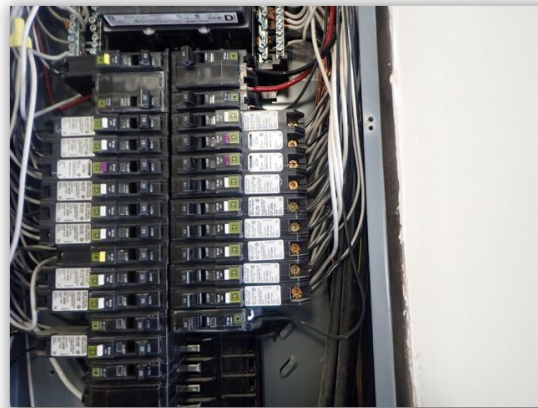
All components were found to be performing and in satisfactory condition on the day of the inspection.

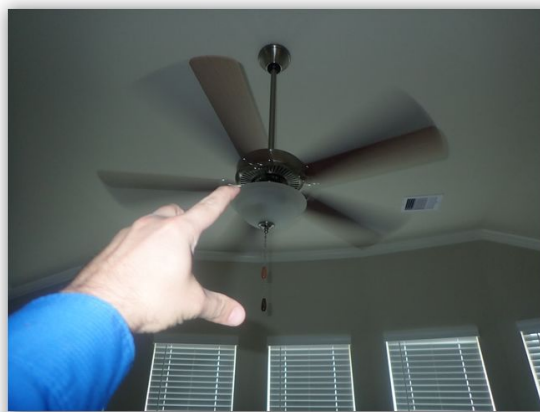
Fixtures

- The ceiling fan was observed to be noisy when operated in the primary bedroom.

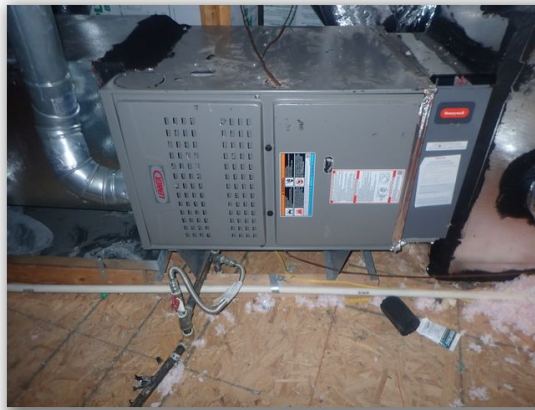
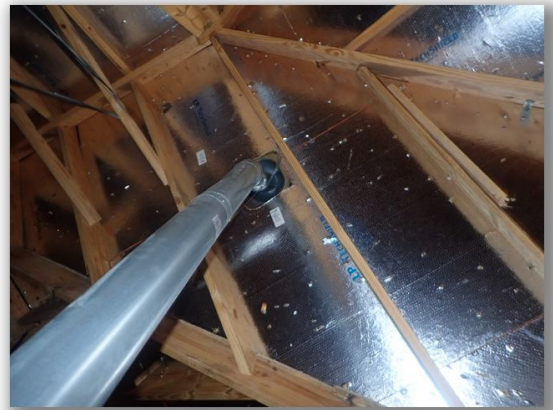
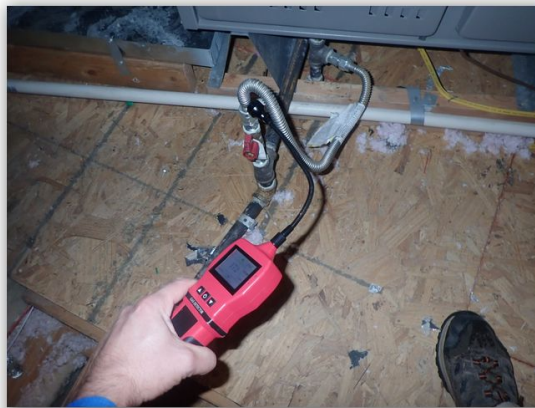
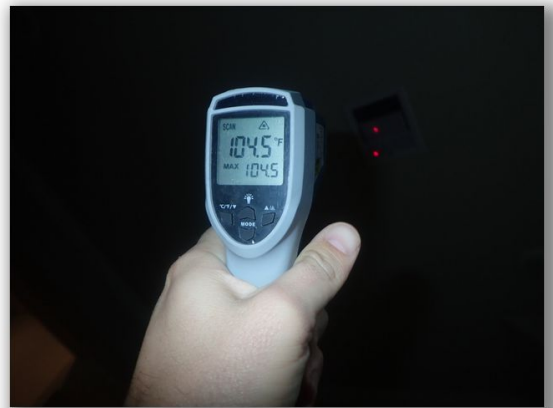
Brand Name: Lennox

This component appears to be performing adequately at the time of this inspection. It is achieving an operation, function, or configuration consistent with accepted industry practices for its age.

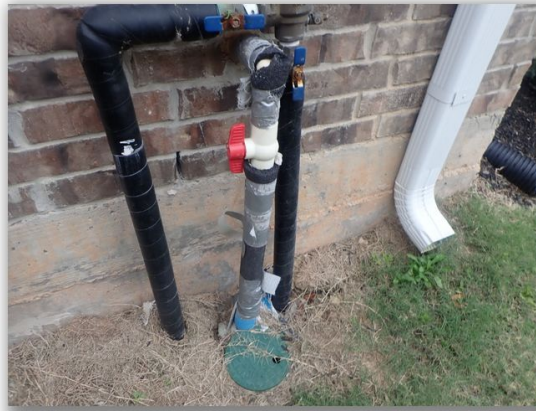
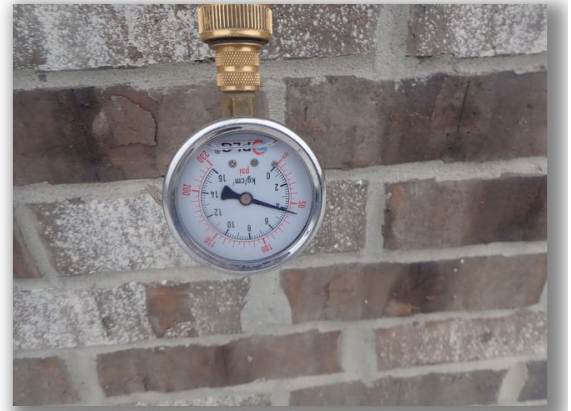
All components were found to be performing and in satisfactory condition on the day of the inspection.

Note: The exterior water hose bibb(s) (faucet) and exposed main water shut off adjacent to the home should be protected from physical damage and/or possible freeze.

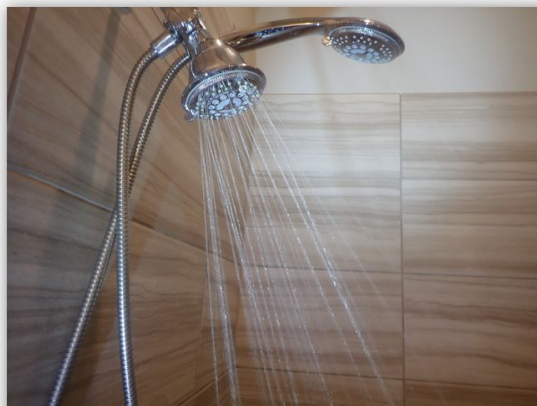
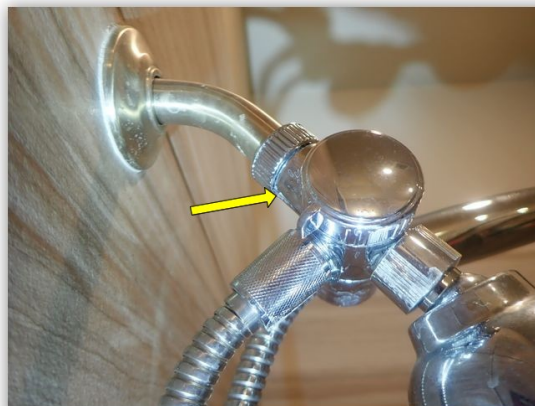
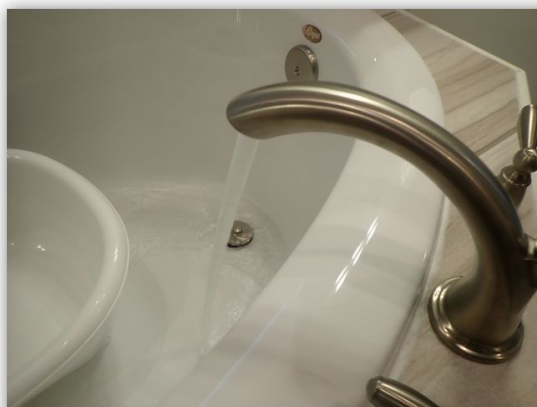
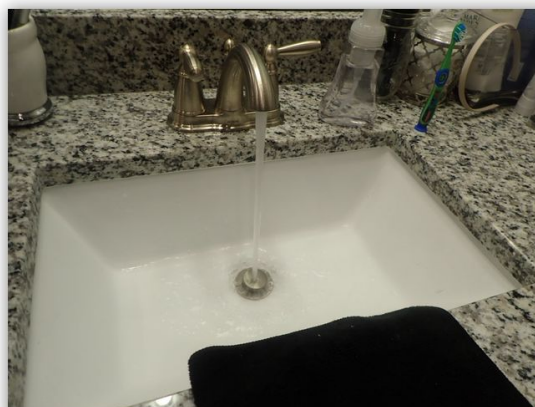
Shower

- The shower spout is leaking at the neck connection.

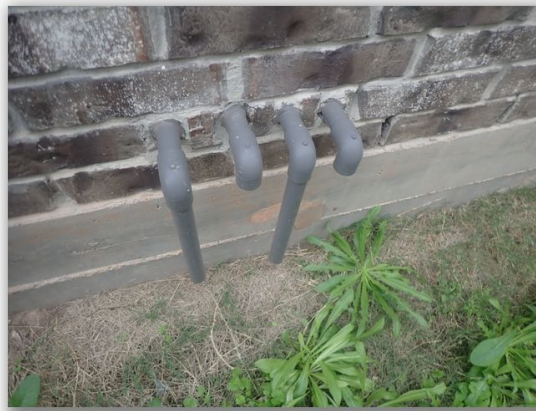
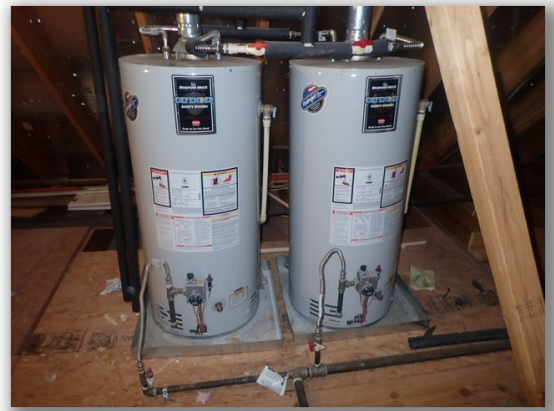
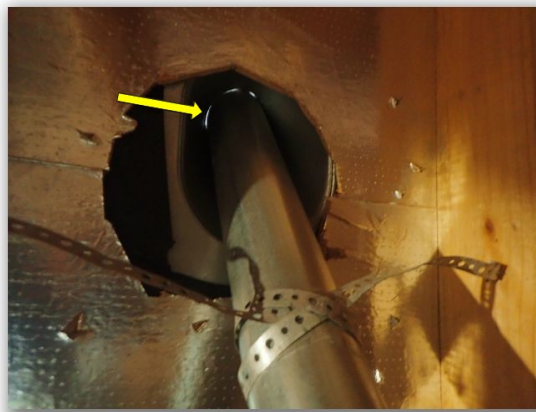
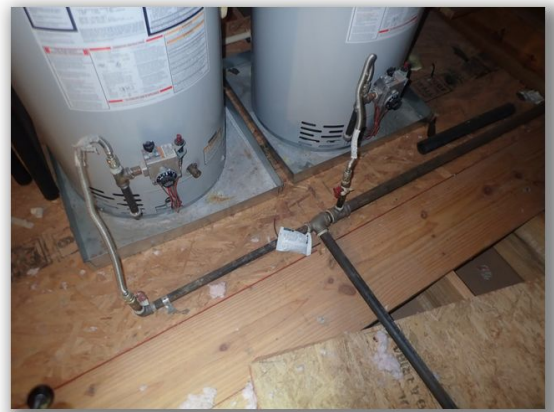
Brand Name: Bradford White

- The roof level flue storm collar needs to be properly sealed to help prevent water intrusion into the structure.

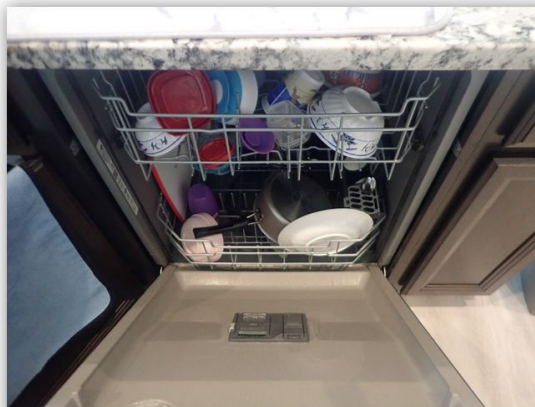
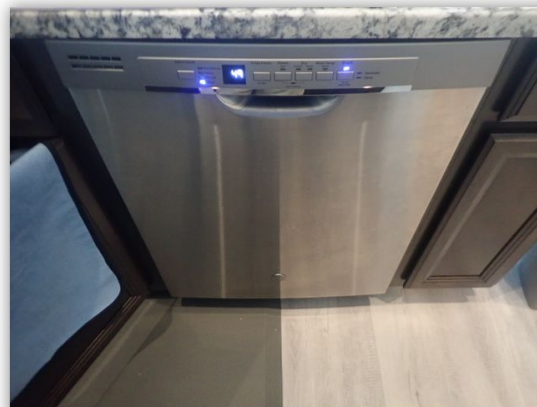
Brand Name: General Electric – GE

This component appears to be performing adequately at the time of this inspection.

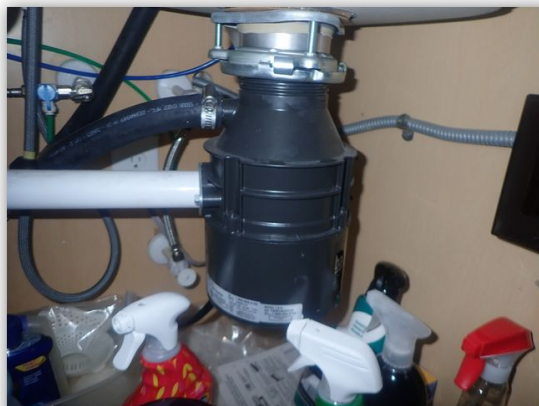
B. Food Waste Disposers

This component appears to be performing adequately at the time of this inspection.

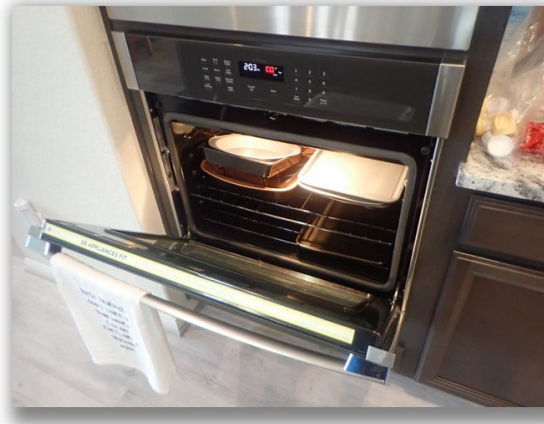
Built-in Oven Brand Name: General Electric – GE

This component appears to be performing adequately at the time of this inspection.

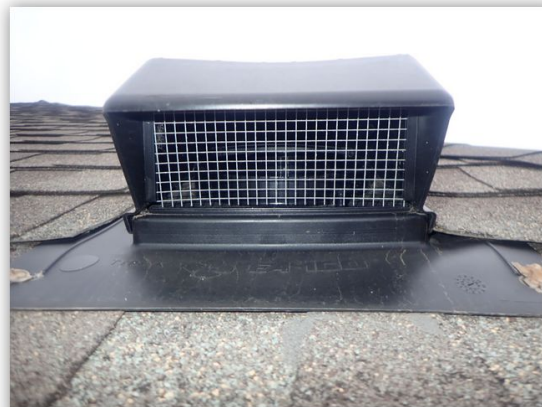
F. Mechanical Exhaust Vents and Bathroom Heaters

- The mechanical exhaust vent fan is noisy when not in use in the gameroom bathroom, primary bathroom.

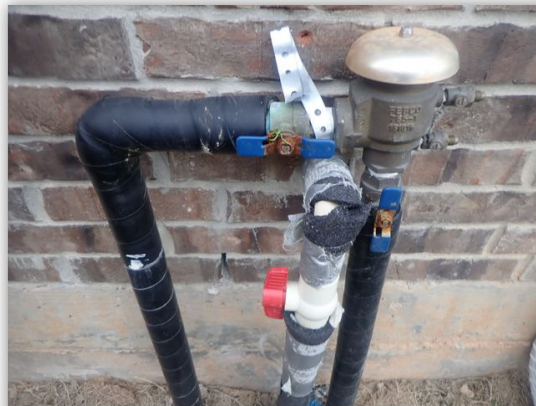
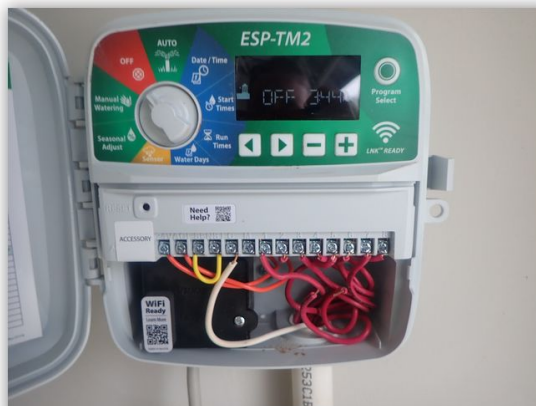
Sprinkler System and Associated Components

- The exterior moisture (rain/freeze) sensor device does not appear to be properly installed and should be corrected for proper sensor operation.
- One or more of the sprinkler heads need to be adjusted and/or straightened so to disperse water properly in station(s); **7**.
- One or more of the handles were observed to be damaged/rusted at the anti-siphon device. This may prevent you from being able to shutoff the water to the system or test the device.

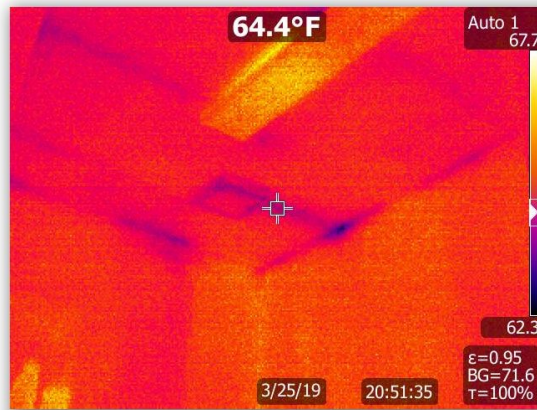
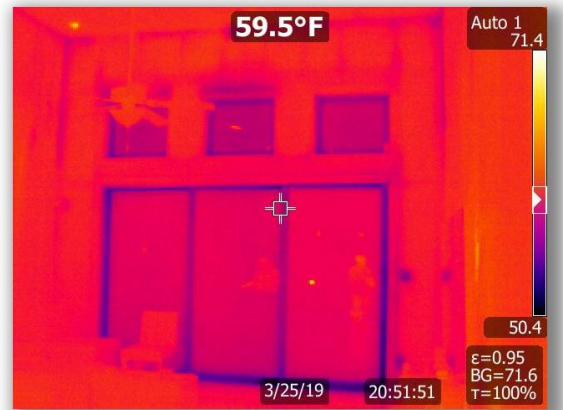
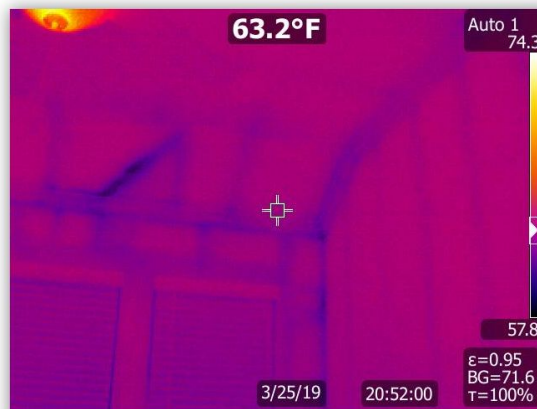
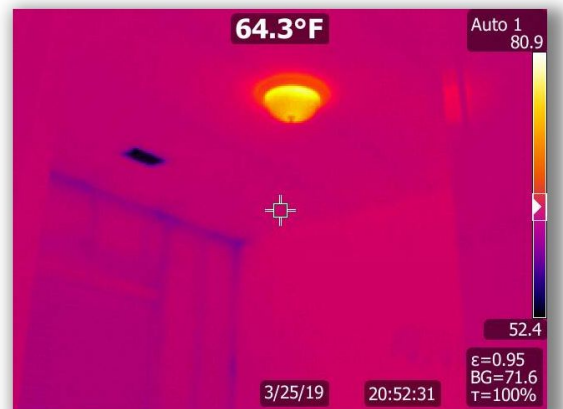
B. Thermal Imaging / Infrared

All components were found to be performing and in satisfactory condition on the day of the inspection.
