**Sample Report
1234 Sample St.
City, TX 77777**

December 7, 2021

PROPERTY INSPECTION REPORT FORM

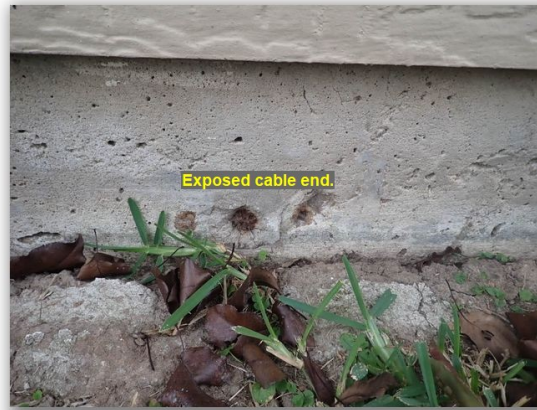
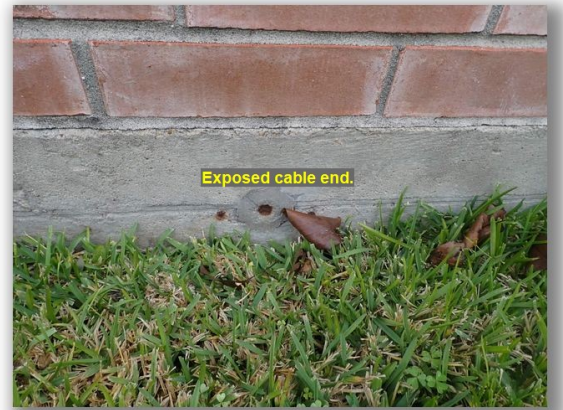
- One or more of the post tension cable ends are exposed and need to be properly sealed on the north side, east side of the structure.

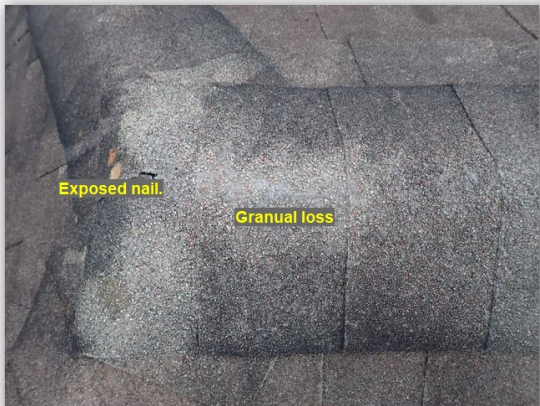
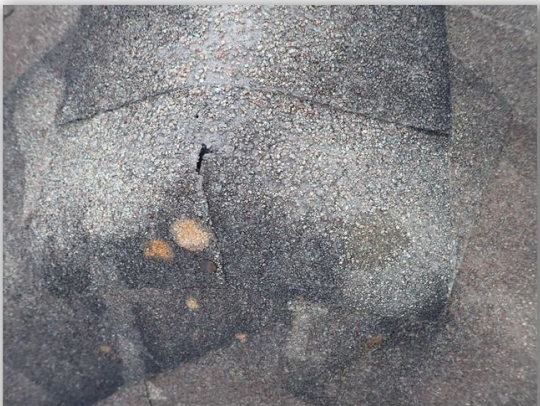
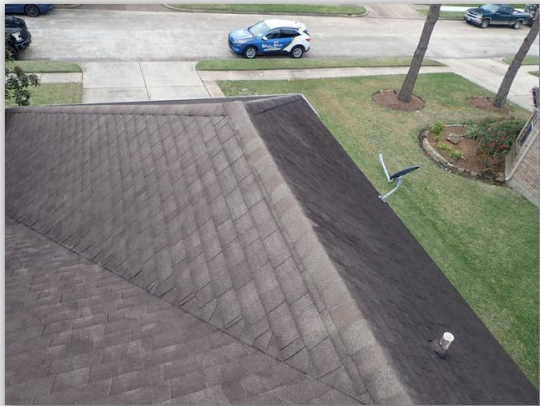
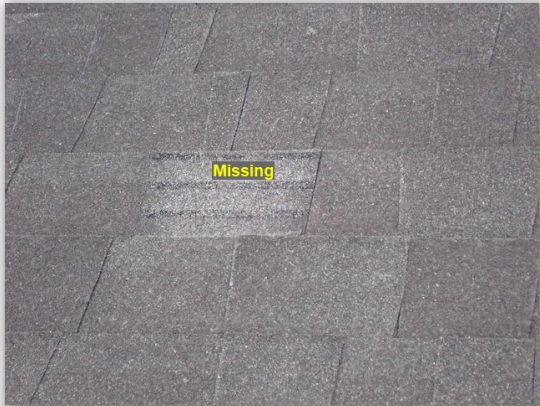
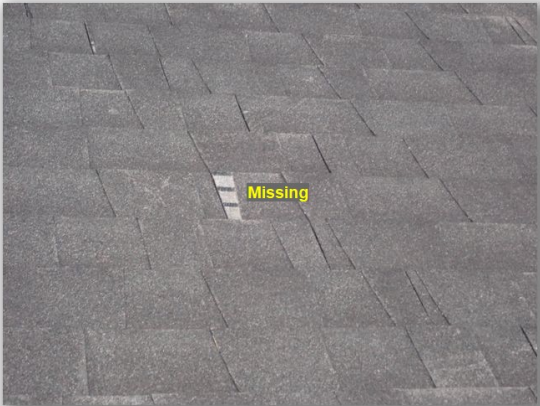
- Missing shingles were observed on the south side of the roof structure.
- Exposed fasteners were observed at the shingles in one or more locations.
- The composition roofing material has experienced granular loss in various locations throughout the roof.

You are strongly encouraged to have a properly certified roofing contractor to physically inspect the roof, prior to the expiration of any time limitations such as option or warranty periods, to fully evaluate the condition of the roofing material. The observation made to support the rendering of this opinion are listed but not limited to the following:

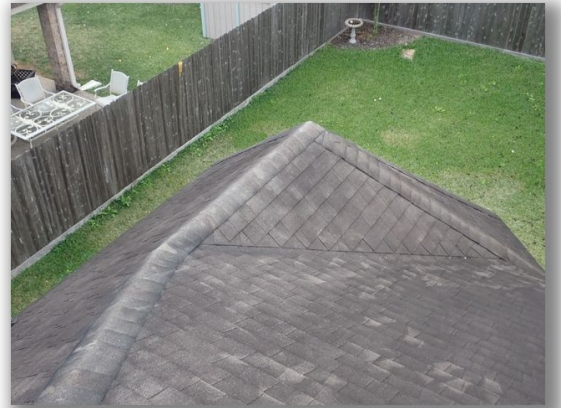
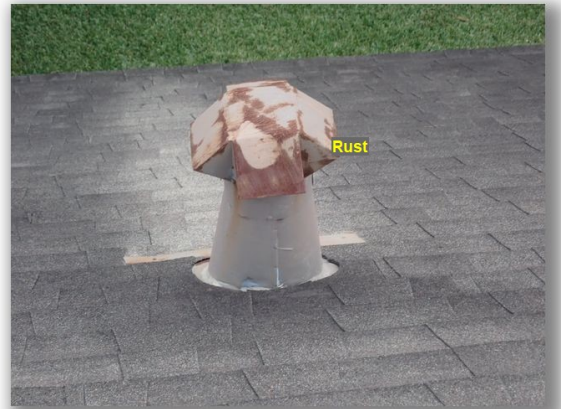
Flashing Details

- Some of the metal flashing details were observed to be rusted and should be corrected as necessary.
- The flashing needs to be painted to prevent rust and/or UV damage.

You are strongly encouraged to have a properly certified roofing contractor to physically inspect the roof, prior to the expiration of any time limitations such as option or warranty periods, to fully evaluate the condition of the roofing material. The observation made to support the rendering of this opinion are listed but not limited to the following:

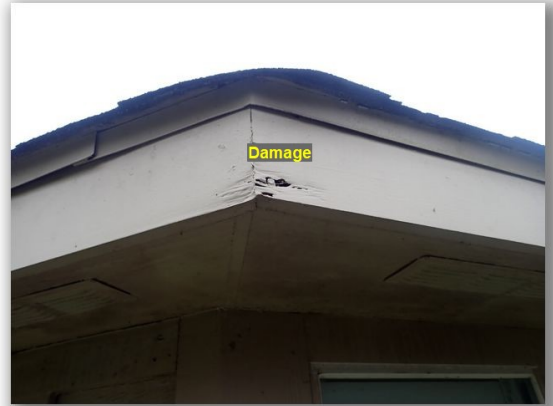
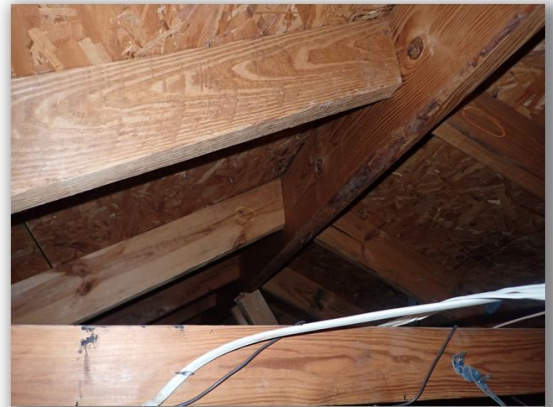
Roof Structure

- The fascia board material has some deterioration and/or damage on the east side of the roof structure.

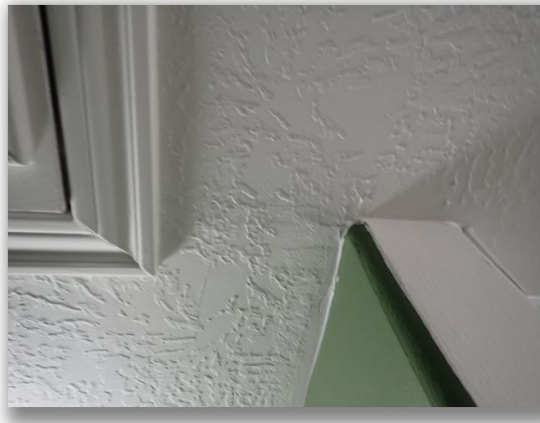
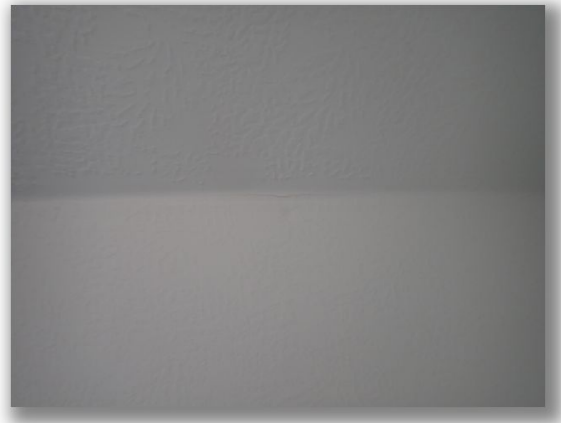
- Ceiling joint cracks were observed in the various locations throughout the house.
- The ceiling texture has some deterioration and/or damage in the living room.

Note: Nail heads were observed to be pushing through the interior finish in one or more locations.

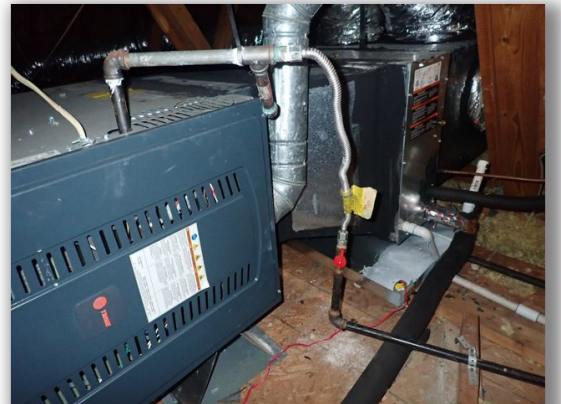
- The air return system currently has two filters in place (Double Filtered). The configuration will adversely affect the return air flow and performance of the HVAC system. This condition should be further evaluated and corrected as necessary.

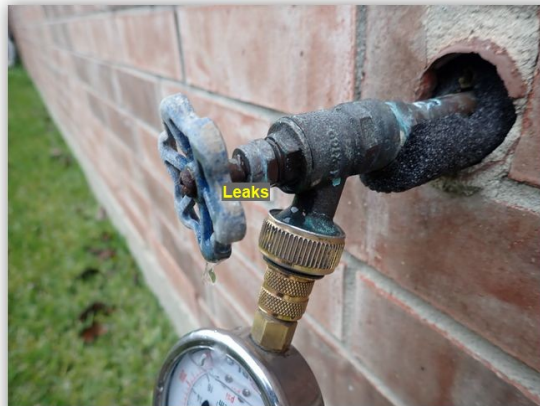
Exterior Faucets/Fixtures

- The exterior water hose bibb (faucet) is leaking at the handle when operated on the east side of the structure.

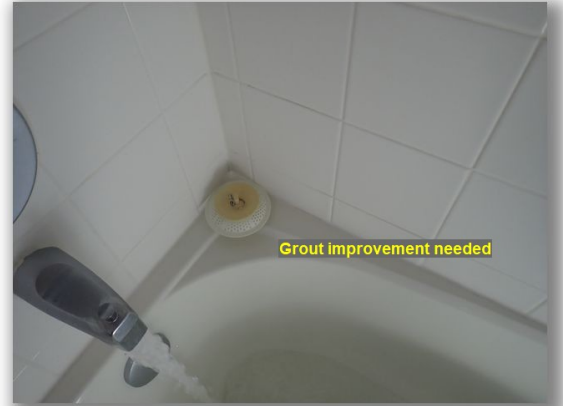
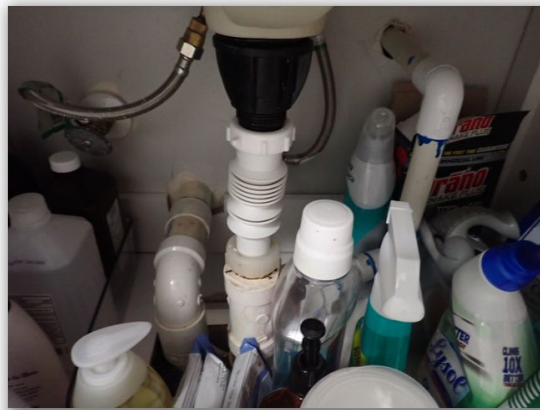
Lavatory / Sink

- The drain line is made of corrugated material. It is recommended to use smooth wall/PVC type material to prevent blockage.

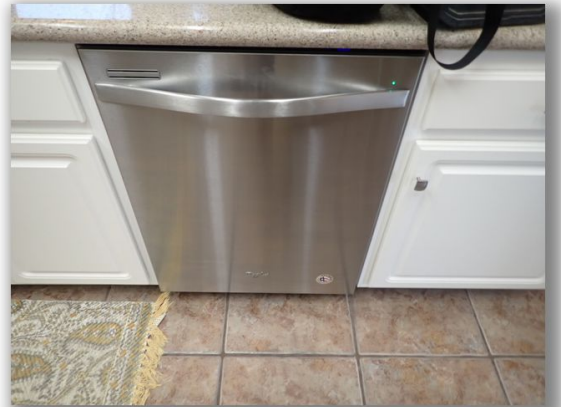
- The dishwasher drain hose is not properly installed to prevent back flow or anti-siphoning. It is recommended that an air gap device or high drain loop be installed in the drain line.

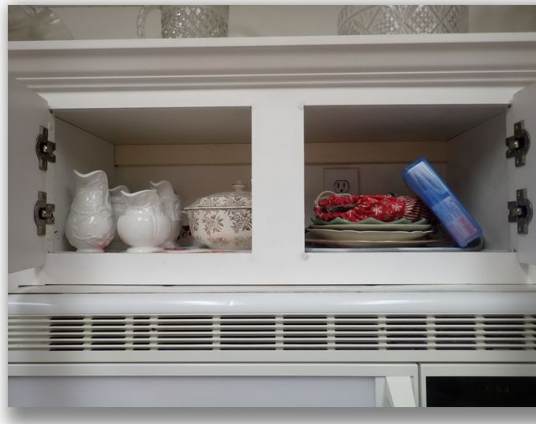
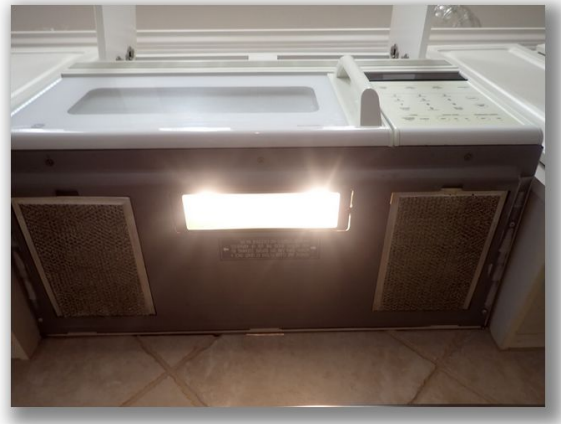
C. Range Hood and Exhaust Systems

- The range hood in place is ductless. The range hood does not terminate outside and is dependent on the charcoal filter installed. It is recommended to regularly clean your filter system to prevent damage to the structure.

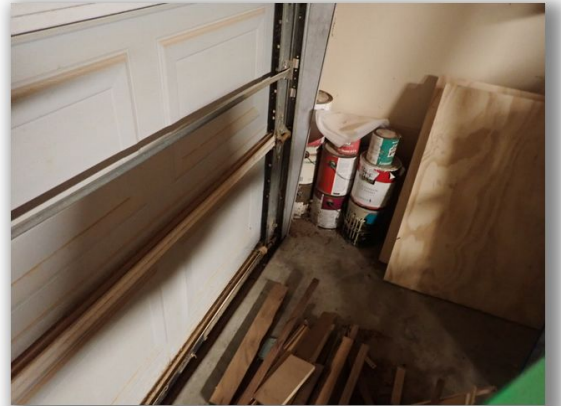
- The garage door reverse photo electric sensor was observed to be missing.
