Sample Report 12345 Sample Report Humble, TX 77346

PROPERTY INSPECTION REPORT FORM

Sample Report Name of Client	12/08/2021 Date of Inspection			
12345 Sample Report, Humble, TX 77346 Address of Inspected Property				
James Lee Name of Inspector	23485 TREC License #			
Name of Sponsor (if applicable)	TREC License #

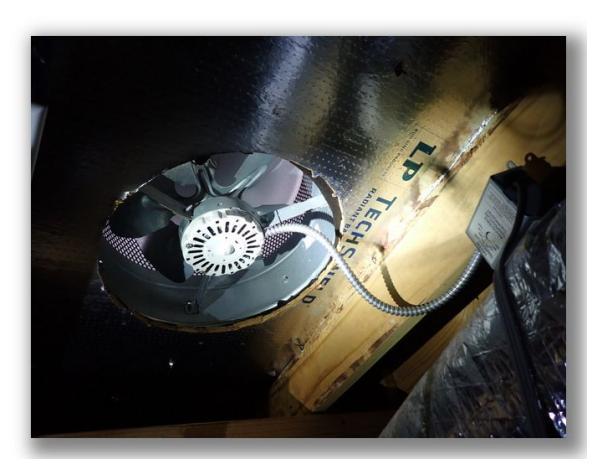
Attic Power Vents

- One or more of the attic power ventilators appears to be inoperative.
- One of the power ventilations adjustment knobs were observed to be missing at the time of inspection.

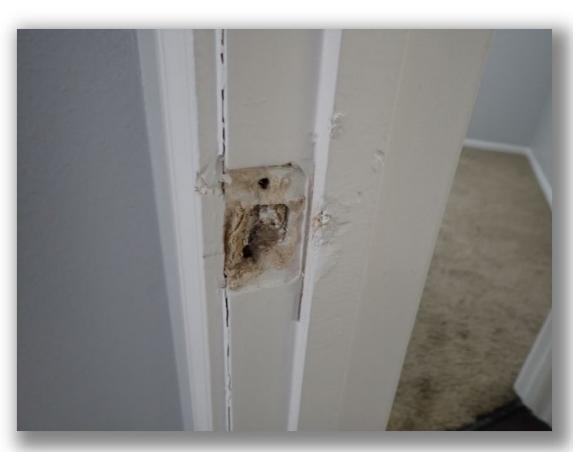
Exterior Doors

- Weather-stripping improvements are recommended for the front entry, backyard entry exterior door(s).
- The door is not latching properly to the front entry door.

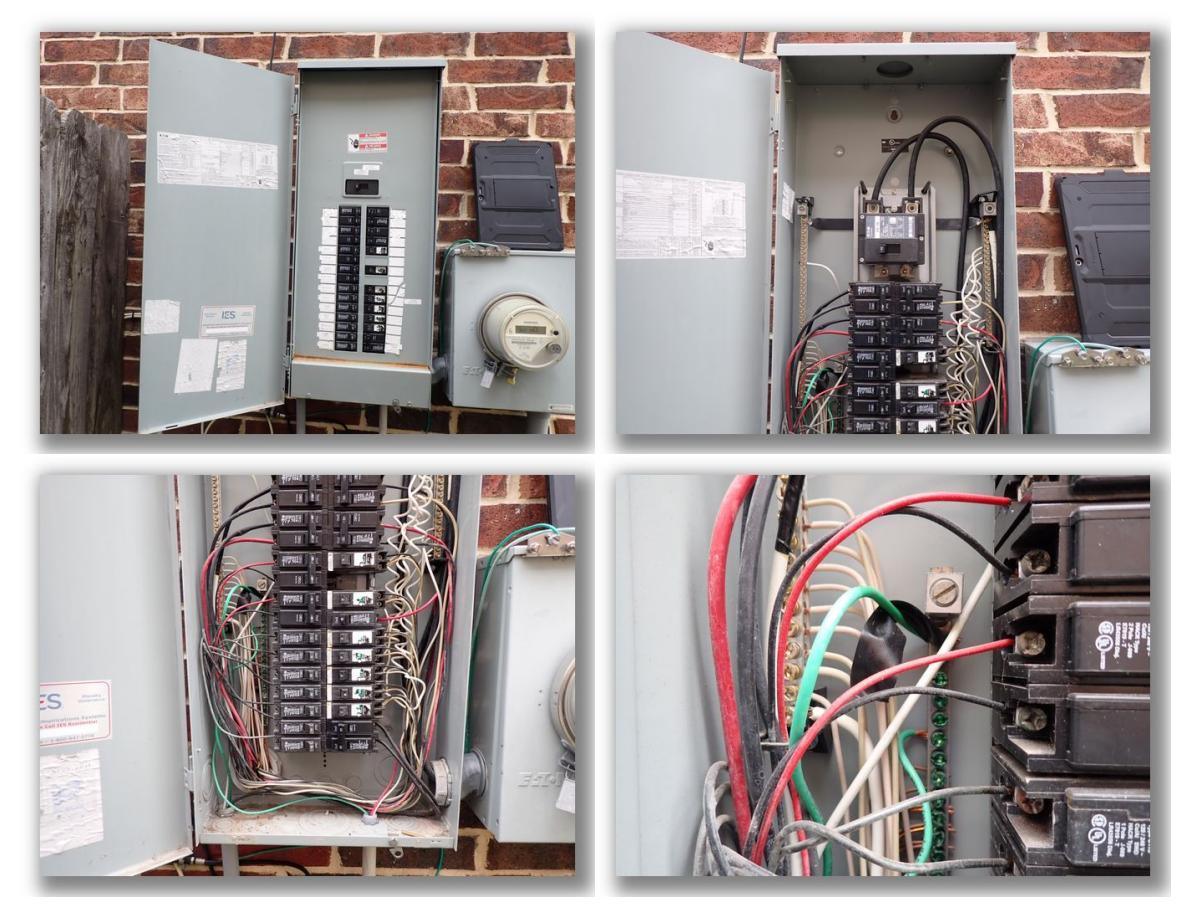
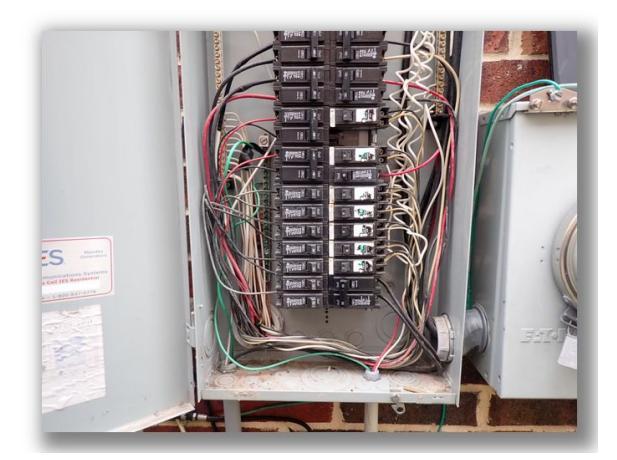
Arc-Fault Circuit Interrupter Protection (AFCI)

One or more of the arc-fault circuit interrupter (AFCI) devices in the electrical cabinet did not trip • and/or respond properly when tested. This condition should be further evaluated and corrected as necessary.

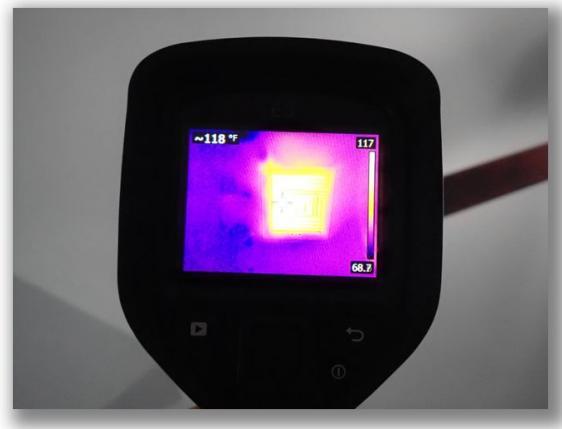
Central Heating System(downstairs) – *Energy Source*: Gas *Brand Name*: Lennox

- The heater gas supply line sediment trap was observed to be improperly installed. This condition does not meet current installation requirements and should be corrected.
- The heating equipment appears to be inoperative at the time of the inspection.

The HVAC system needs to be checked and serviced by a Qualified / Licensed HVAC Technician. The observations made to support the rendering of this opinion are listed but may not be limited to the following:

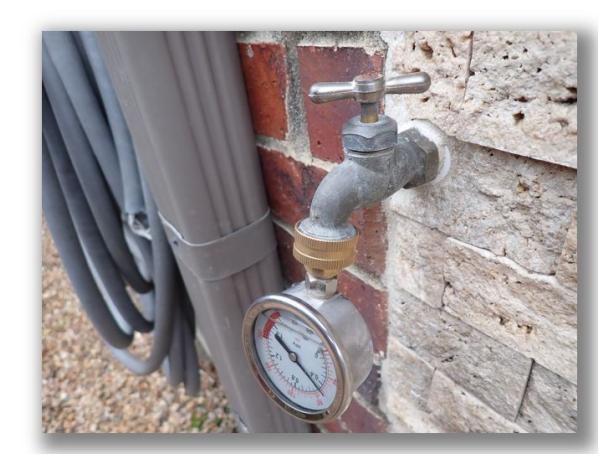
• One or more of the exterior water hose bibbs (faucet) do not have a back-flow or anti-siphon device (Vacuum Breakers) in place. Note: *This is not uncommon to observe with a home of this age.*

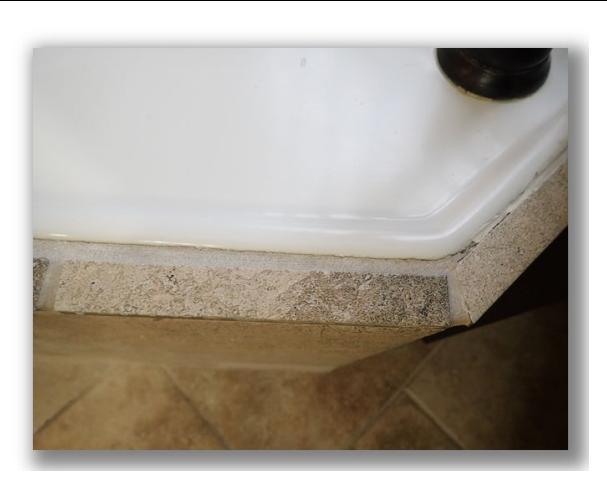
<u>Half Bath</u>

- The stopper is missing.
- Commode / Toilet
- The commode is loose at the floor mount.

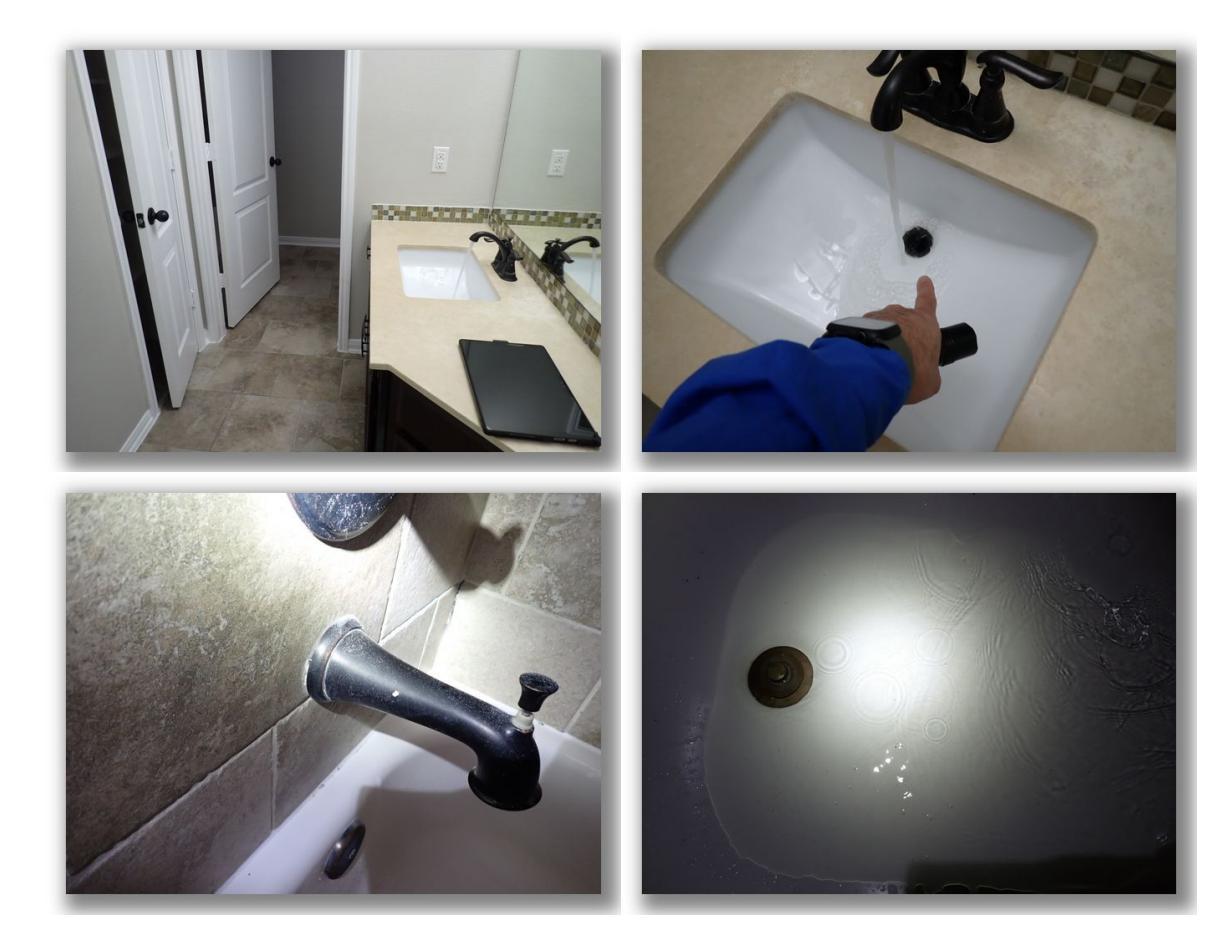
Commode / Toilet

The commode flapper does not function properly. •

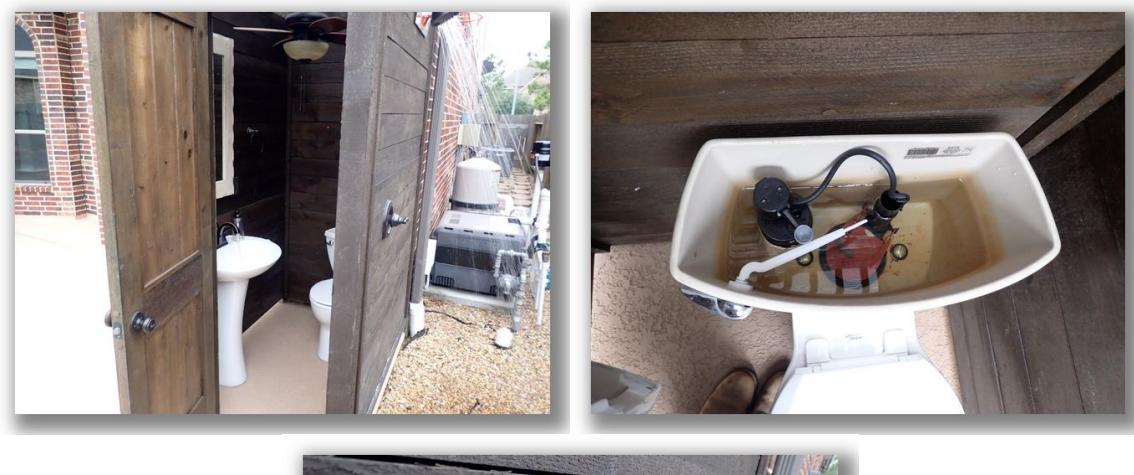
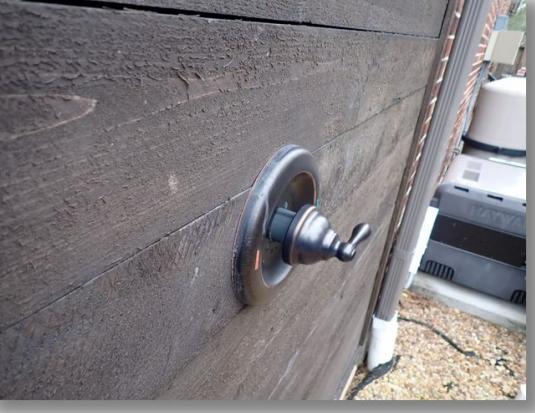
Shower

• The faucet assembly is not sealed at the wall. This condition has the potential to allow water to leak back into the wall cavity.

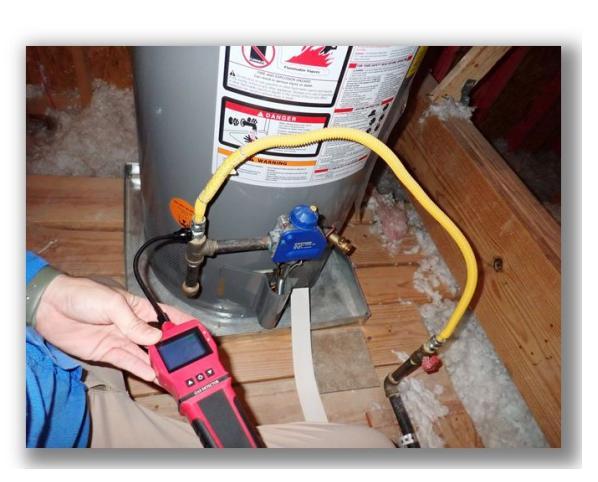
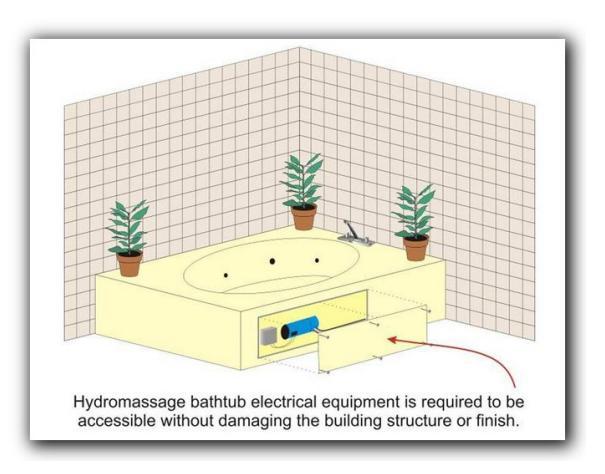
D. Hydro-Massage Therapy Equipment

• The access to the hydro-massage therapy equipment motor is not readily accessible and inspection of the equipment lines and motor could not be performed. This does not meet current installation standards.

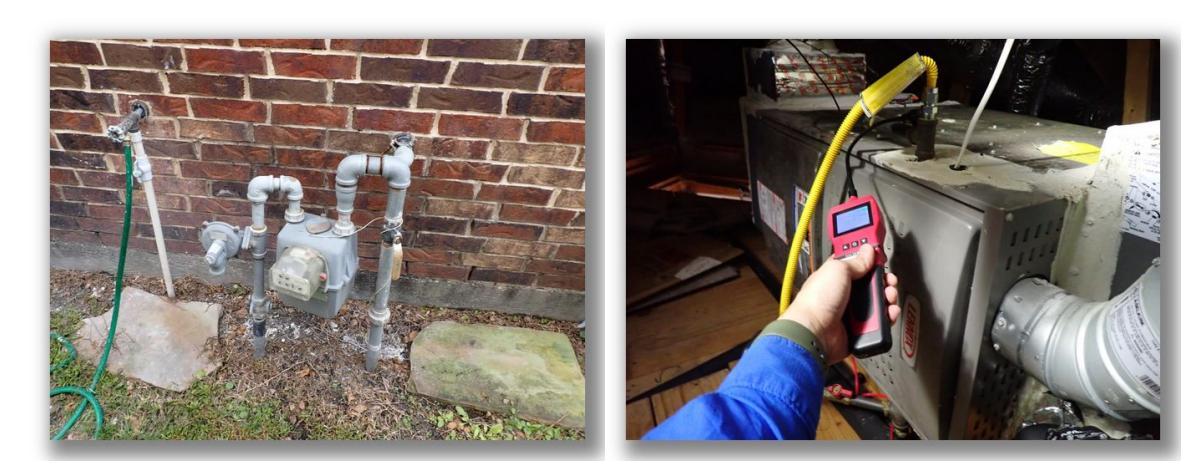
E. Gas Distribution Systems and Gas Appliances

• The heater gas supply line sediment trap was observed to be improperly installed. This condition does not meet current installation requirements and should be corrected.

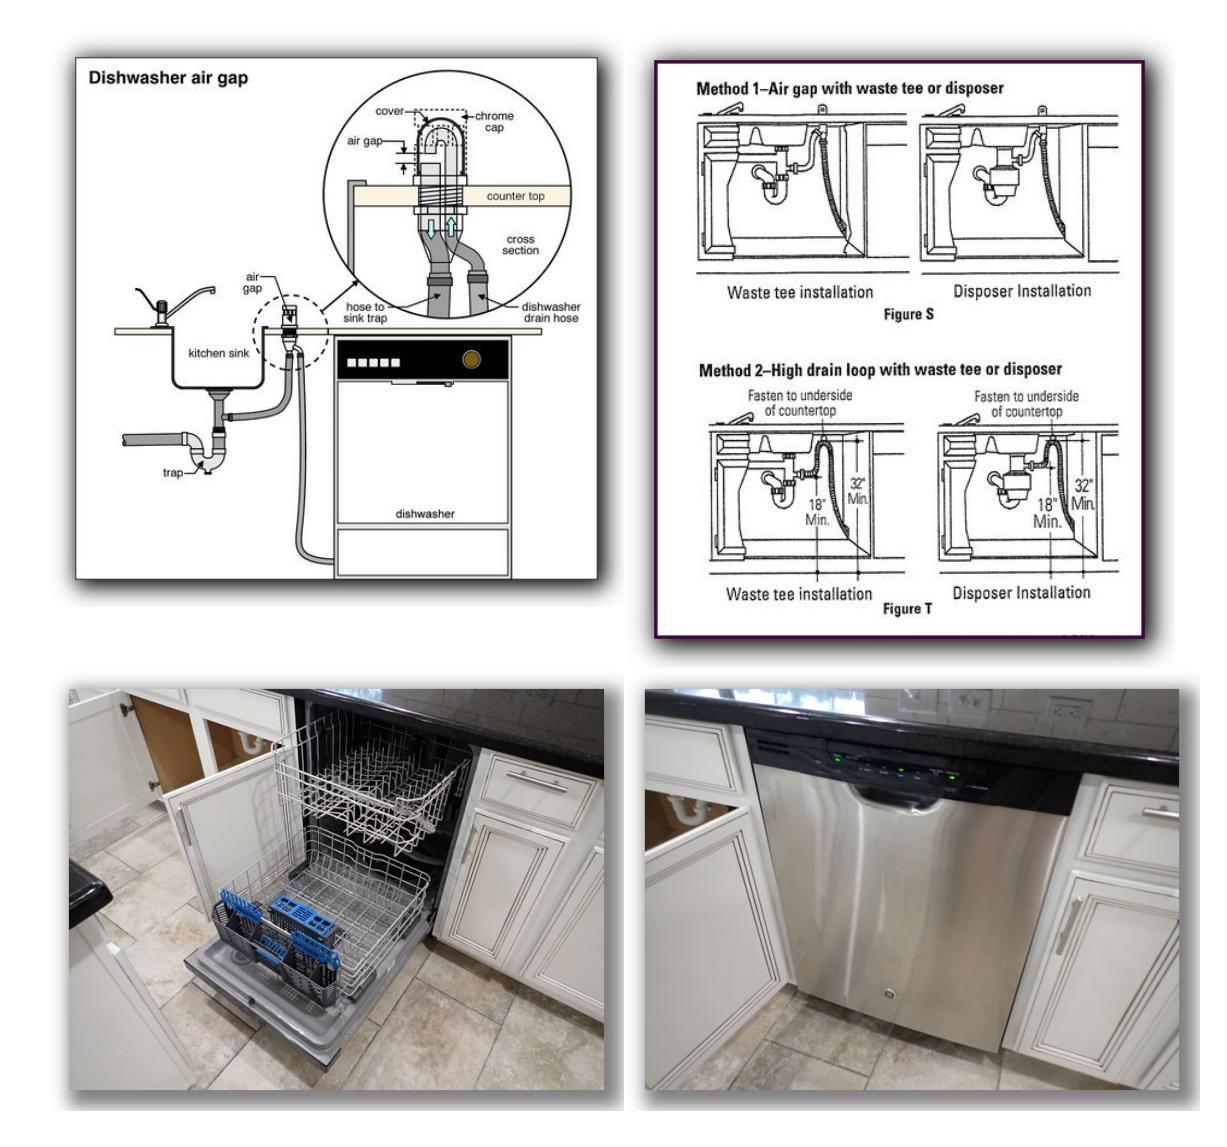
• The dishwasher drain hose is not properly installed to prevent back flow or anti-siphoning. It is recommended that an air gap device or high drain loop be installed in the drain line.

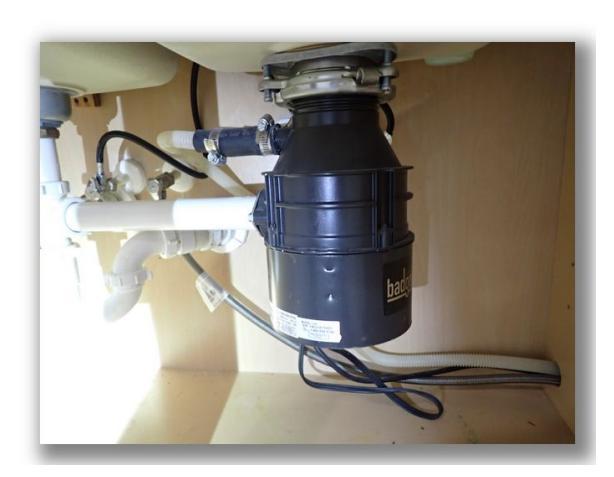
Food Waste Disposer

• The splashguard for the food waste disposer is damaged and/or missing.

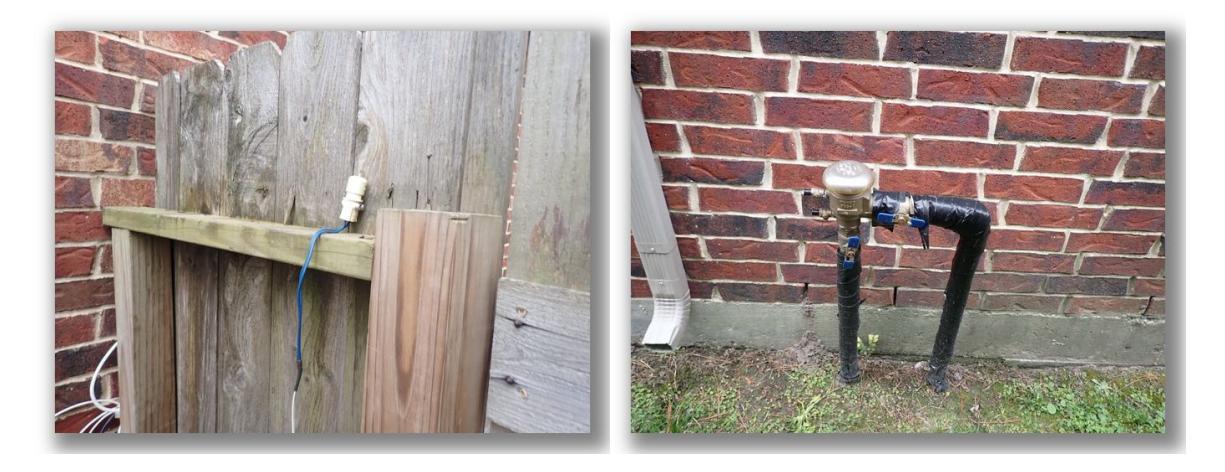
- The exterior moisture (rain/freeze) sensor device does not appear to be properly installed and should be corrected for proper sensor operation.
- One or more of the sprinkler heads need to be adjusted so not to spray water onto the exterior walls, surfaces or windows in stations; 2.
- One or more of the sprinkler heads need to be adjusted and/or straightened so to disperse water properly in station(s); 2.
- One or more of the sprinkler heads were observed to be damaged and/or missing in station(s); 2, 3.
- Sprinkler station(s) 1 did not respond when tested in the manual setting. The cause and remedy should be further evaluated and corrected as necessary.

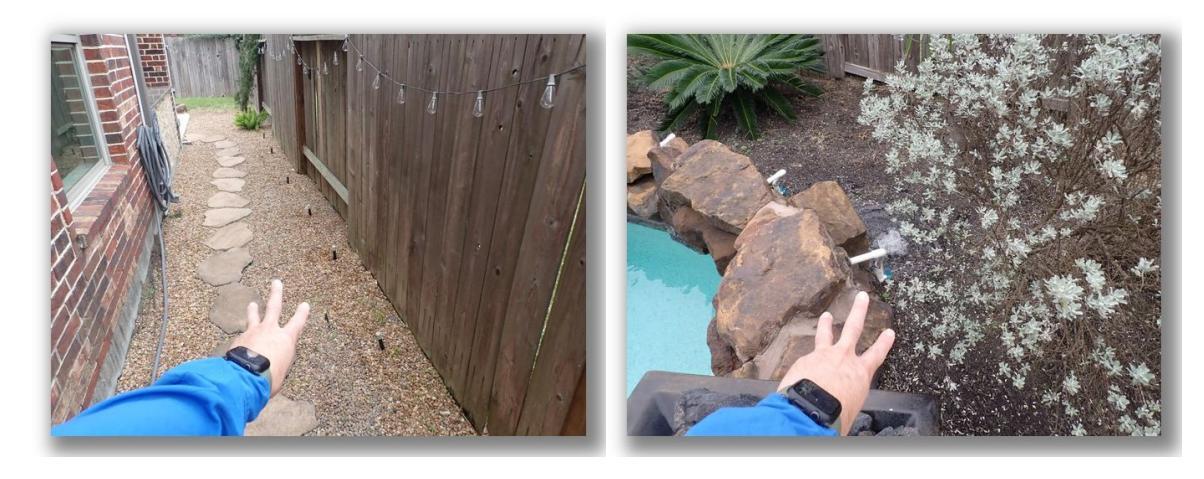
B. Swimming Pools, Spas, Hot Tubs, and Equipment

Some of the pool and/or spa components appear to have deficiencies that are beyond normal. The buyer should have this condition further evaluated by a pool technician familiar with pool structures and associated pool components for remedial cost estimates. The observations made to support the rendering of this opinion are listed but may not be limited to the following:

- It is recommended to paint all exposed PVC pipes to prevent UV break down.
- The filter gauge has a high pressure reading. Filter pressure should be maintained between 5 to 20 psi.
- The water level in the pool was low at the time of this inspection. This condition needs to be further evaluated and corrected as necessary.
- Some cracking of the deck was observed.
- The sweeper does not appear to be performing properly at this time.

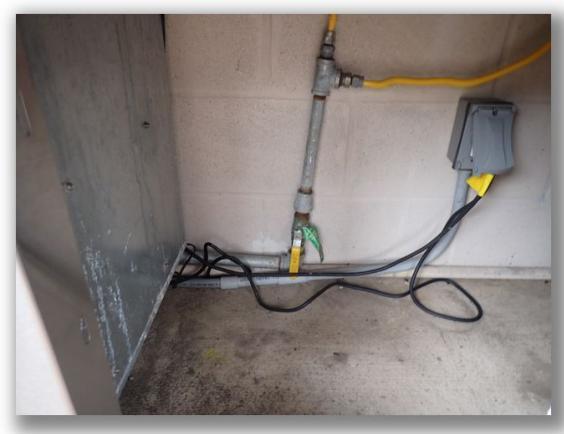
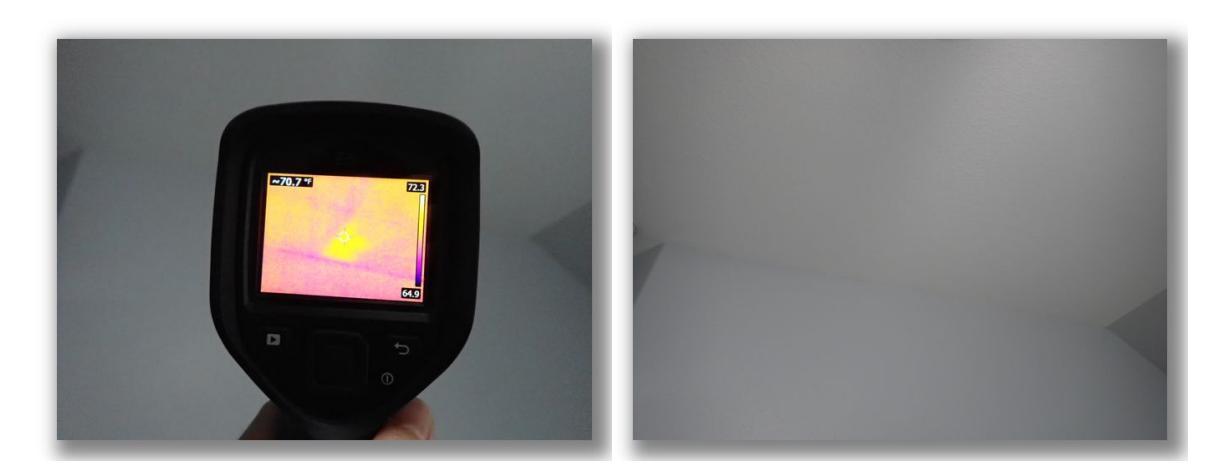
D. Thermal Imaging / Infrared *Comments*:

• Missing insulation was observed at the ceiling in the upstairs rear corner bedroom.
