## **CLADDING MOISTURE REPORT**

INSPECTED FOR  
**TEST STUCCO**

**June 4, 2020**

Subject Property : , TX

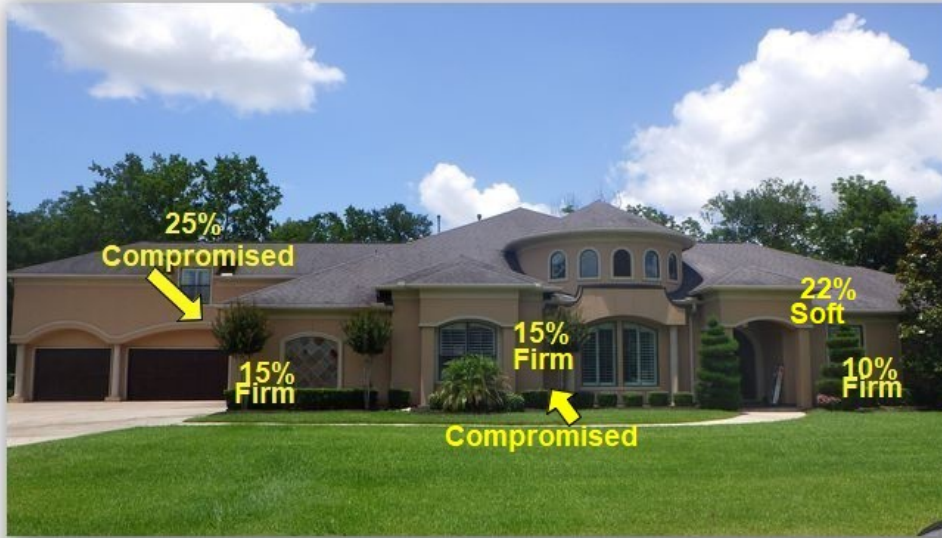
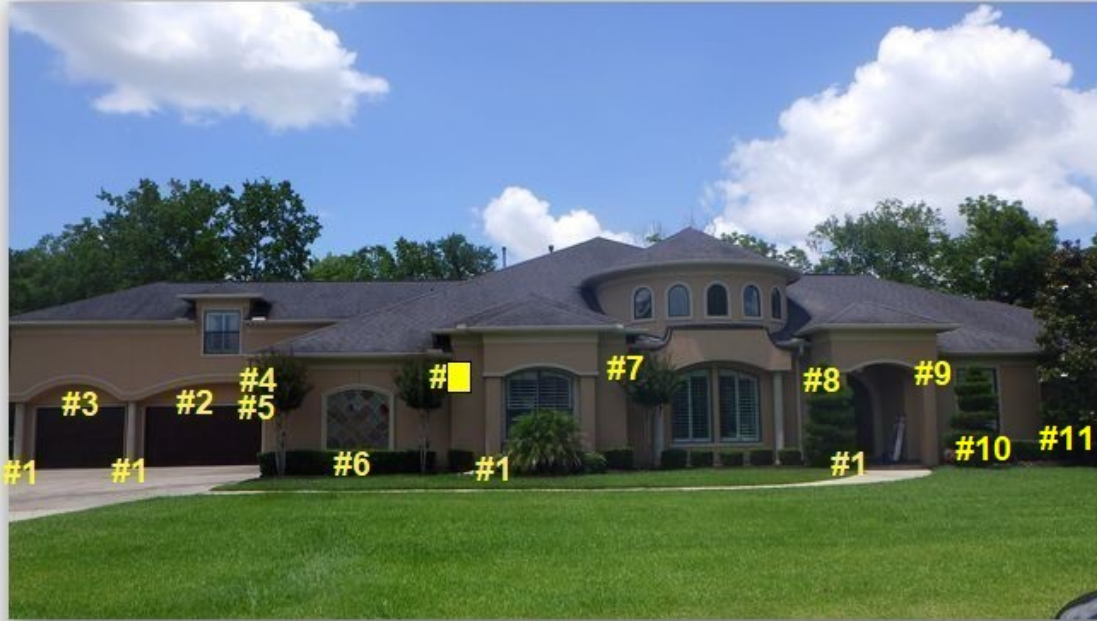
**Front Side of Structure**

- The stucco has poor clearance from the concrete flatwork. Under current installation standards, there should be at least 1.5 to 2-inches of clearance between the concrete flatwork and the stucco material. There are no visible defects related to this application at this time and no remedial repairs are recommended.

- Some minor cracking of the stucco finish was observed in one or more locations at the time of this inspection. The cracks observed were less than 1/16-inch and are consistent to be within accepted industry standards and no remedial repairs are recommended.

- There is missing kickout flashing details at the lower bottom edge of the roof line interface and the sidewall that continues past the edge of the roof. The lack of this kickout flashing will allow water to penetrate at these points. It is recommended to have kickout flashing details installed to help prevent future water intrusion at this locations.

- The substrate (sheathing) behind the stucco finishes appear to be compromised. The stucco is bulging and very spongy to the touch. This condition needs to be further evaluated and repaired as necessary. It is my professional opinion that the stucco in the affected areas will need to be removed, the substrate replaced and the stucco finishes replaced.

- There is visible evidence of water intrusion through the stucco cladding system. This condition has caused some visible damage to the stucco cladding. This condition should be further evaluated and [repairs are recommended](#).

- Rust was observed on the stucco finish. This is an indication that water intrusion behind the stucco finish has occurred. [Repairs are recommended](#).

- Elevated moisture levels were detected in the wall finished surfaces.

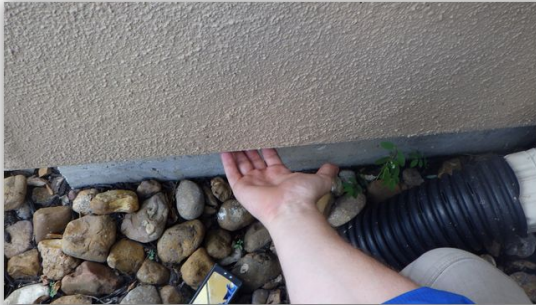
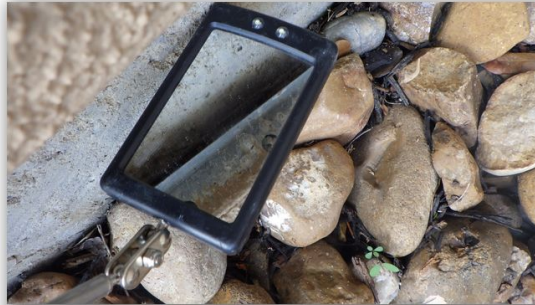
**Item Number 7**

- There is missing kickout flashing details at the lower bottom edge of the roof line interface and the sidewall that continues past the edge of the roof. The lack of this kickout flashing will allow water to penetrate at these points. It is recommended to have kickout flashing details installed to help prevent future water intrusion at this locations.
- The substrate (sheathing) behind the stucco finishes appear to be compromised. The stucco is bulging and very spongy to the touch. This condition needs to be further evaluated and repaired as necessary. It is my professional opinion that the stucco in the affected areas will need to be removed, the substrate replaced and the stucco finishes replaced.

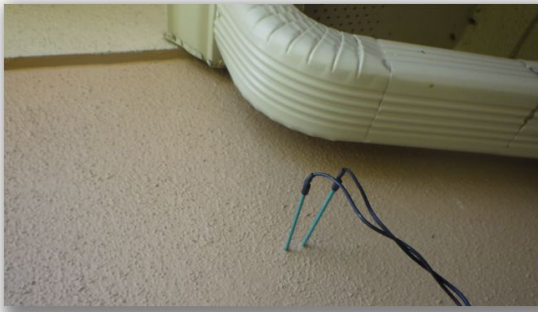
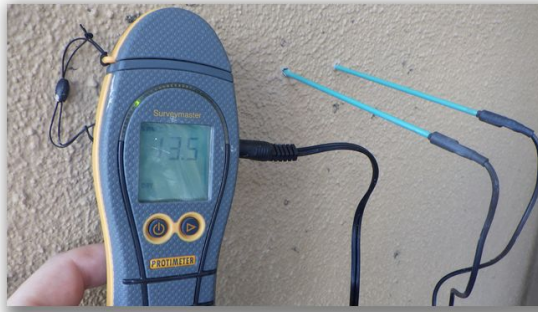
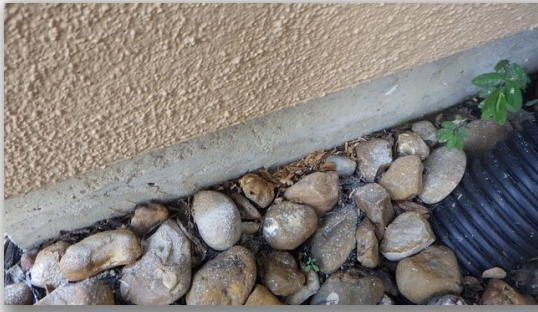
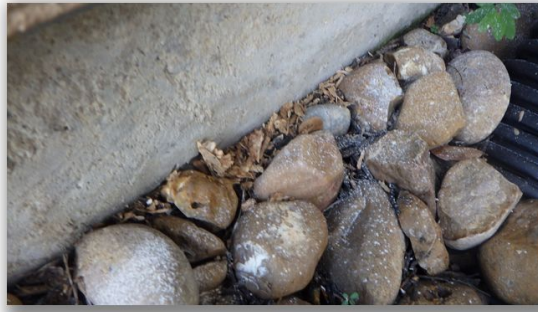
**Item Number 8**

- There is missing kickout flashing details at the lower bottom edge of the roof line interface and the sidewall that continues past the edge of the roof. The lack of this kickout flashing will allow water to penetrate at these points. It is recommended to have kickout flashing details installed to help prevent future water intrusion at this locations.
- The stucco weep screed was observed to be missing.

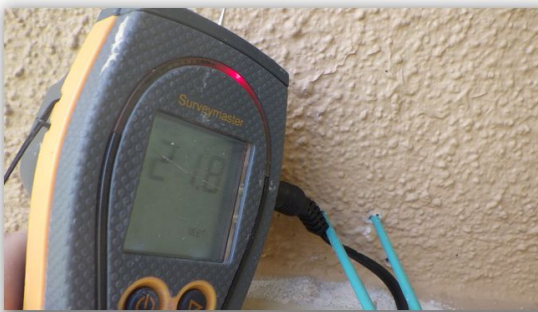
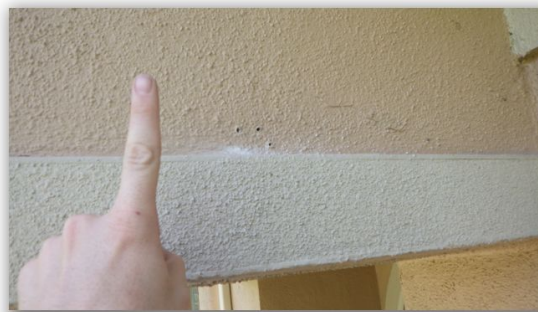
**Item Number 9**

- There is missing kickout flashing details at the lower bottom edge of the roof line interface and the sidewall that continues past the edge of the roof. The lack of this kickout flashing will allow water to penetrate at these points. It is recommended to have kickout flashing details installed to help prevent future water intrusion at this locations.
- The substrate (sheathing) behind the stucco finishes appear to be compromised. The stucco is bulging and very spongy to the touch. This condition needs to be further evaluated and repaired as necessary. It is my professional opinion that the stucco in the affected areas will need to be removed, the substrate replaced and the stucco finishes replaced.

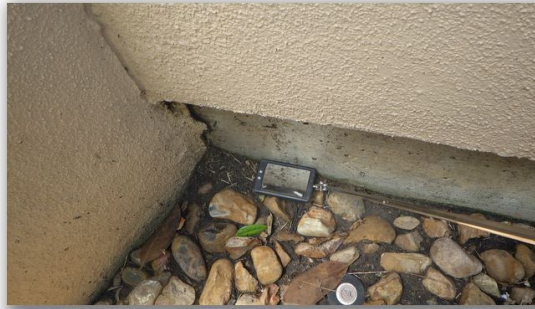
**Item Number 10**

- The ants have built a nest behind the stucco veneer. It is recommended to remove the nest to prevent moisture damage behind the stucco.

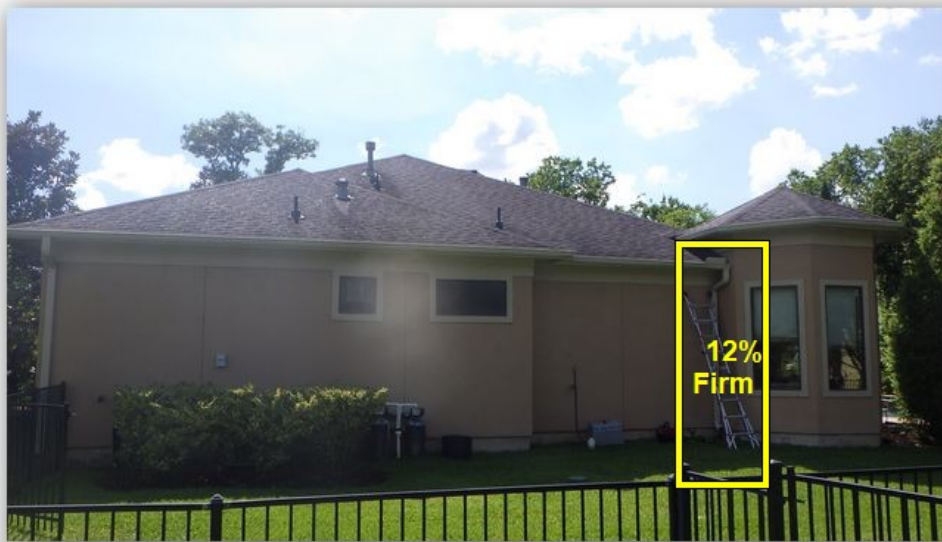
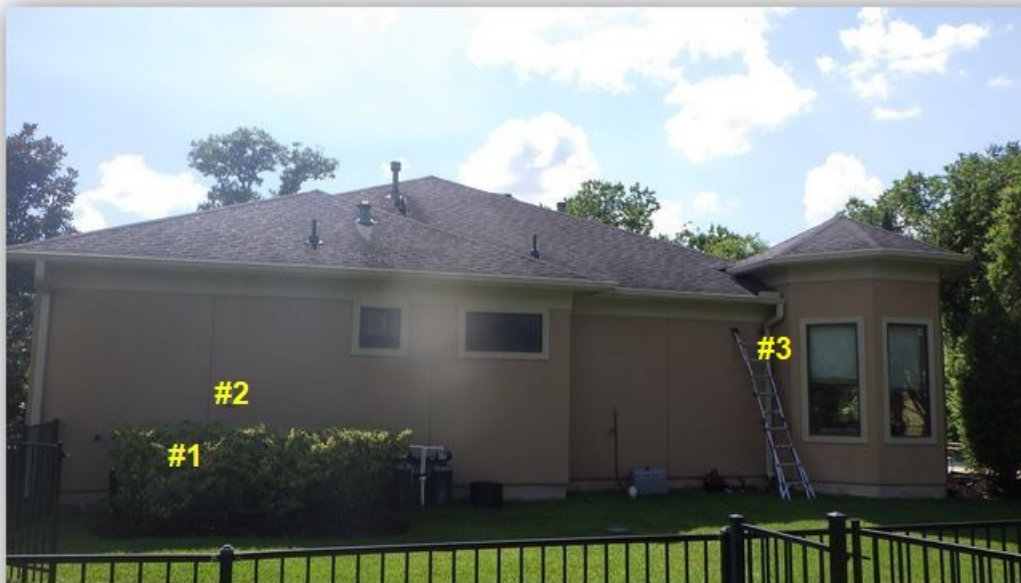
### Item Number 1

- There is foliage in contact with the exterior stucco finishes. It is recommended to trim the foliage at least 18-inches off the exterior walls.

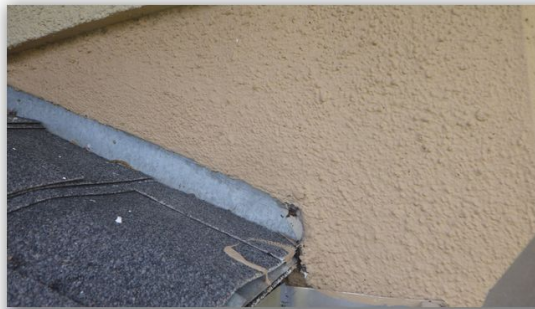
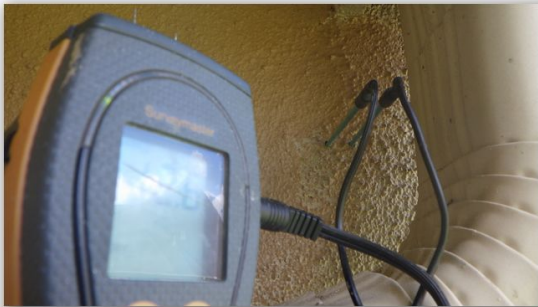
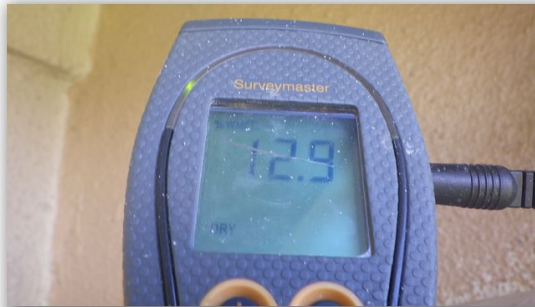
### Item Number 3

- There is missing kickout flashing details at the lower bottom edge of the roof line interface and the sidewall that continues past the edge of the roof. The lack of this kickout flashing will allow water to penetrate at these points. It is recommended to have kickout flashing details installed to help prevent future water intrusion at this locations.

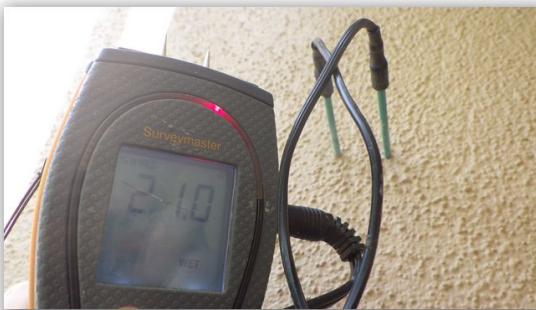
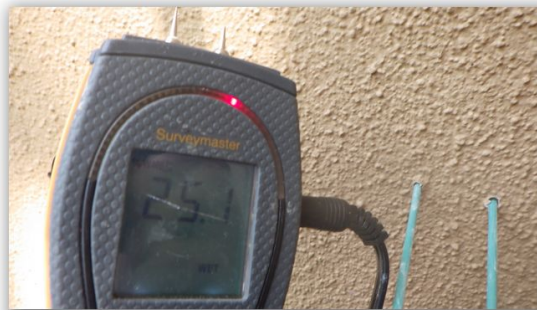
### Item Number 1

- There is missing kickout flashing details at the lower bottom edge of the roof line interface and the sidewall that continues past the edge of the roof. The lack of this kickout flashing will allow water to penetrate at these points. It is recommended to have kickout flashing details installed to help prevent future water intrusion at this locations.

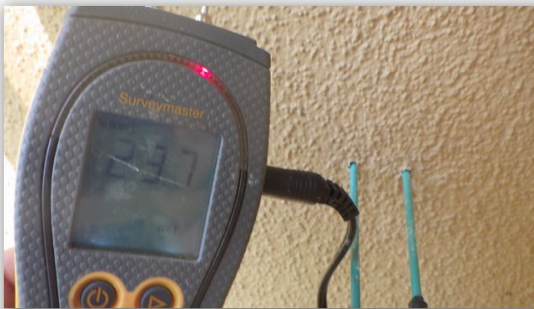
### Item Number 5

- There is missing kickout flashing details at the lower bottom edge of the roof line interface and the sidewall that continues past the edge of the roof. The lack of this kickout flashing will allow water to penetrate at these points. It is recommended to have kickout flashing details installed to help prevent future water intrusion at this locations.
