## **CLADDING MOISTURE REPORT**

**Stucco Inspection  
1234 No Name Street  
TX**

April 30, 2020

## Cladding Inspection Report

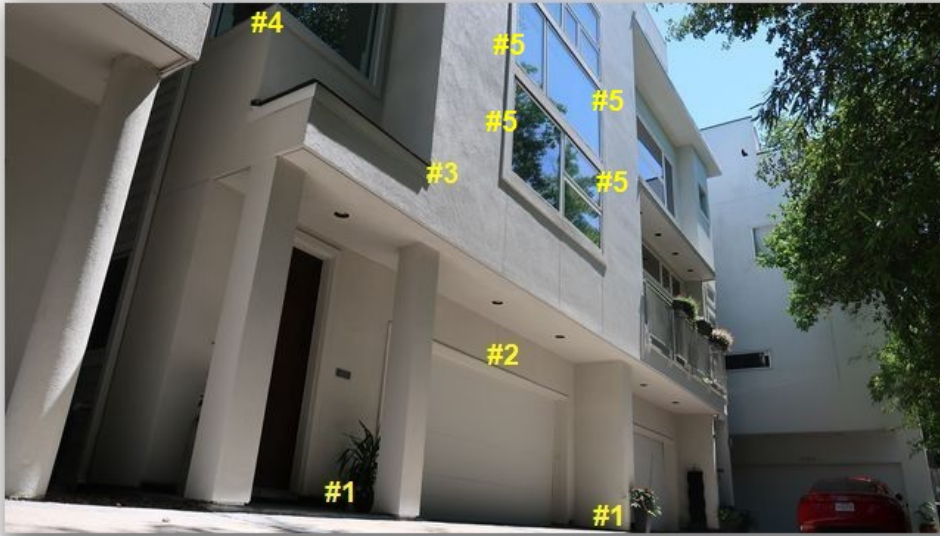
### Front Side of Structure

- There is failing and/or missing sealant at and around the window openings. [Repairs recommended](#) to prevent water intrusion to the stucco.
